TALLINNA TEHNIKAÜLIKOOL
TALLINN UNIVERSITY OF TECHNOLOGY

IMPREGNATED WOOD PERFORMANCE IN OUTDOOR ENVIRONMENT

MASTER THESIS

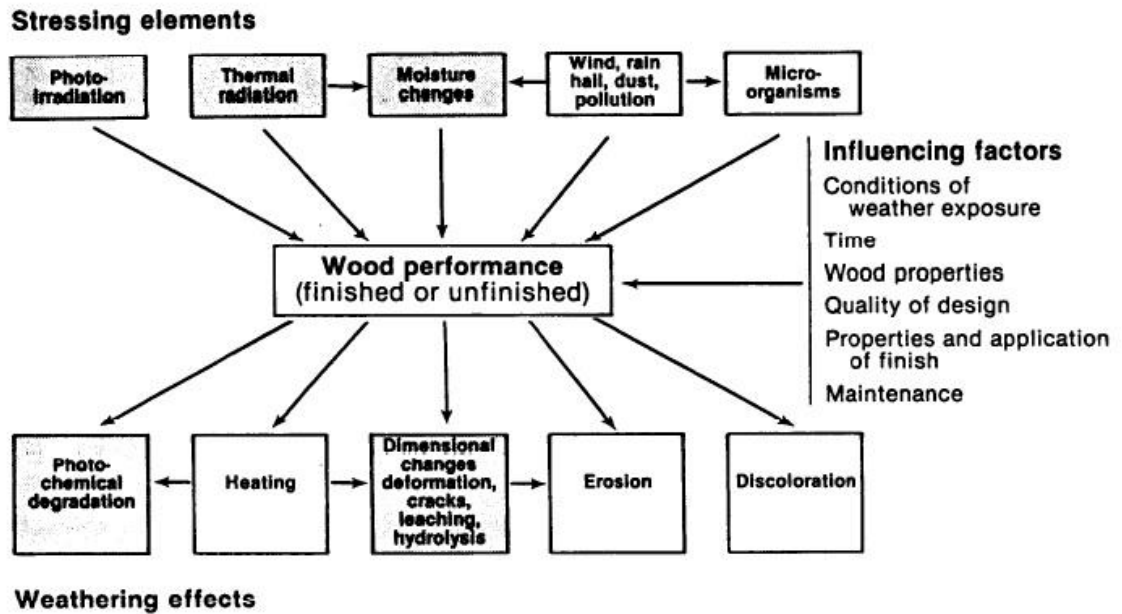
Figure 1. Stressing factors, influencing factors and weathering effects that contribute to wood/finish performance [1]

There is two main types of treatments being used to protect wood surfaces during outdoor exposure: firstly those finishes that form a film, layer, or coating on the wood surface, and secondly those finishes which penetrate the wood surface and leave no distinct layer or coating on the surface. [1] Stressing factors, influence factors and weathering effects that contribute to wood-finish performance and weathering, are summarized in Figure 1.

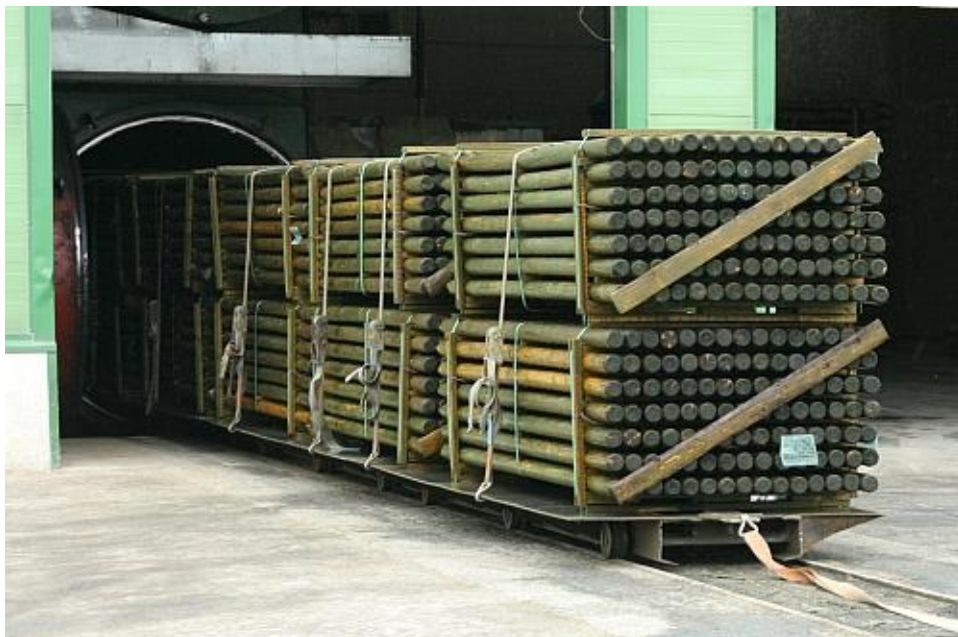
Figure 3. AS Imprest products exiting from auroclave after impregnation [9]

In the Baltic countries AS Imprest is the leading manufacturer of machine rounded timber products. They started operating in the year 2000 and today they export 93% of their output to 24 European countries and more than 250 trade customers. On Estonian market they supply all major retail chains with gardening and construction materials. All Imprest AS products are treated using a vacuum-pressure-vacuum method and they also offer timber treatment as a separate service. They have two treatment tanks (one treatment tank is presented on Figure 3) and they use water-borne, chromium free wood preservative – Impralit-KDS. Impralit-KDS ensures the necessary protection depending on the hazard class. For different products, markets and customers they are using different treatment processes but the majority of their timber is being treated according to European Standard EN 351-1 to meet the use classes described earlier. [9]

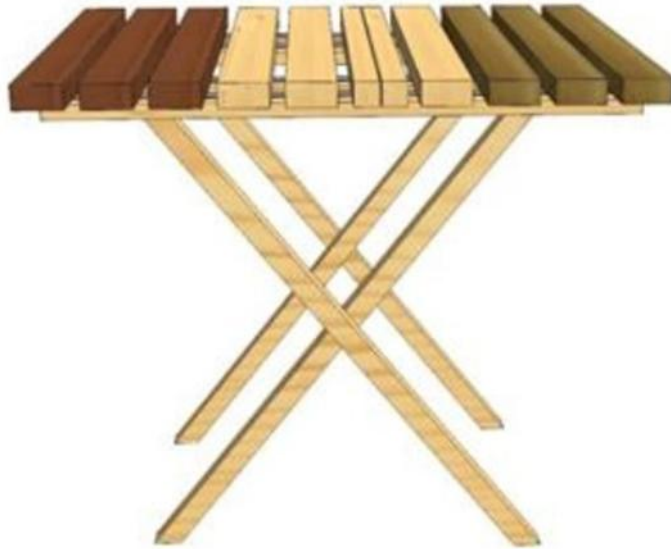
Figure 4. Folding table for performance test [20]

A folding table for fixing the spruce specimens was obtained through COST Action FP 1303 and principle concept can be seen on Figure 4. The specimens are fixed onto the table with screws, which are evaluated regarding of corrosion. Folding table has a plastic insulator strips to avoid moisture build up between the table and the specimens, this way the behavior of the specimens is more inherent.

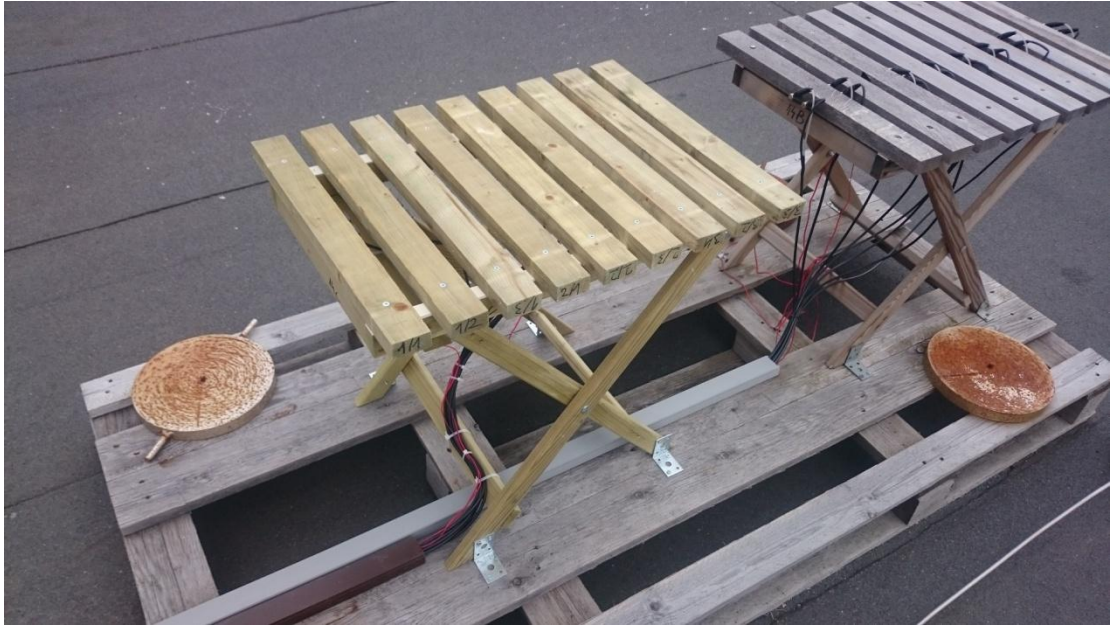
Figure 5. Performance table set up at the exposure site on 8th of April 2016

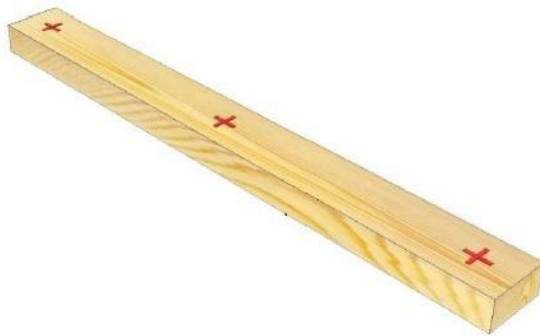
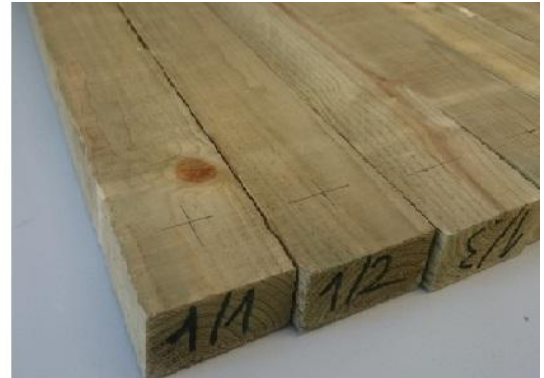
Figure 11. Position for measuring L*a*b color values [20] and measuring points on the specimens

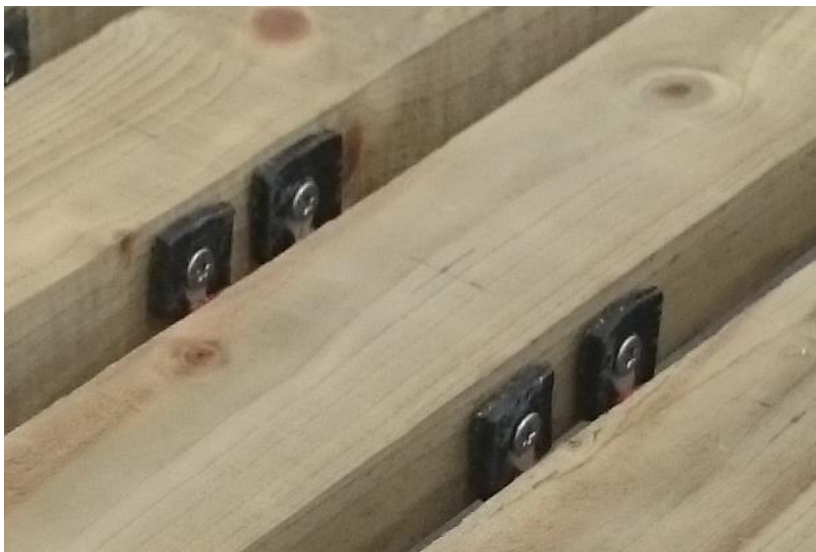
Figure 13. Isolated fasteners were used for fixing electrodes on wood specimens

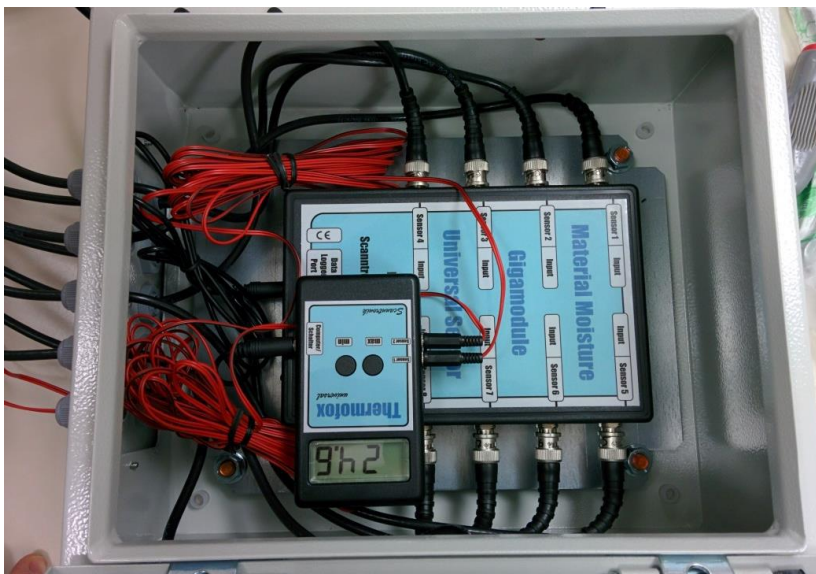
Figure 14. Thermofox datalogger and gigamodule [20]

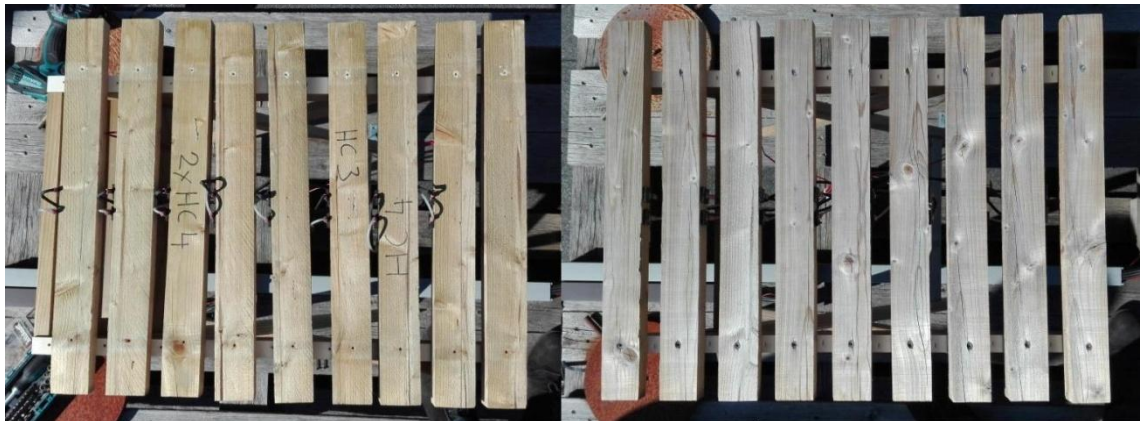
Figure 16. Under (left) and top (right) of the specimens on 5th of May 2017 for evaluation decay of the specimens

On 1st of December and 5th of May specimens were evaluated regarding decay and visually no progress of decay was found. On Figure 16, both sides of the specimens are shown during the last evaluation of decay on 5th of May 2017 which is approximately 13 months from exposure of the performance table.

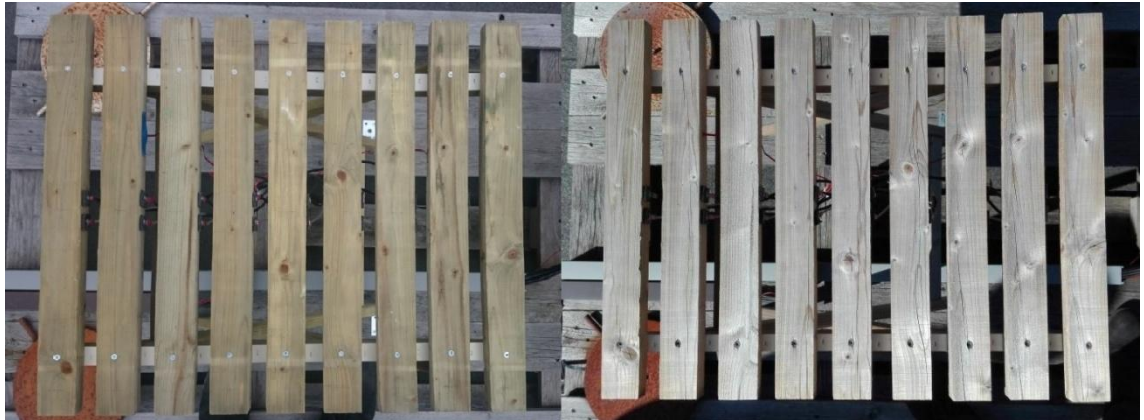
Figure 17. Topside of performance table on 8th of April 2016 (left) and on 5th of May 2017 (right)

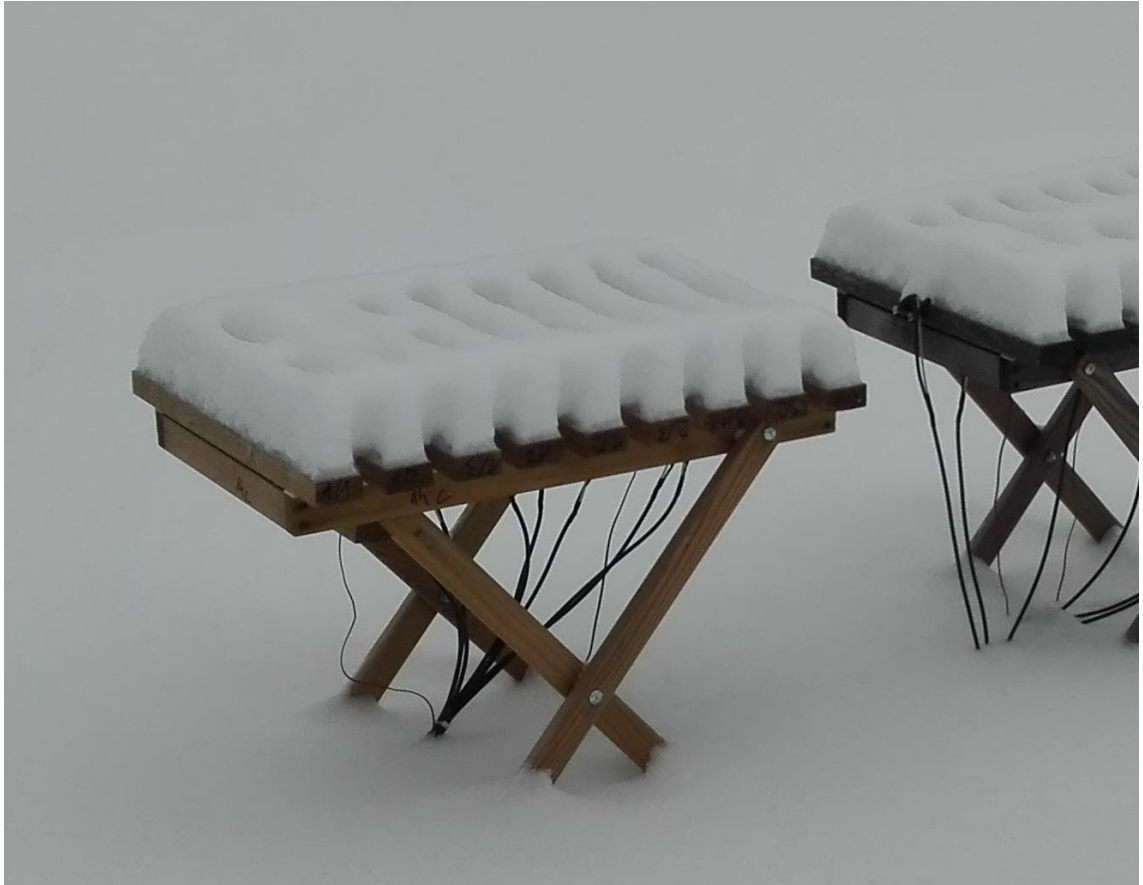
Figure 21. Performance table on 9th of November 2016

Preservative Impralit KDS manufacturer has promised temporary protection against blue stain and mold, and they have not specified the term temporary [17]. During 13 months of exposure no surface disfigurement due to mold and staining fungi was detected on specimens impregnated with Impralit KDS and all three impregnation cycles have ensured wood moisture content and protection which did not offer suitable conditions for mold and staining fungi to grow.

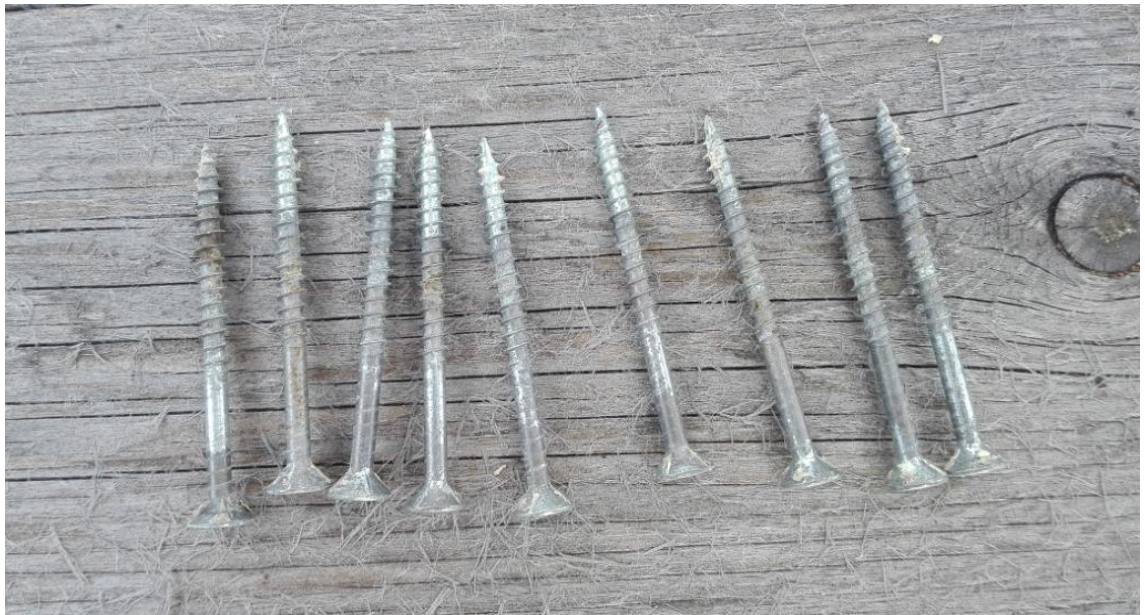
Figure 22. Galvanized screws removed from performance table on 29th of April 2016 for inspection

than untreated wood, because in similar performance test with similar conditions untreated Norway spruce was used and it took four weeks for the corrosion of metal fasteners to occur[33]. After 13 months of exposure it can be said that in current performance test Impralit KDS seems to be as corrosive as CCA and different impregnation cycles have not influenced the corrosion rate of the specimens. More accurate conclusion can be made after three years of exposure as the performance test is still ongoing.

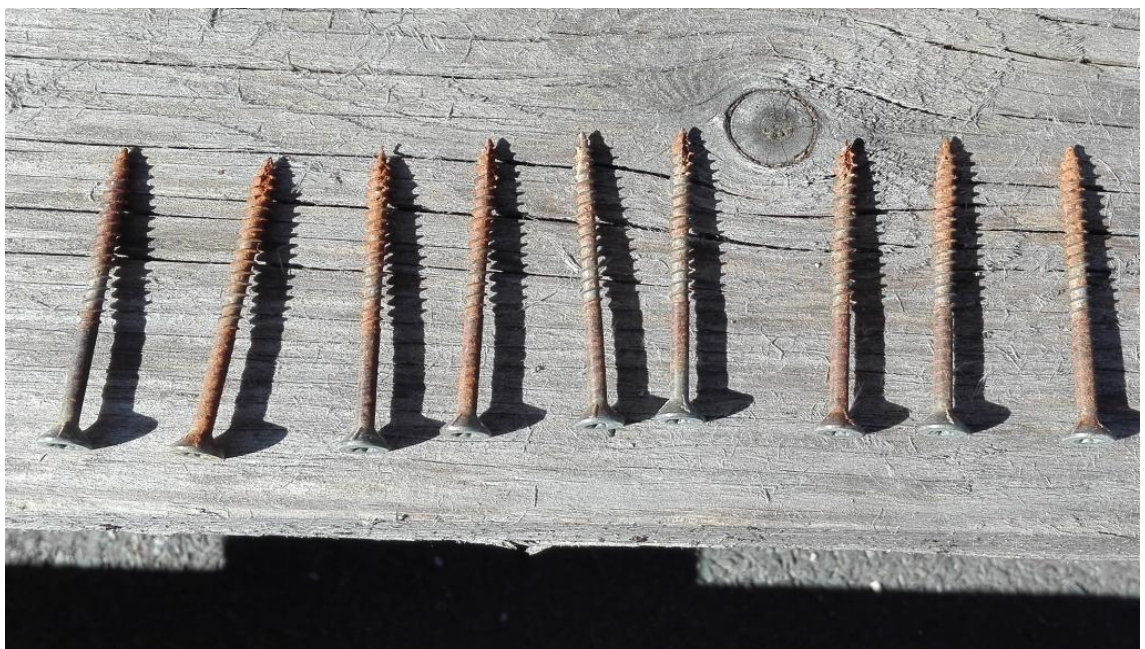
Figure 23. Galvanized screws removed from performance table on 5th of May 2017 for inspection

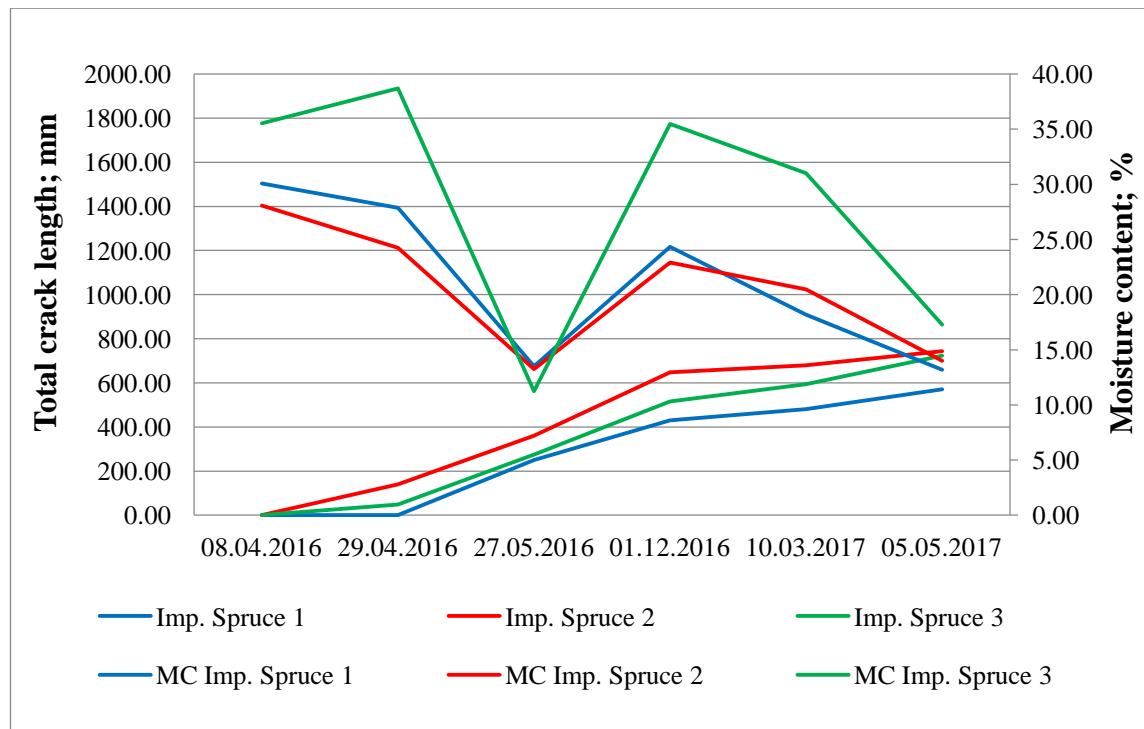
Figure 24. Total crack length and moisture contents of specimen groups

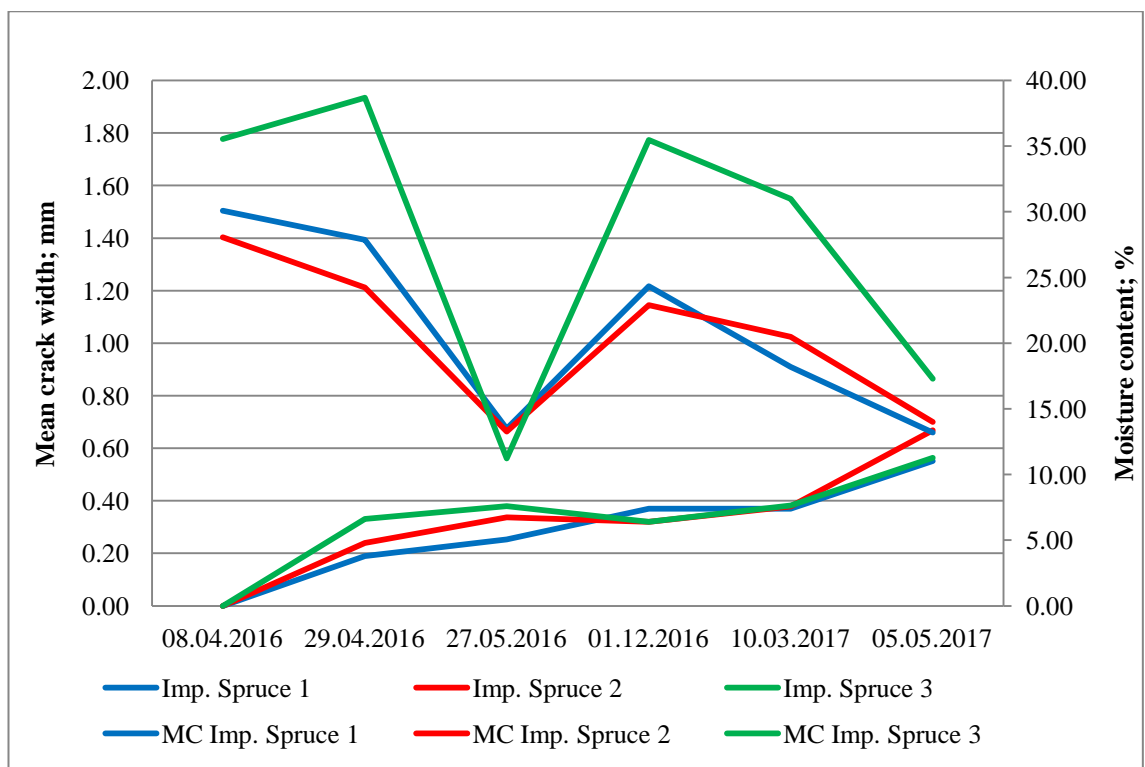
Figure 26. Mean crack width and moisture contents of specimen groups

After 13 months of exposure the crack formation of the specimen groups is rather similar as all the specimen groups have similar number of cracks with similar width and

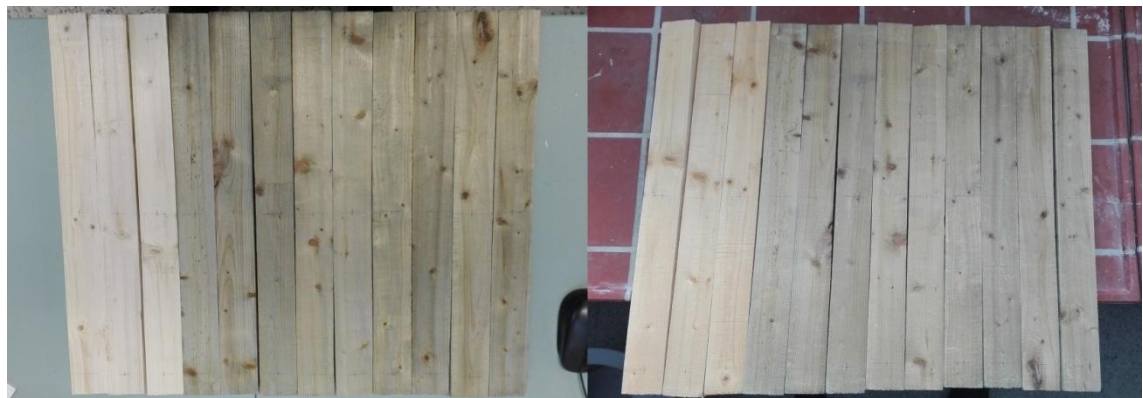
Figure 29. Test specimens before (left) and after (right) 336 hours of artificial UV irradiation

One continuous cycle was used for irradiation of the specimens and a total irradiation time was 336 hours. Test specimens were placed under UV irradiation alternately by specimen group and during the UV irradiation test intensities of irradiation at a wavelength of 350nm were checked with a radiometer Delta OHM HD 2102.2. On Figure 29, upper sides of test specimens are presented before and after the artificial UV irradiation.

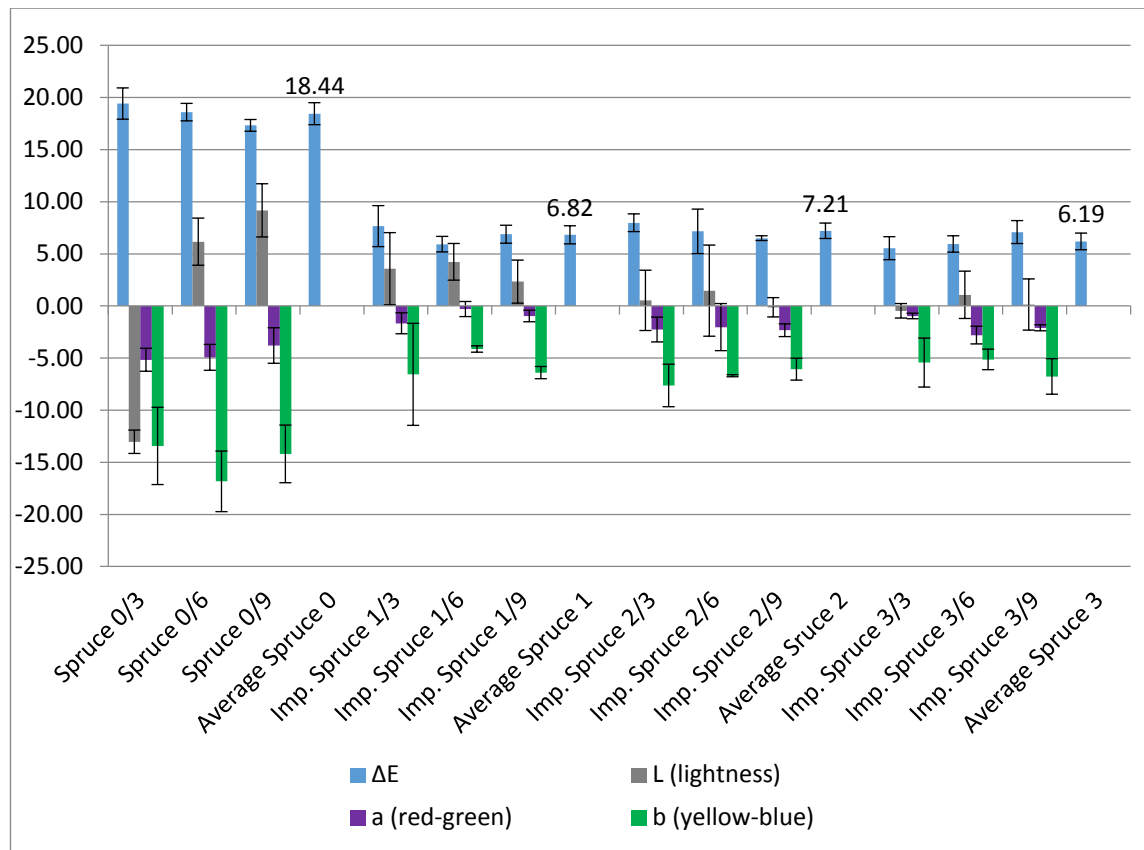
Figure 30. Color change of specimens after UV irradiation of 336 hours

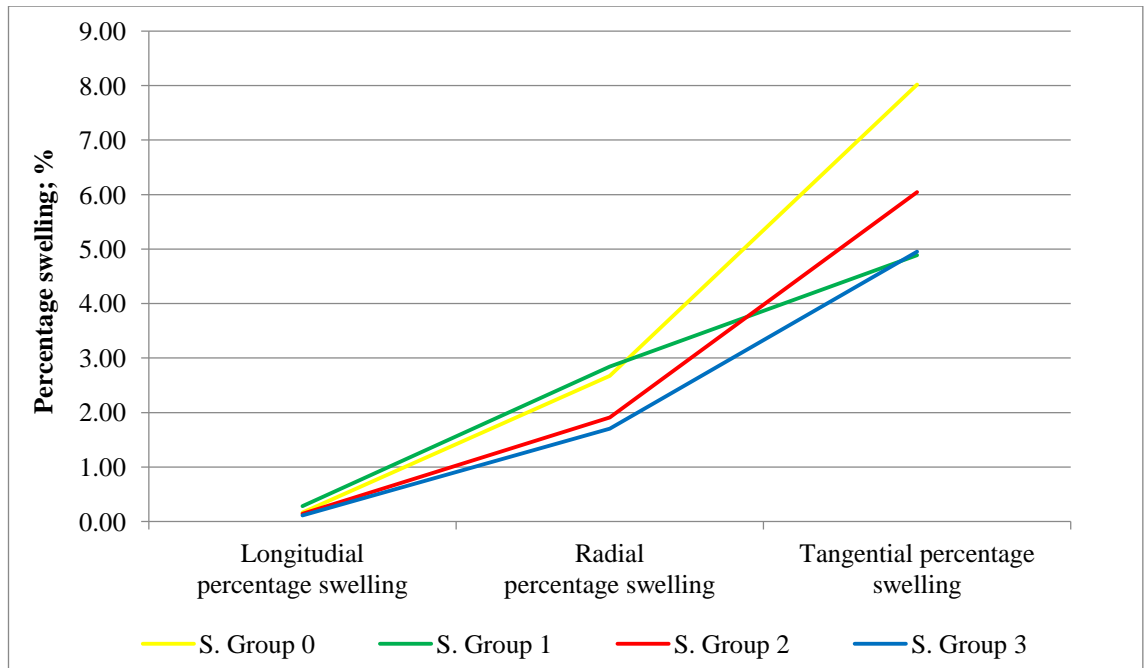
Figure 33. Longitudinal, radial and tangential percentage swelling of the laboratory specimens provided by AS Imprest during the swelling test

Result from the swelling test show and correlate with statements described earlier in chapter of crack formation, that the tangential swelling was approximately 2 to 3 times greater than the radial swelling, which also is the reason why more stresses form in tangential surfaces and result in greater crack formation.
