THESIS ON CIVIL ENGINEERING F65

**Renovation and Energy
Performance Improvement of Estonian
Wooden Rural Houses**

TALLINN UNIVERSITY OF TECHNOLOGY
School of Engineering
Department of Civil Engineering and Architecture
Nearly Zero Energy Buildings Research Group

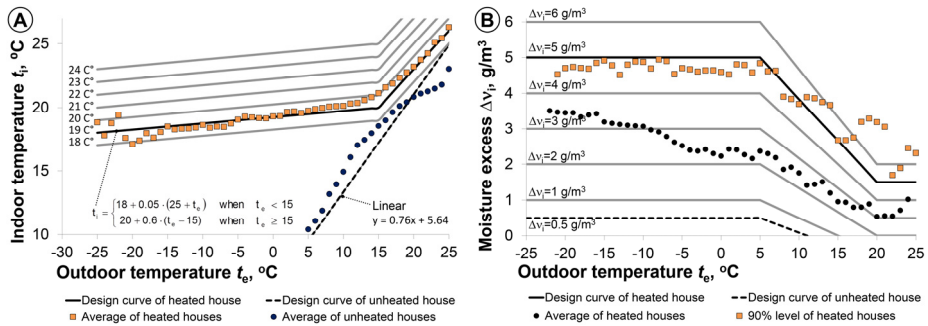
Figure 3.3. Dependence of the indoor temperature on the outdoor temperature in wooden houses (A) and 90% level of weekly maximum moisture excess at the corresponding outdoor temperature (B). Figures are developed based on measurements presented in II.

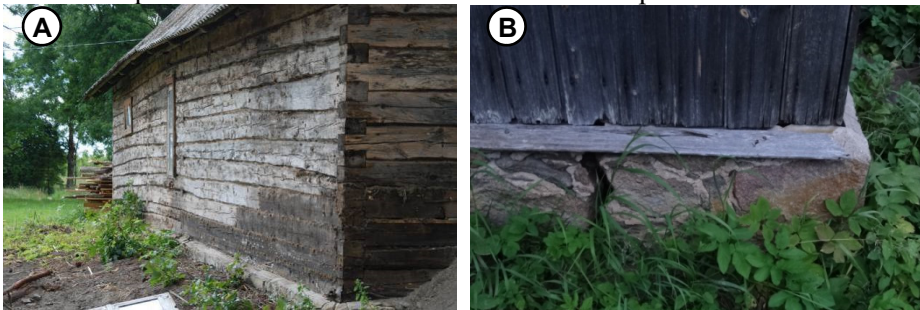
Figure 4.2. Uneven settlement of the foundation and an excessively low foundation wall (A) and large cracks in the foundation due to the soil freezing and damaged water boarding (B).

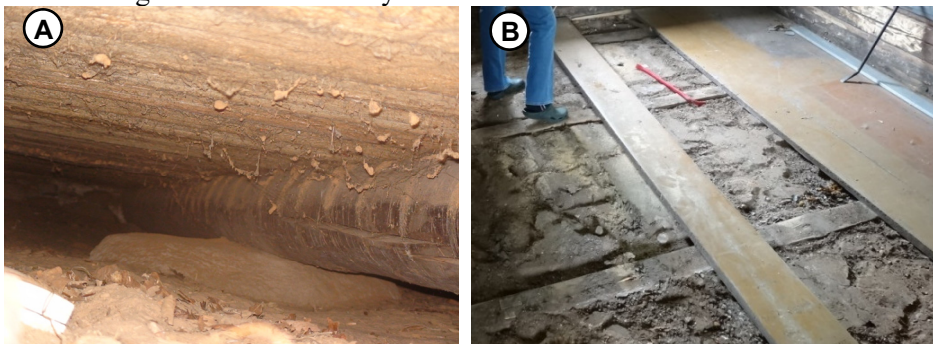
Figure 4.3. Wooden floor on roundwood beams (A). Floor beams inside damp soil (sand) (B).

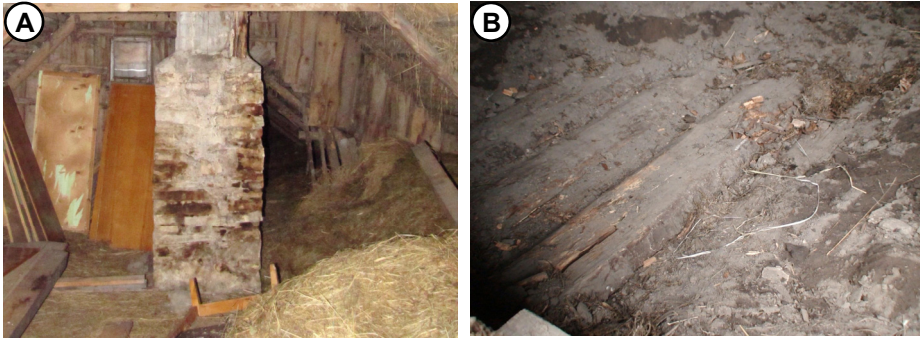
Figure 4.7. Fire risk in the attic (A). Rot damage to wooden ceiling details insulated with soil (B).

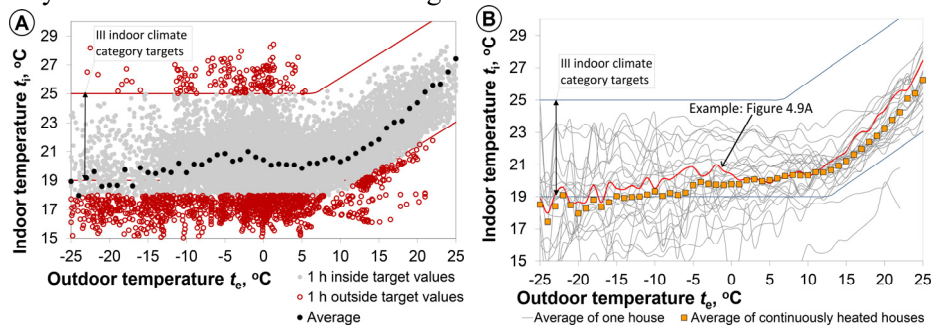
Figure 4.9. Dependence of the t_i on the t_e in one measured house (A) and in all continuously used houses, including average value (B).

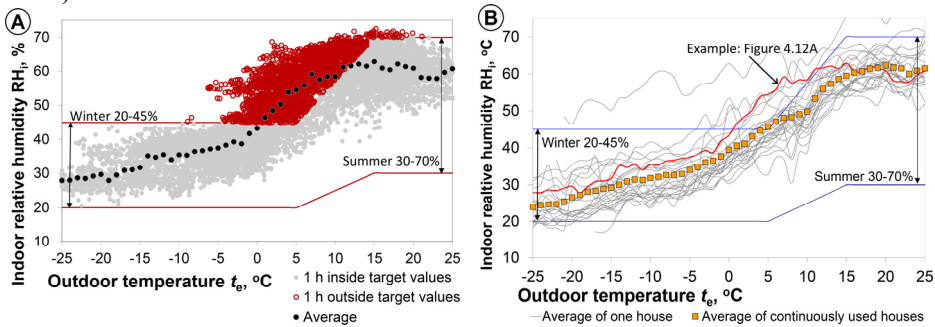
Figure 4.12. Dependence of the indoor RH on the t_e in one house (A) and in all continuously used houses (B).

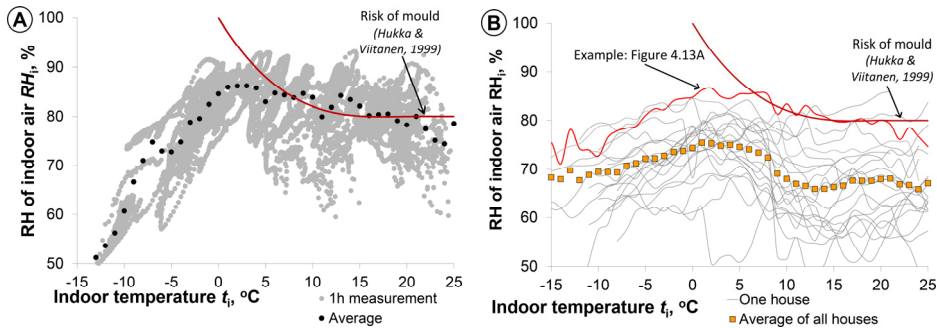
Figure 4.13. Dependence of the indoor RH on the t_i and risk of mould growth in one house (A) and in all unheated houses (B).

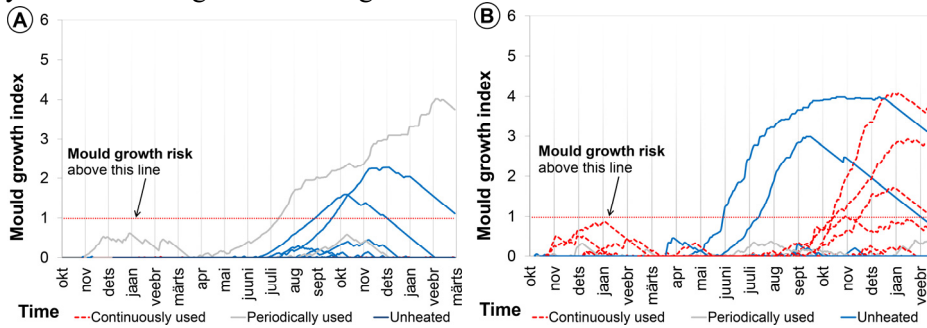
Figure 4.14. The level of M in the indoor air (A) and at the inner surface of the joint of the external wall and the base floor (B) in continuously used, in periodically used/heated and in unheated houses.

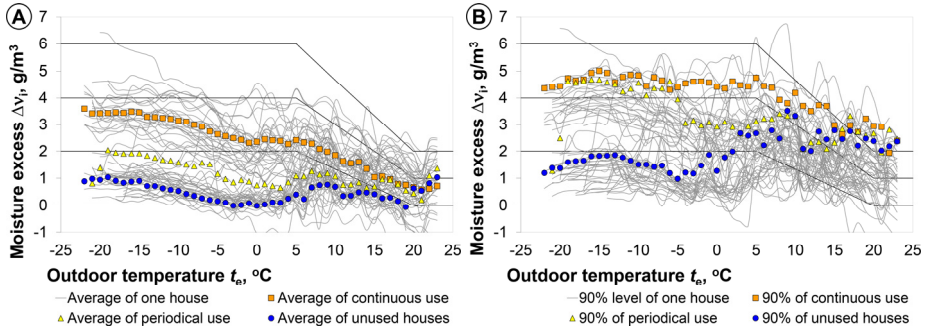
Figure 4.16. Weekly average (A) and 90% level (B) of moisture excess in all measured houses according to the usage profile. The horizontal straight lines represent high (starting from 6) and low (starting from 4) moisture excess design values (90 % level) based on previous studies in Estonian houses.

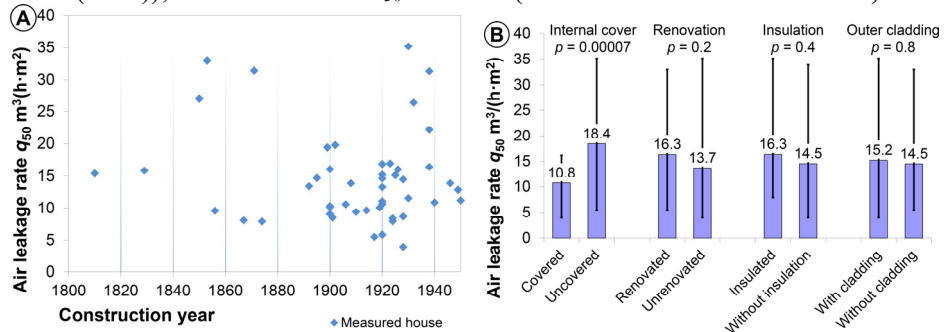
Figure 4.18. Correlation of air leakage rate and construction year (A) in all measured houses. Air leakage rate depending on selected characteristics of the envelope (B) in the measured houses.

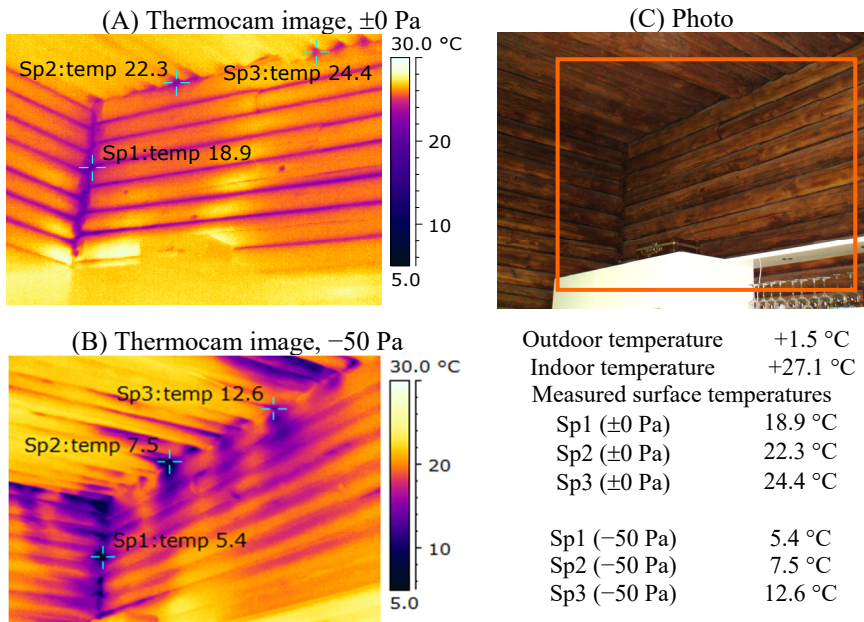
Figure 4.19. Thermocam image from the junction of the external wall and the ceiling under normal conditions (A); thermocam image after 50 Pa depressure (B). Normal image (C) and numeric data (table).

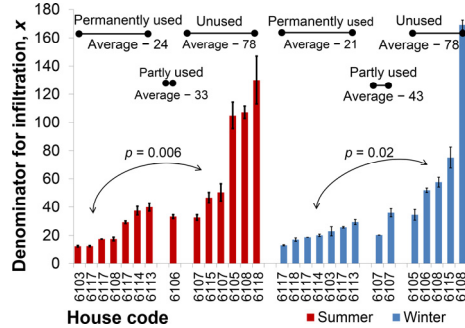
Figure 4.21. Passive infiltration in houses with a different usage profile in summer and winter.

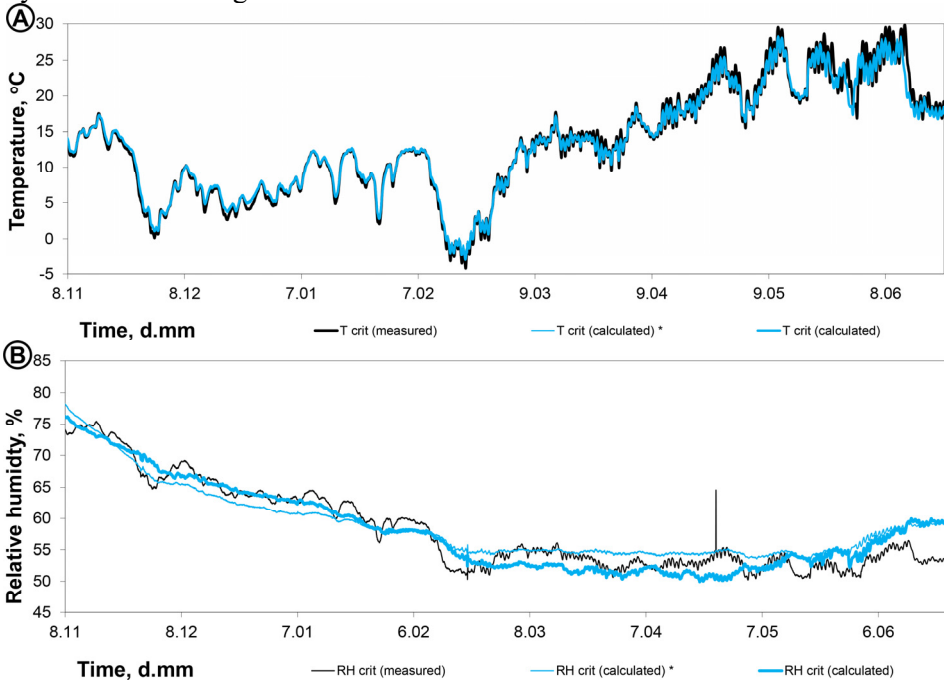
Figure 4.22. Comparison of the measured and calculated temperature (A) and *RH* (B) on the studied critical surface between mineral wool and log wall layers (Figure 3.2). Calculated temperature and *RH* marked with an asterisk represent the calculation case where air leakage was excluded.

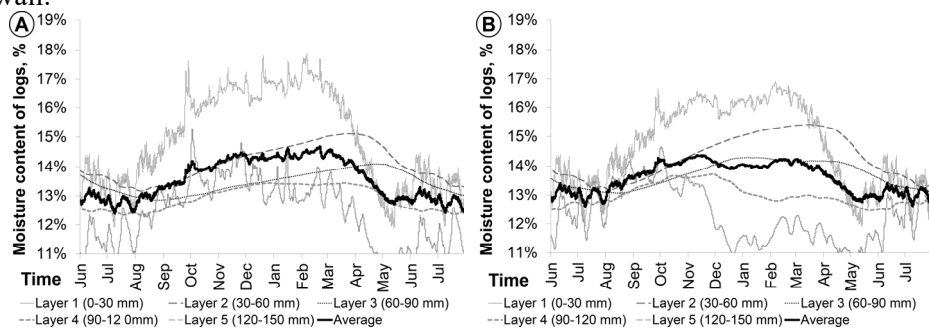
Figure 4.23. The *MC* in log layers (Figure 3.2) in an unheated house (A) and a continuously heated house (B).

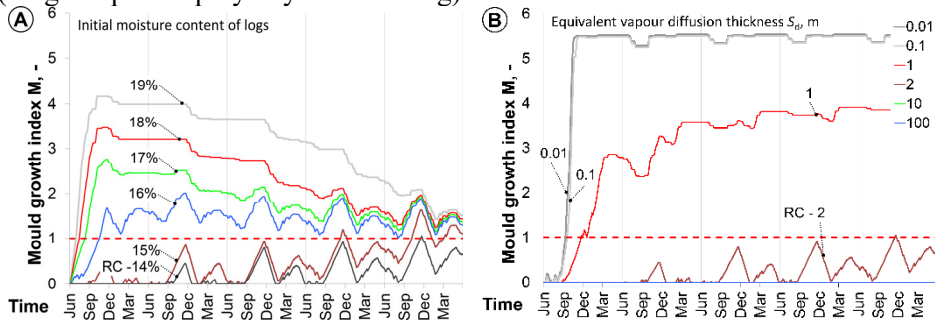
Figure 4.25. The level of M between the inner surface of a log and insulation depending on the initial moisture level of logs (A) and on the S_d of the water vapour membrane (B).

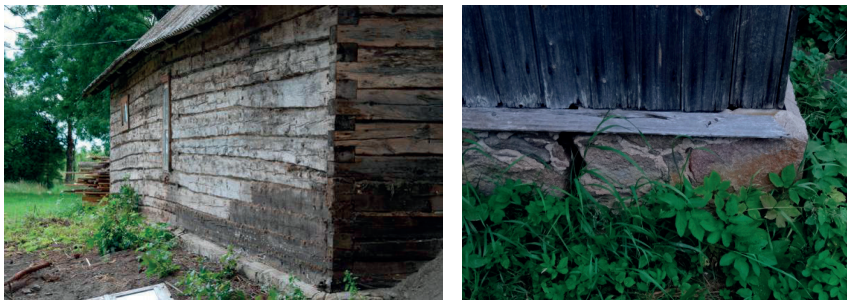
Figure 3: Uneven settlement of the foundation and an excessively low foundation wall (left) and cracks in the foundation due to the soil freezing and damaged water boarding (right).

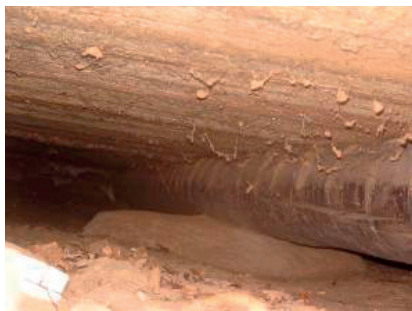
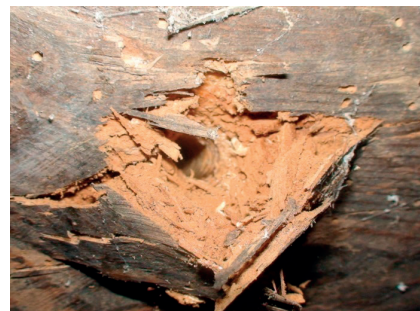
Figure 4: Wooden floor on roundwood beams (left) damaged by rot and insects (right).

In many of the houses examined, wooden beams had rot damage. Therefore, the effective cross-section of the beams had decreased and the floors had sagged. Hygrothermal conditions in the crawl space were almost always favourable for mould growth or even rot. These favourable conditions may be due to one or more causes:

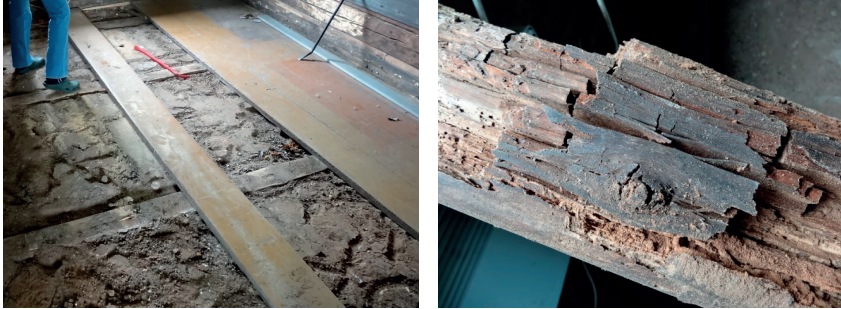
Figure 5: Floor beams inside damp soil (sand) (left). Floor planks are ~4 cm thick, and a ~1 cm thick layer from the lower surface is rotten (right).

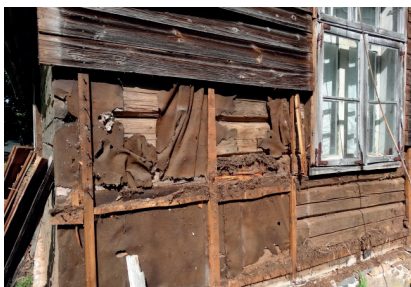
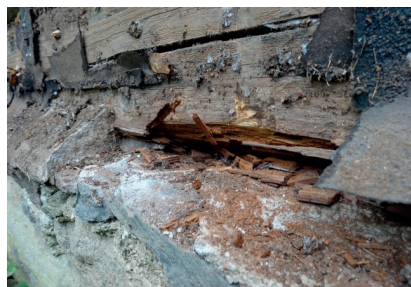
Figure 7: The bitumen paper behind the external boarding that should stop the rain load on the log is broken and has clogged the air layer behind the boarding (right). Missing waterproofing between the foundation and the log and the mortar above the log result in rot damage to the lower log (right).

A waterproofing layer between the foundation and the wall is damaged or is not laid at all during construction. Mainly for this reason, in half the houses moisture damage is evident in the first log rows. On top of the foundation edge, mortar surface tilting outwards has been built in many houses to direct rainwater away from the wall (Figure 7, right). If any water gets between the log wall and the additional concrete edge, the drying of the log surface will take much longer and the moisture will increase the

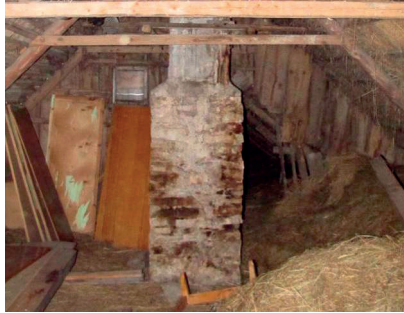
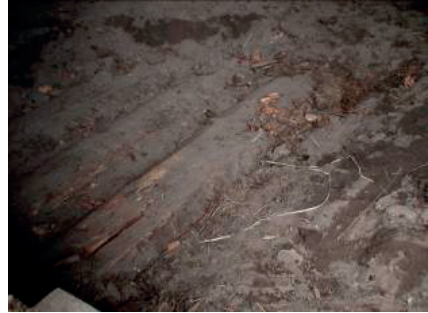
Figure 10: Fire risk in the attic (left). Rot damage to wooden ceiling details insulated with soil.

If the ceiling is insulated with soil or sand and if there are water leaks through the roof, insulation may be wet permanently (or for extended periods). Wet insulation causes wooden ceiling details to rot (Figure 10, right). Insulation particles (sawdust, sand or mixtures thereof) fall into rooms through cracks in the ceiling boarding, and cleaning this dust causes extra work and inconvenience for inhabitants. The falling dust problem is solved with a double ceiling below the original one, made of matchboards or plywood. In a few renovated buildings, the old insulation has been replaced and/or

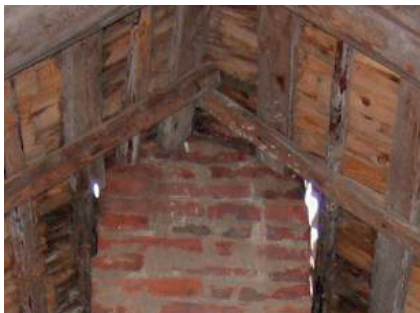
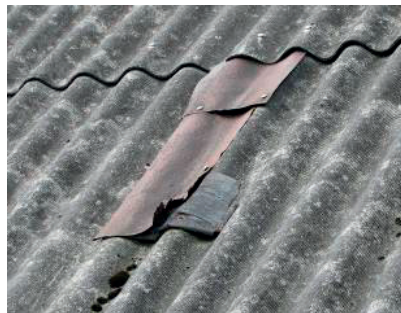
Figure 11: Typical leaks: around the chimney (left) and due to excessively old roof covering (right).

Every possible water leak area in the roof covering visible either from inside or outside should be marked on a roof sketch, and temporary fixings (Figure 11, right) should be also recorded. Immediate repairs of leaks should be recommended to the owners. Likely leak areas are near chimneys (Figure 11, left) or other through elements, and these areas should be inspected carefully. Fixing, water tightness and any potential need for repairs in case of flashings should be indicated in the survey report. If a rain-water drainage system has been installed, every component in it should be checked for damage. Gutters need to be cleared of leaves and downpipes fixed firmly to the wall. The drainage system must be continuous, without any gaps.

The main function of the roof is to protect the house from precipitation. Water leaks in roof covering are the main cause for roof construction damage. Main causes for water leaks include:

- Ageing roof covering.
- Poor roof maintenance (moss and leaves on the roof).
- Faulty fastening of roof covering.
- Temporary repairs of leak areas.
- Extensive settlement of load-bearing construction.
- Defective edges or covering components.
- Holes or cracks near components passing through the roof (chimneys, ventilation pipes, antennas etc.).

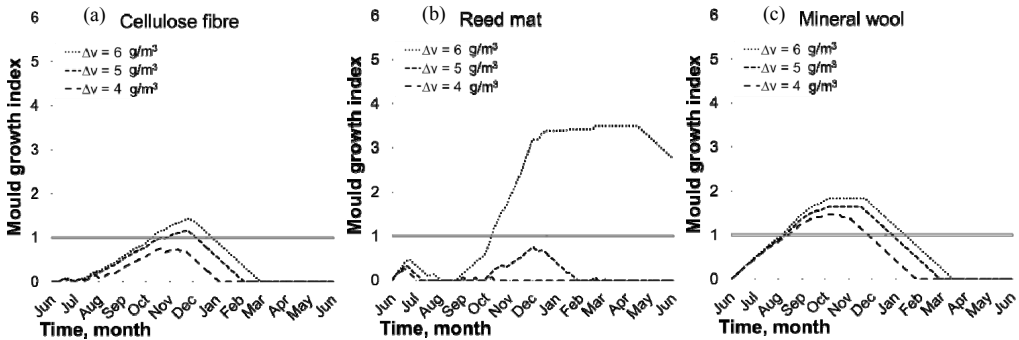
Fig. 7 Mould growth index on the inner surface of the log in contact with cellulose fibre (a), reed mat (b) and mineral wool (c) depending on the indoor humidity load.

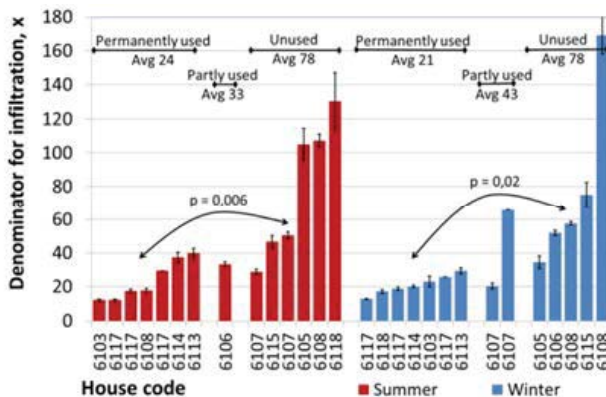
Fig. 4 Passive infiltration in houses with different usage profile in summer and winter

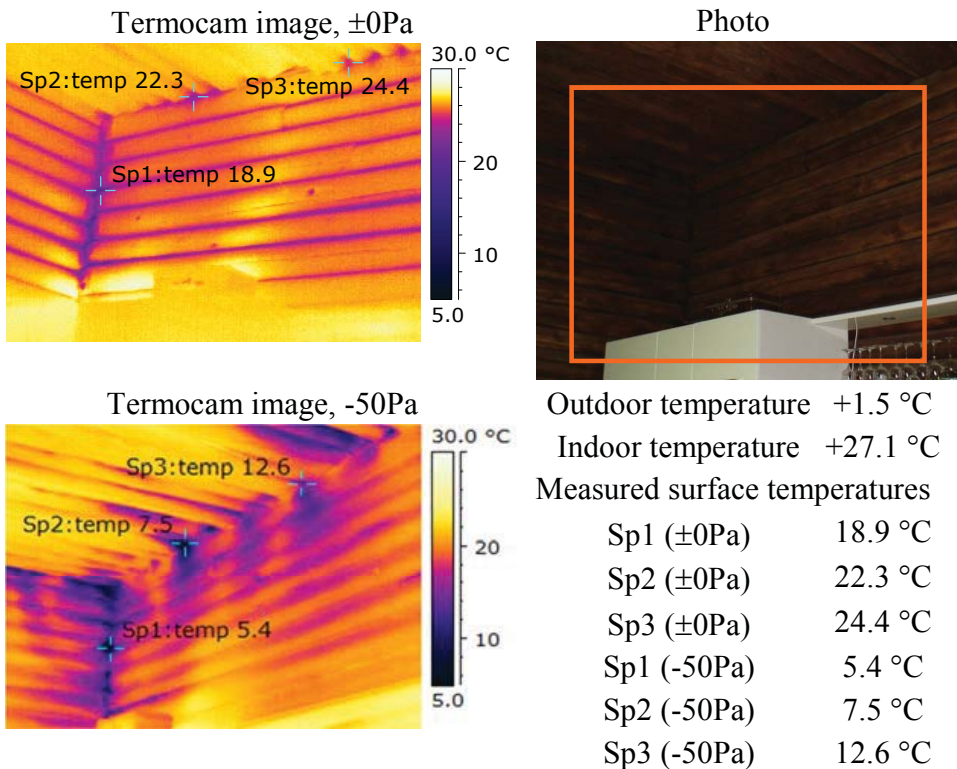
Fig. 5 Termocam image from junction of external wall and ceiling under normal conditions (upper left) termocam image after 50Pa depressure (lower left) with normal image (upper right) and numeric data (lower right).
