Investigation of the causes of deterioration of old reinforced concrete constructions and possibilities of their restoration

THESIS ON CIVIL ENGINEERING F20

TALLINN UNIVERSITY OF TECHNOLOGY
Faculty of Civil Engineering
Department of Structural Design

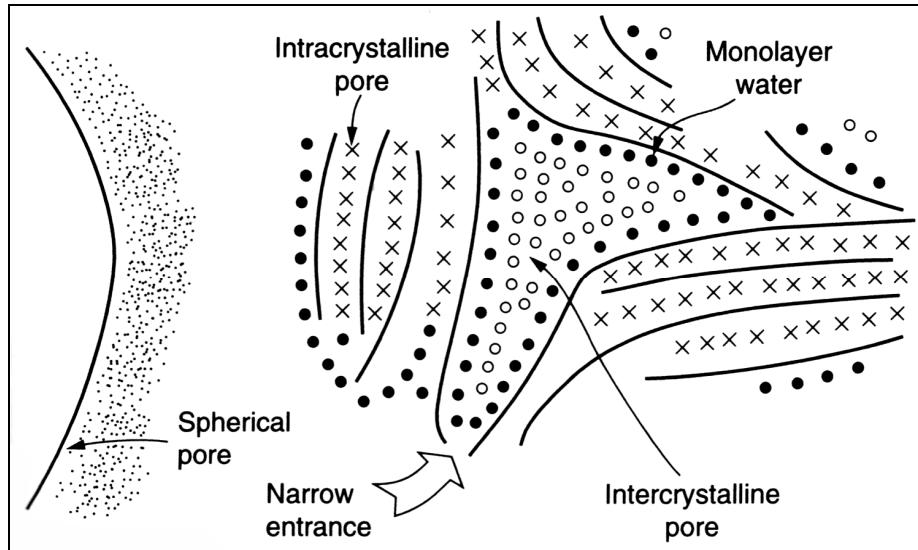
Figure 2.1 Diagrammic representation of the pore system in hydrated cement paste based on Rahman's model [13]

The pores relevant to permeability are those with a diameter of at least 120 or 160 nm. These pores have to be continuous. Pores which are ineffective with respect to flow, that is to permeability, include, in addition to discontinuous pores, those which contain adsorbed water and those which have a narrow entrance, even if the pores themselves are large (see Figure 2.1).

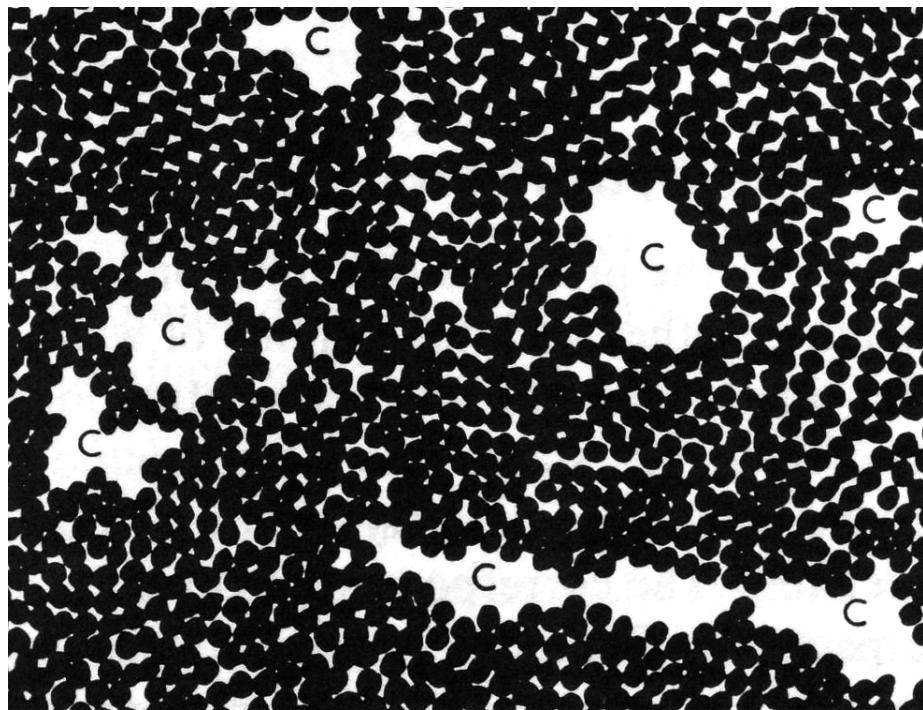
Figure 2.3 Simplified model of paste structure. Solid dots represent gel particles; interstitial spaces are gel pores; spaces such as those marked C are capillary pores. Size of a gel pore is exaggerated [1]

Fresh cement paste is a plastic network of cement in water, but once the paste has set, its apparent or cross volume remains approximately constant. At any stage of hydration, the hardened paste consists of very poorly crystallized hydrates of various compounds referred to collectively as gel, of crystals of $\text{Ca}(\text{OH})_2$, some minor components, unhydrated cement, and the residue of the water-filled spaces in the fresh paste. These voids are called capillary pores but within the gel itself, there exist interstitial voids called gel pores. The nominal diameter of gel pores is about 3 nm while capillary pores are one or two orders of magnitude larger. Thus, in the hydrated paste there are two distinct classes of pores represented diagrammatically in Figure 2.3.

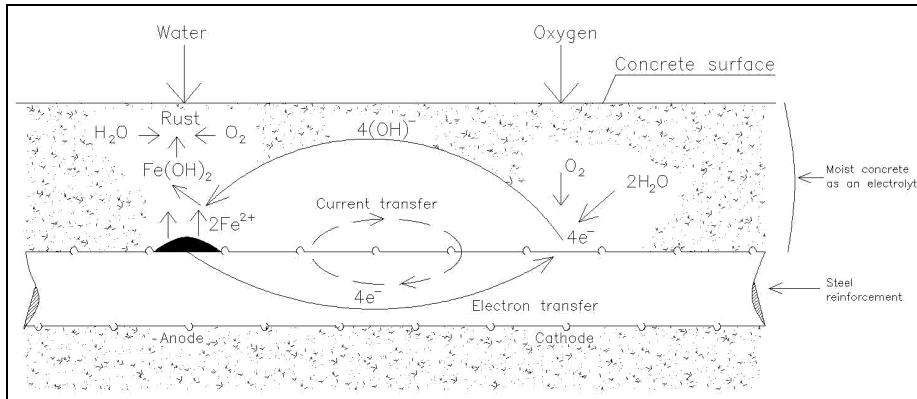
Figure 2.7 Simplified model of the corrosion process of reinforcement steel in concrete

These travel through the electrolyte and combine with the ferrous ions to form ferric hydroxide which is converted by further oxidation to rust (see Figure 2.7).

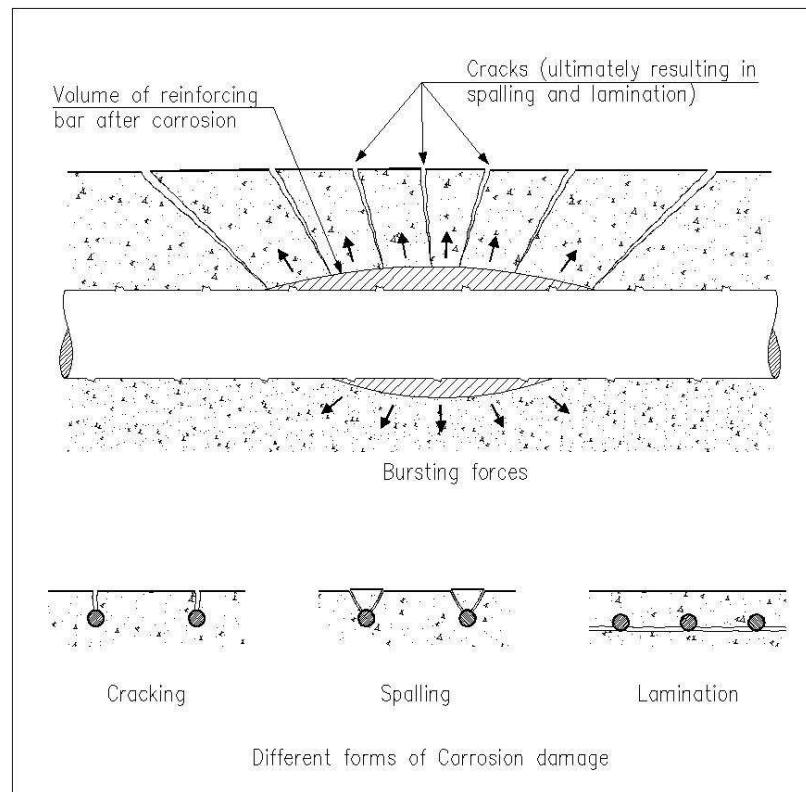
Figure 2.8 Cracking and spalling of concrete caused by corrosion of the reinforcement [3]

There are two consequences of corrosion of steel. First, the products of corrosion occupy a volume several times larger than the original steel so that their formation results in cracking (characteristically parallel to the reinforcement), spalling or in delamination of concrete (see Figure 2.8). This makes it easier for aggressive agents to ingress toward the steel, with a consequent increase in the rate of corrosion.

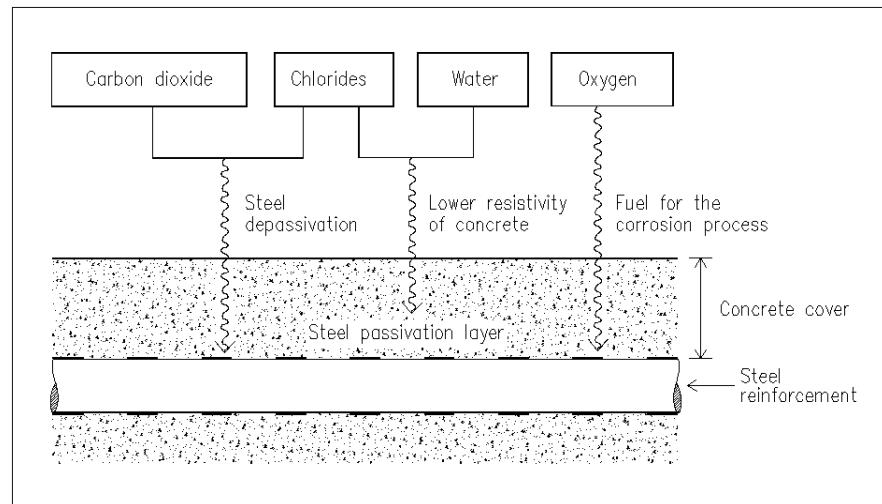
Figure 2.9 Critical environmental factors on corrosion of steel reinforcement

The corrosion reaction, however, can still proceed (see Figure 2.9) when [3]:

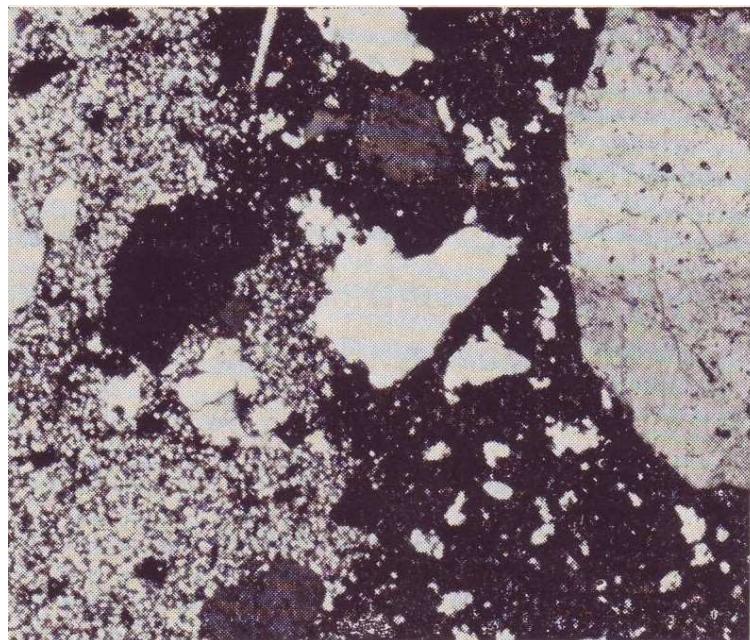
Figure 2.10 Transition over carbonated (left- white) to non carbonated zone (right-dark) of the cement stone under the microscope [8]

Carbonation does not cause deterioration of concrete but it has important effects. With respect to durability, the importance of carbonation lies in the fact that it reduces the pH of the pore water in the hardened Portland cement paste from 12.6 to 13.5, to a value of about 9. When all of Ca(OH)₂ has become carbonated (see Figure 2.10), the value of pH reduces to 8.3 [1].

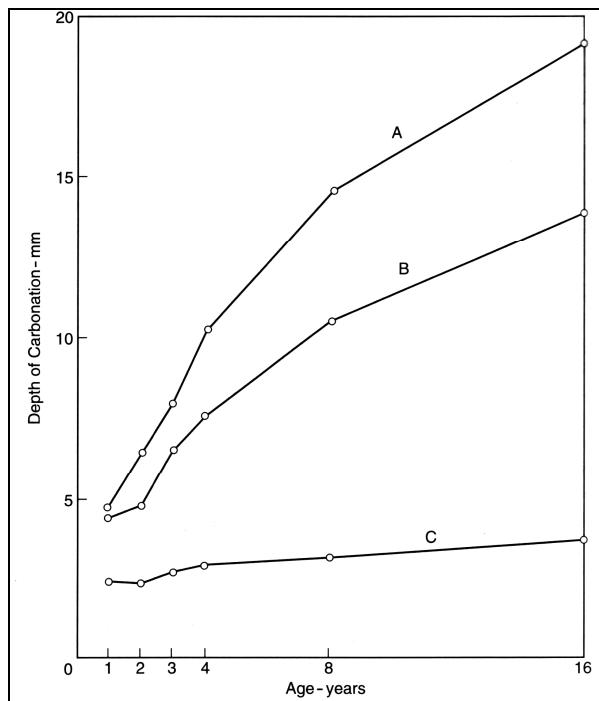
Figure 2.11 Progress of carbonation with time of exposure under different conditions: (A) 20 °C and 65% relative humidity; (B) outdoors, protected by a roof; (C) horizontal surface outdoors in Germany. The values are averages for concretes with water/cement ratios of 0.45, 0.60 and 0.80, wet-cured for 7 days (based on [19])

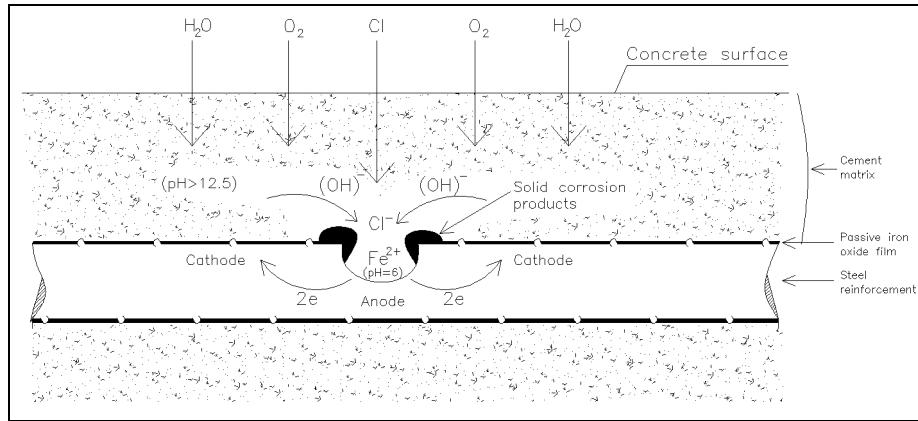
Figure 2.12 Pitting corrosion caused by chlorides

The anode is much smaller in area than the cathode and, as a result, the formation of the ferrous ions in the anode extends deeper and deeper, and pit is formed (see Figure 2.12).

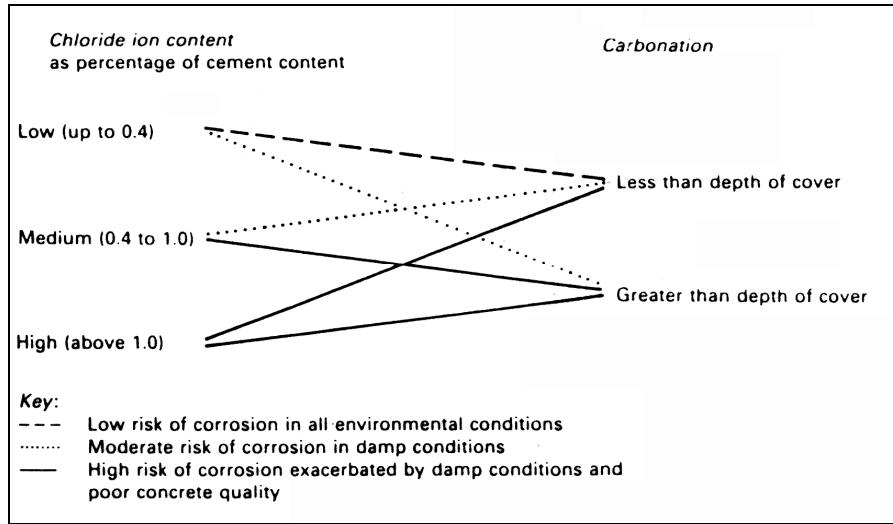
Figure 2.13 Risk of corrosion in relation to concrete analysis [3]

It should be noted that, in practice, it is possible to have both carbonation and chloride attack taking place simultaneously. The risk of corrosion in this case is very much dependent on the chloride ion content and the rate of carbonation (Figure 2.13).

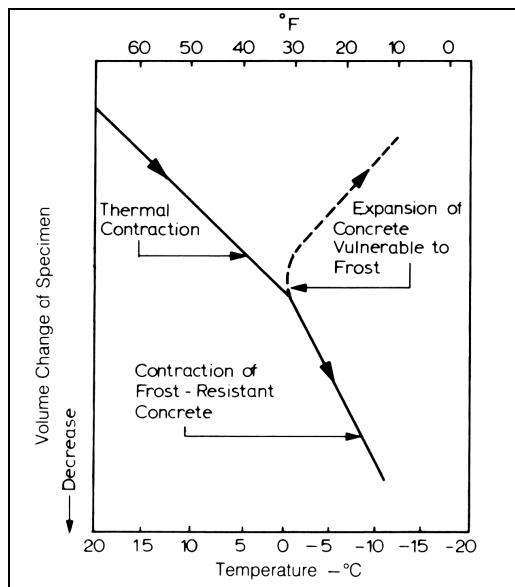
Figure 2.14 Change in volume of frost-resistant and vulnerable concretes in cooling [1]

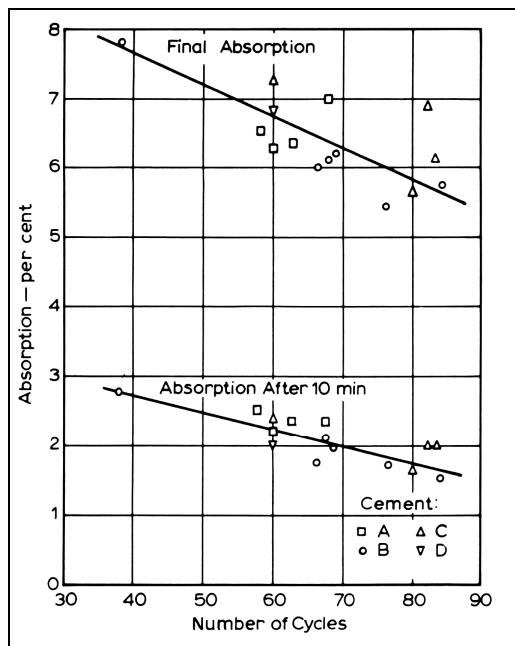
Figure 2.15 Relation between the absorption of concrete and the number of cycles of freezing and thawing required to cause a 2% reduction in the mass of the specimen [1]

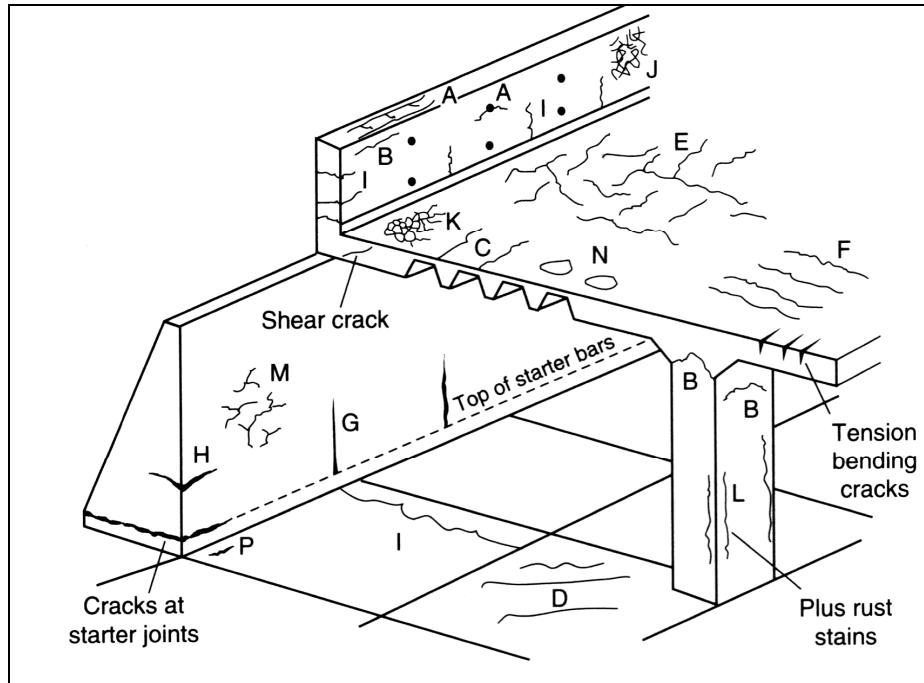
Figure 2.16 Schematic representation of the various types of cracking which can occur in concrete (see Table 2.8) [20]

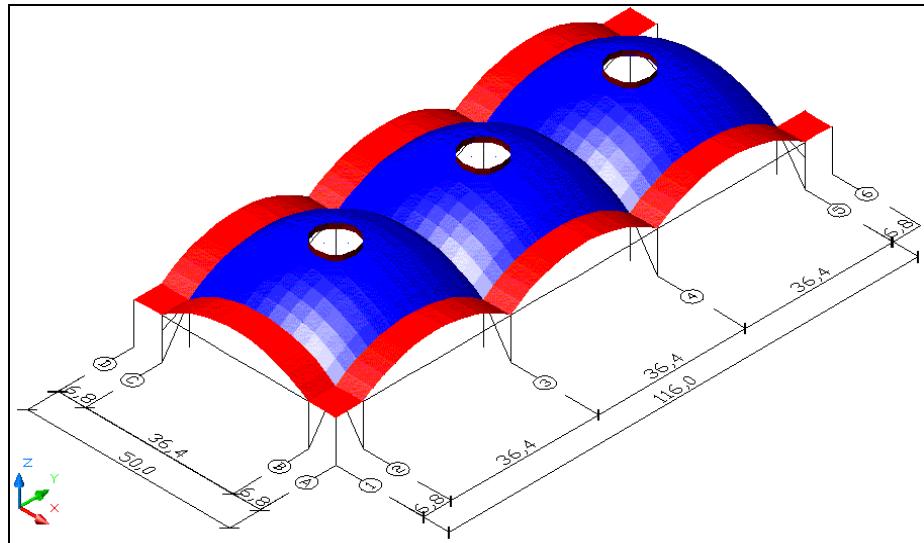
The hydroplane hangar consists of three 36.4×36.4 m in plan reinforced concrete spherical shells and seven short cylindrical shells 36.4×6.8 m connected with them. In every corner there are two storey towers 6.8×6.8 m in plan (see Figure 5.1). At the top of each spherical shell - there is a 12-sided lightning window with a diameter of 10 m. The internal bearing distance is 116.0×36.4 m, the height of the doors is 10.0 m.

Figure 5.1 Dimensions of the hangar

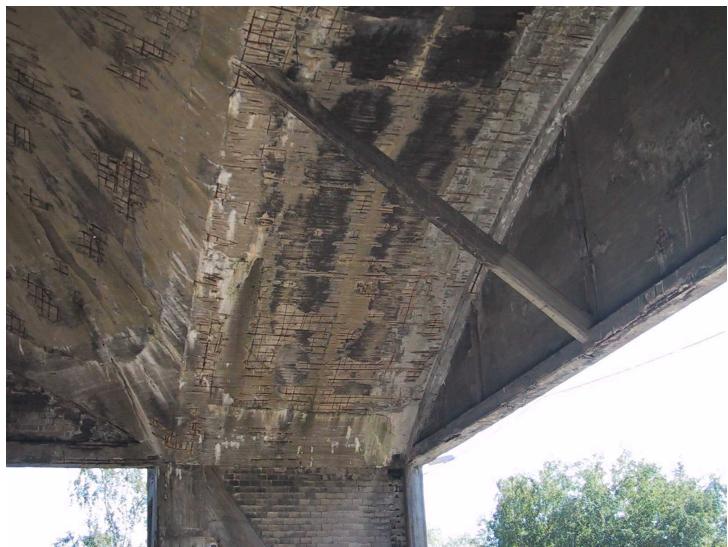
Figure 5.3 Reinforced concrete angle braces used to take wind loads

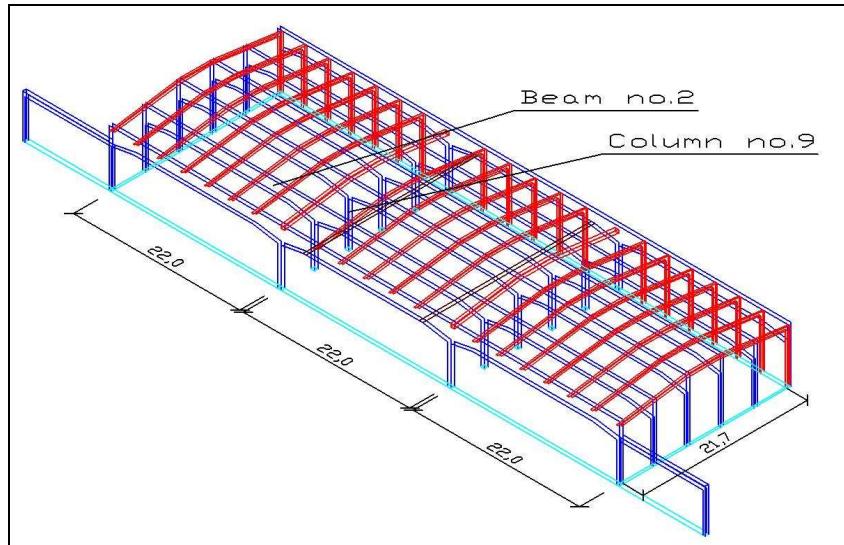
The second hangar consists of two 22.0 x 21.8 m concrete frames.

Figure 5.6 Dimensions of the hangar

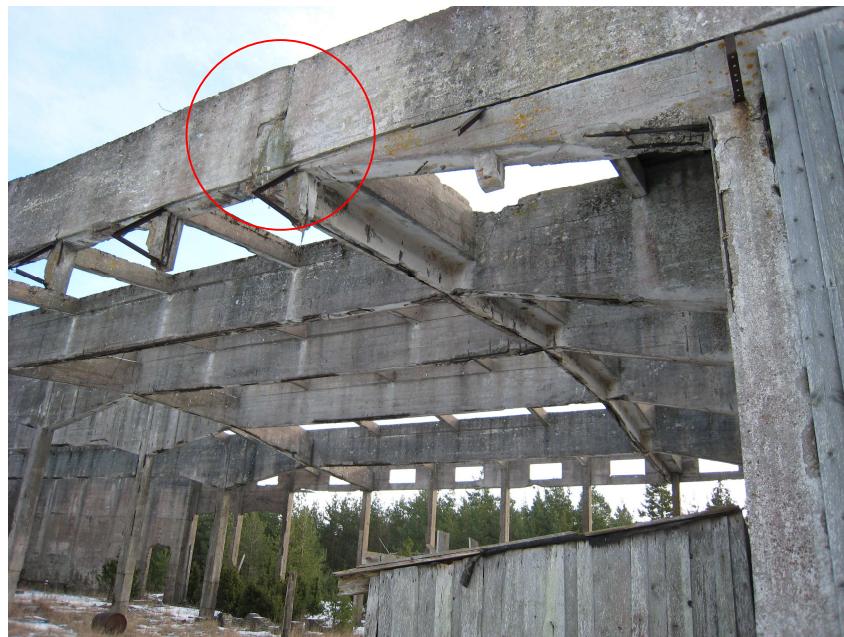
Figure 5.7 Deformation joint

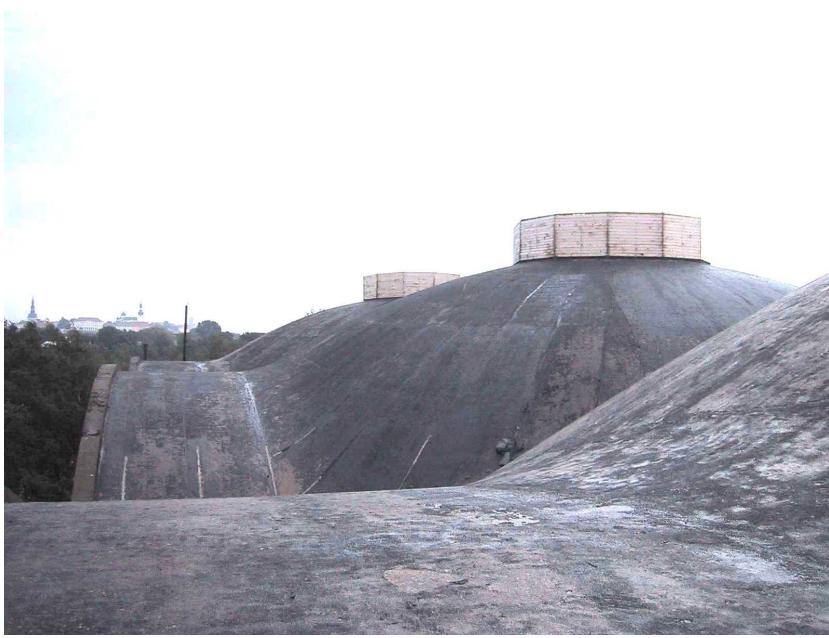
Figure 5.8 Shell coverage

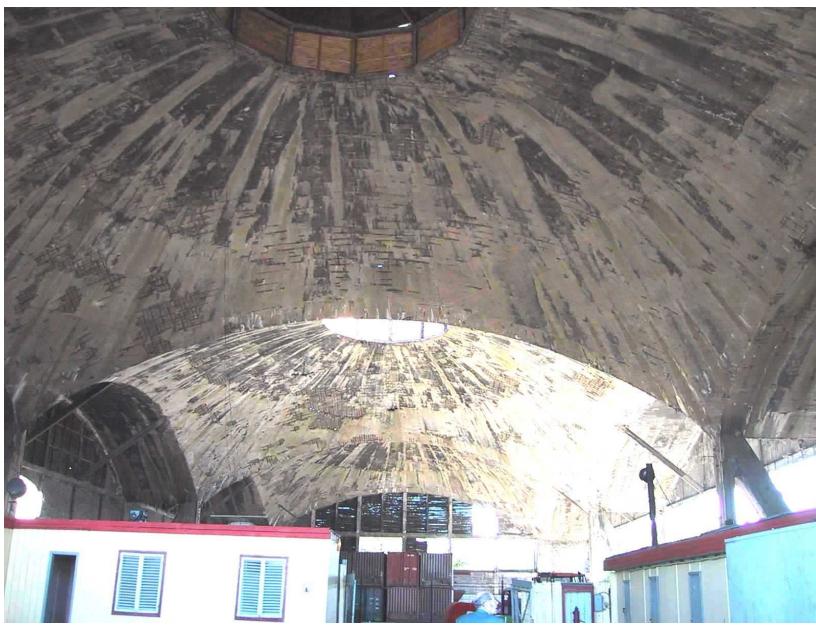
Figure 5.9 Damages of the lower surface

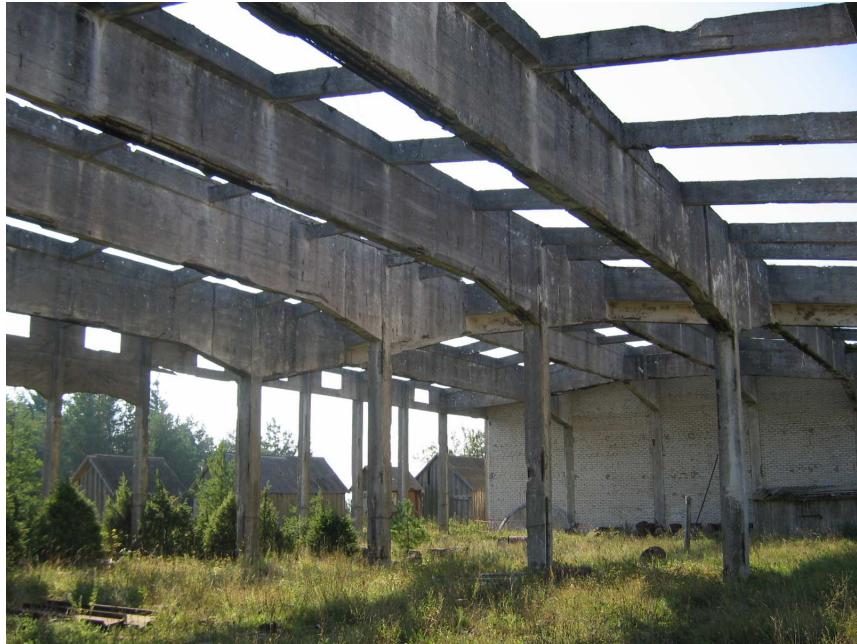
Figure 5.11 Damages of the hangar frame

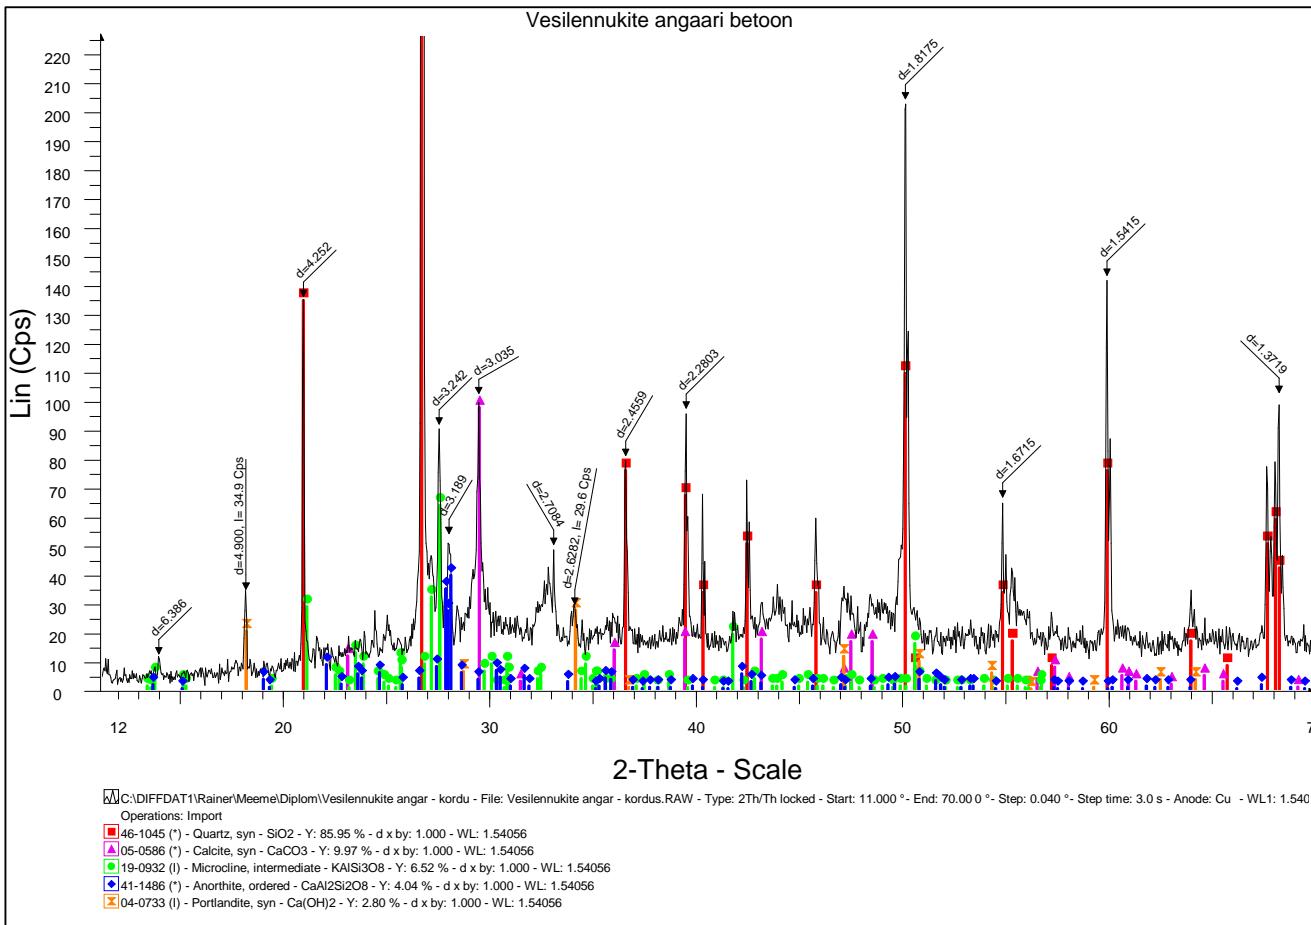
Powder diffractogram of concrete X ray analysis of Tallinn hydroplane hangar shells is shown in Figure 5.12.

Figure 5.12 Powder diffractogram of X ray analysis of concrete shells of the Tallinn hydroplane hangar

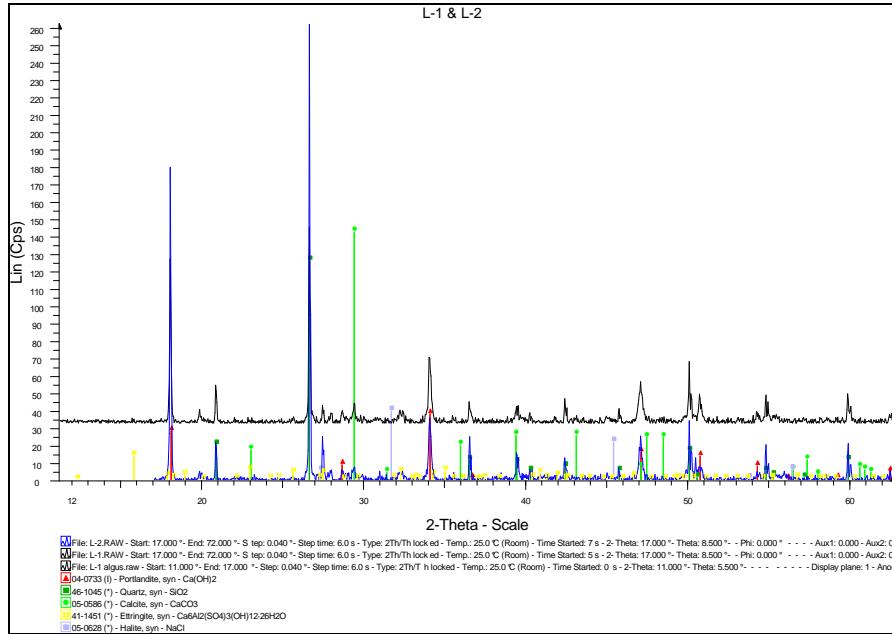
Figure 5.13 Powder diffractogram of X ray analysis of the Tallinn hydroplane hangar column, samples from the depth of 0 - 20mm (sample L1) and 20 – 40 mm (sample L2) from the outer surface

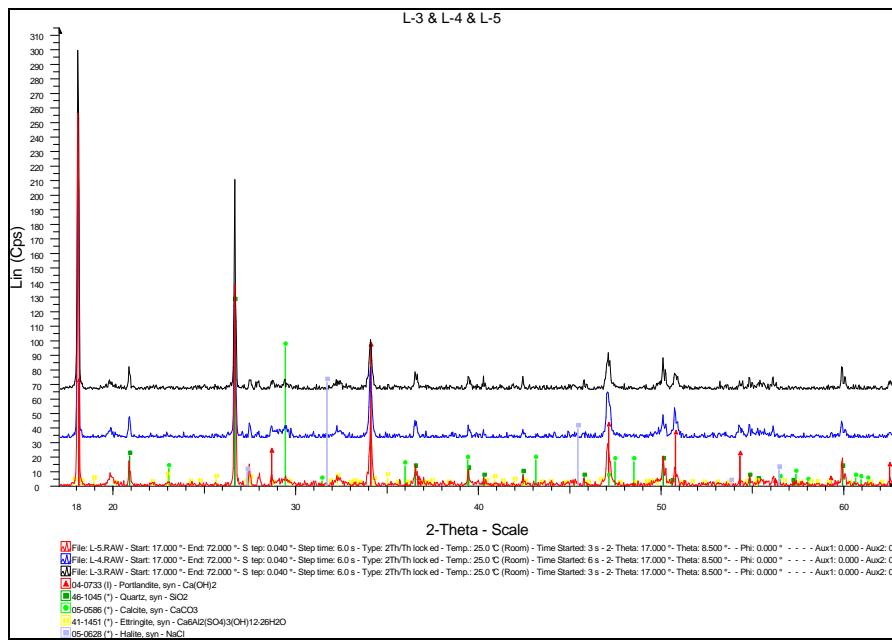
Figure 5.14 Powder diffractogram of X-ray analysis of the Tallinn hydroplane hangar column concrete samples from the depth of 40 mm (sample L3) up to 100 mm (sample L5) from the outer surface

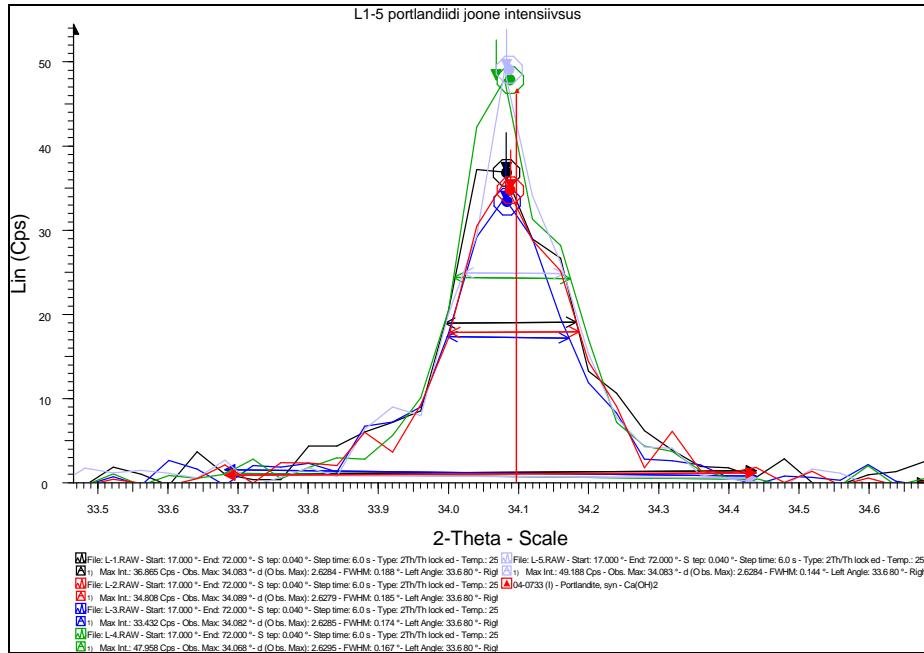
Figure 5.15 Powder diffractogram of X-ray analysis of the Tallinn hydroplane hangar column concrete, $\text{Ca}(\text{OH})_2$ relative concentrations (intensities), samples from the depth of outer surface (sample L1) up to 100 mm of depth on the inner surface (sample L5)

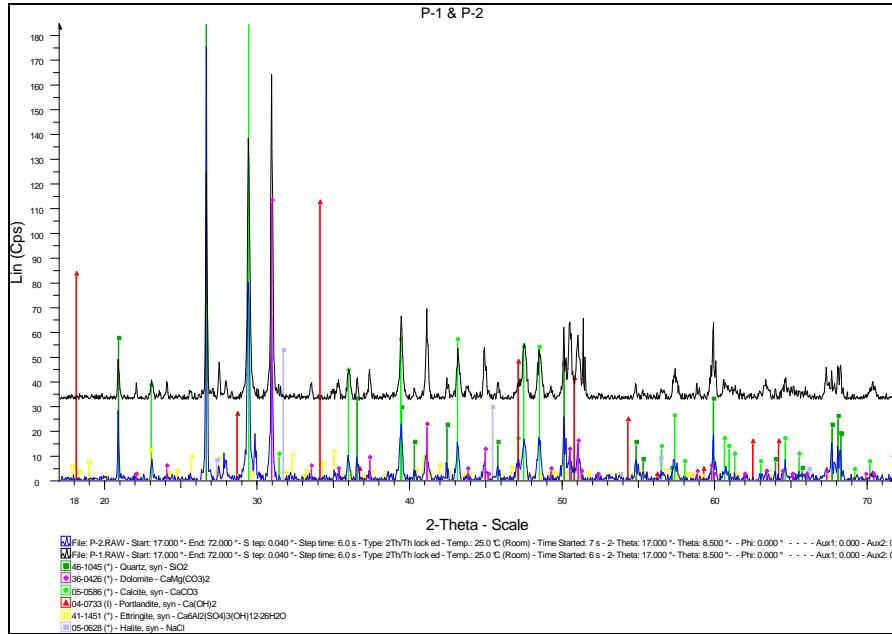
Figure 5.16 Powder diffractogram of X ray analysis of Papisaare hydroplane hangar column concrete, samples from the depth of 0–20 mm (sample P1) and 20–40 mm (sample P2) from the outer surface

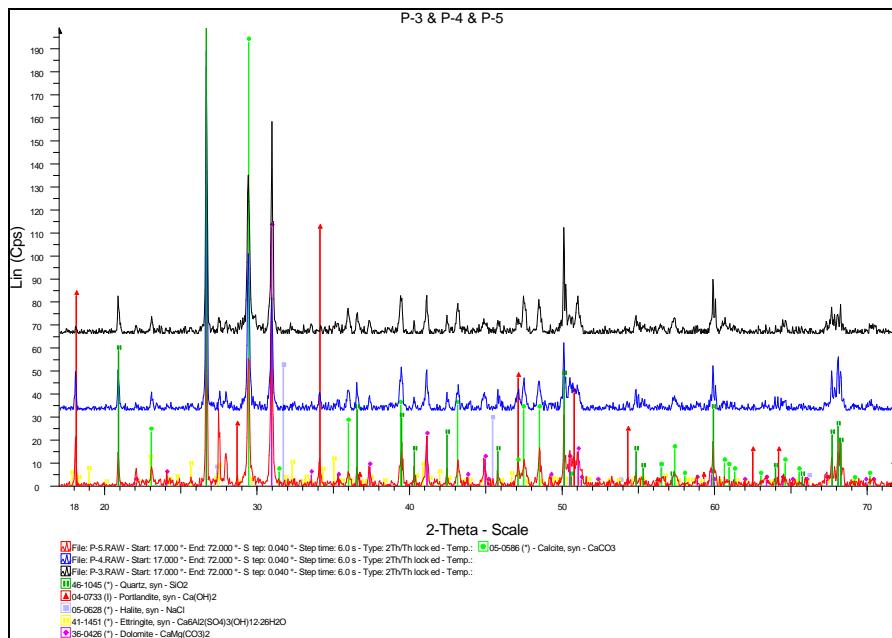
Figure 5.17 Powder diffractogram of X ray analysis of Papisaare hydroplane hangar column concrete, samples from the depth of 40 mm (sample P3) up to 100 mm (sample P5) from the outer surface

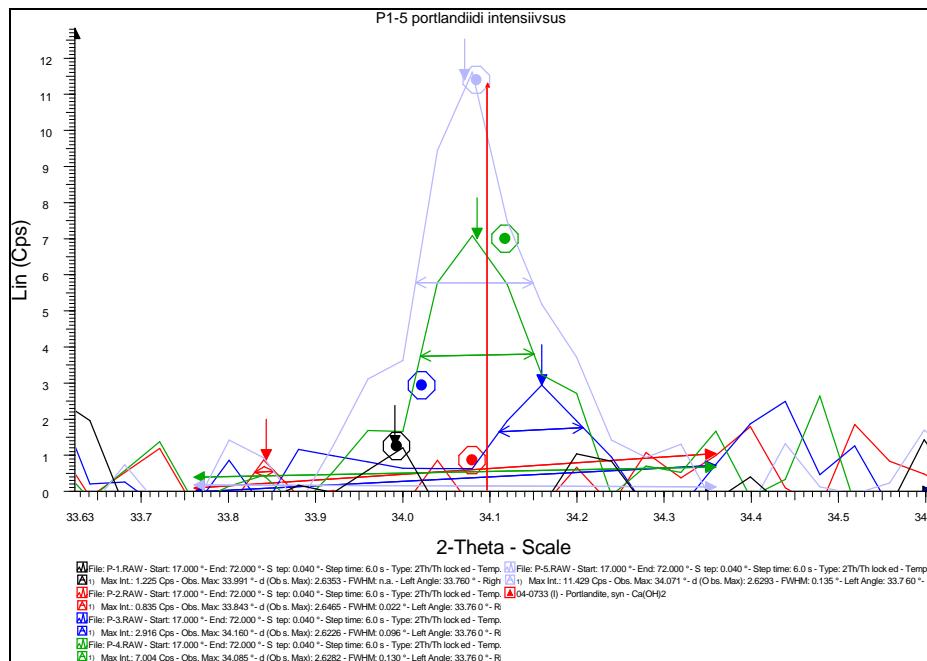
Figure 5.18 Powder diffractogram of X ray analysis of Papisaare hydroplane hangar column concrete, relative concentrations (intensities) of $\text{Ca}(\text{OH})_2$, samples from the depth, outer surface, (P1) up to 100 mm of column depth, on the inner surface (P5)

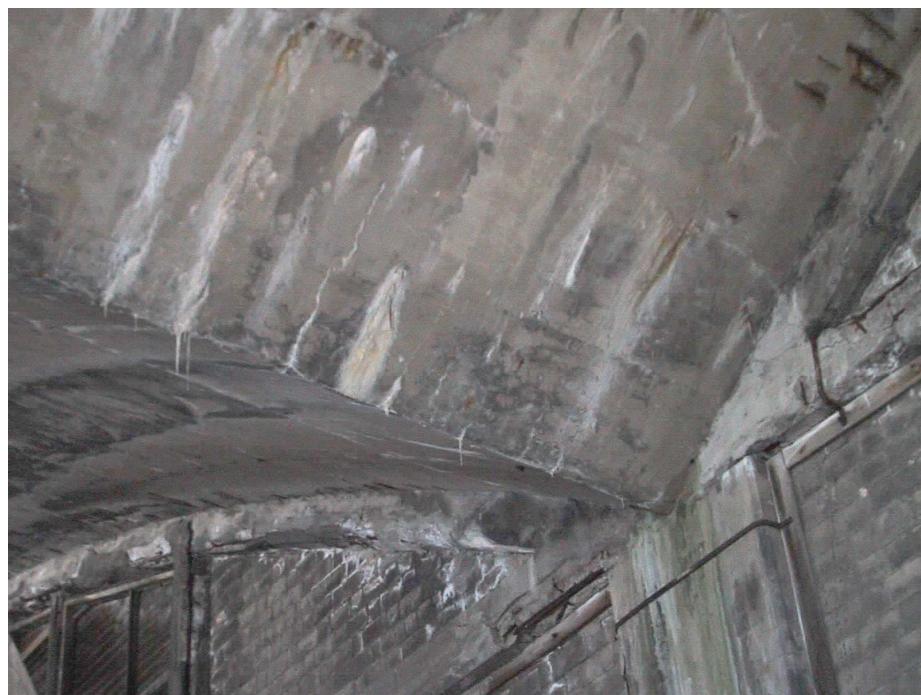
Figure 5.19 Stalactides suspending from the lower shell surface

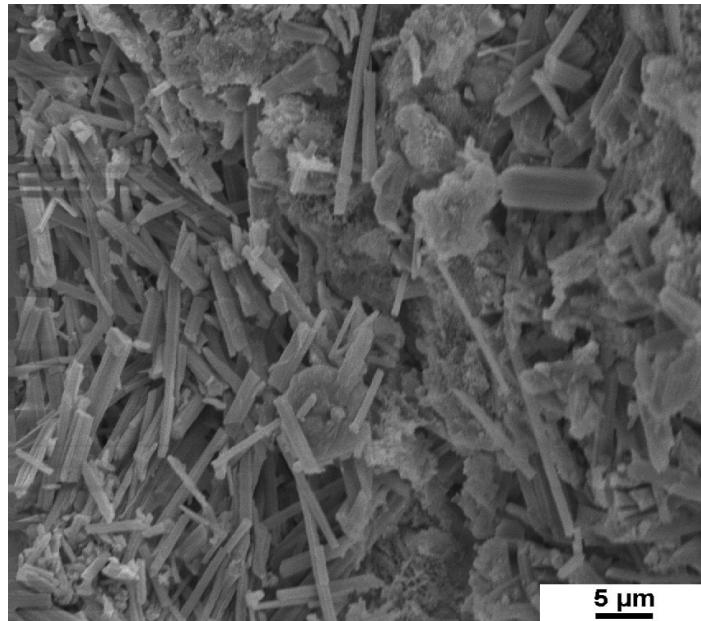
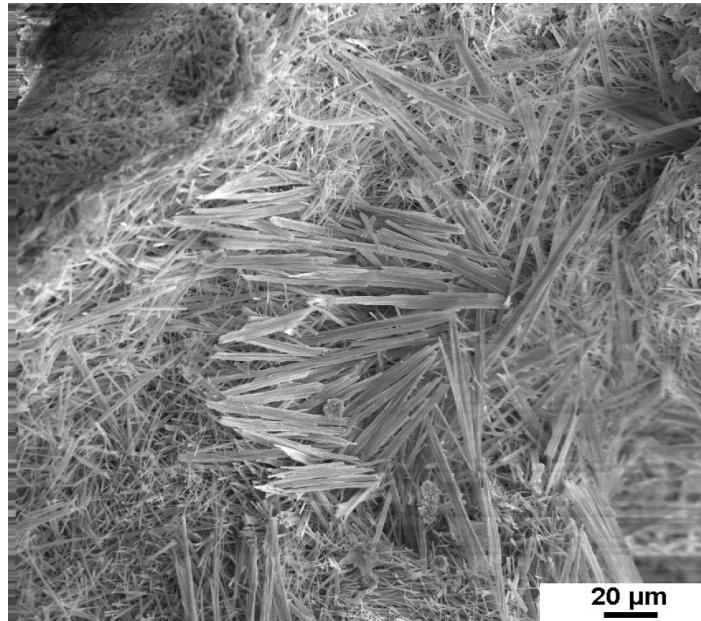
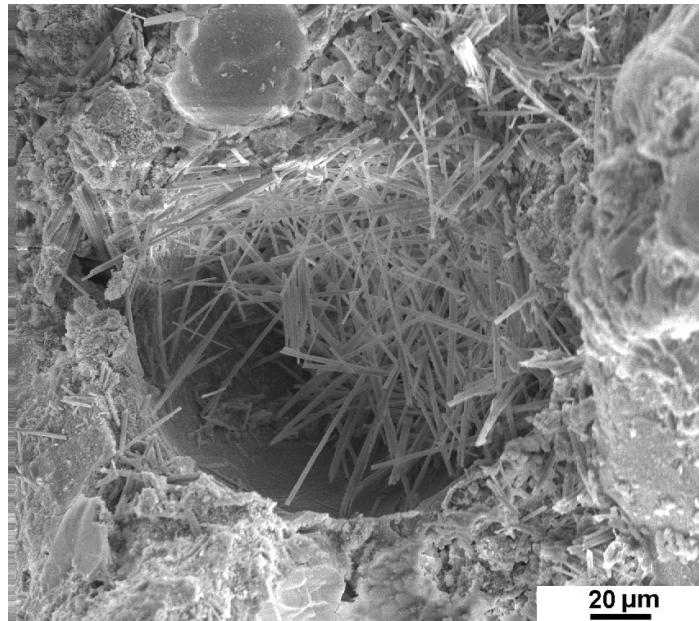
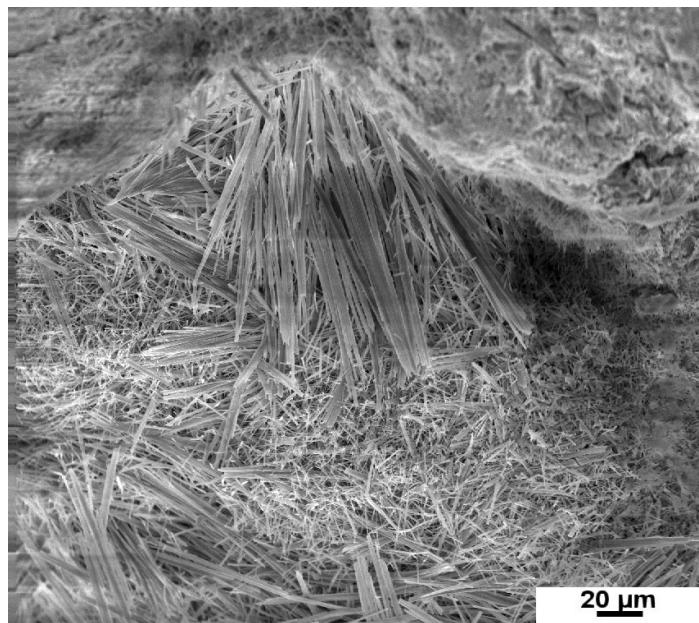
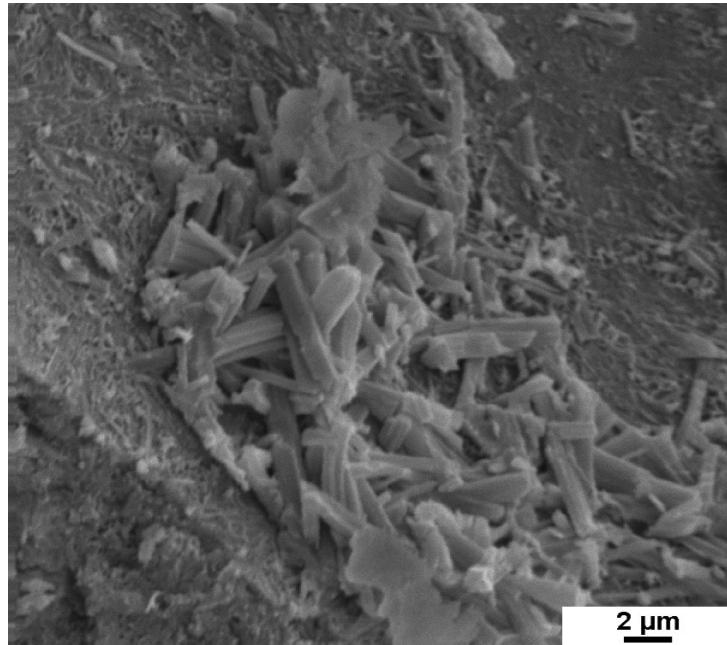
Figure 5.20 Concrete fracture surface taken in the depth of 40-50 mm of the hydroplane hangar shell

Figure 5.21 Concrete fracture surface taken in the depth of 40-50 mm of the hydroplane hangar shell

Figure 5.22 Concrete fracture surface taken in the depth of 40-50mm of the hydroplane hangar shell

Figure 5.23 Concrete fracture surface taken in the depth of 40-50 mm of the hydroplane hangar shell

Figure 5.24 Concrete fracture surface taken in the depth of 40-50 mm of the hydroplane hangar shell

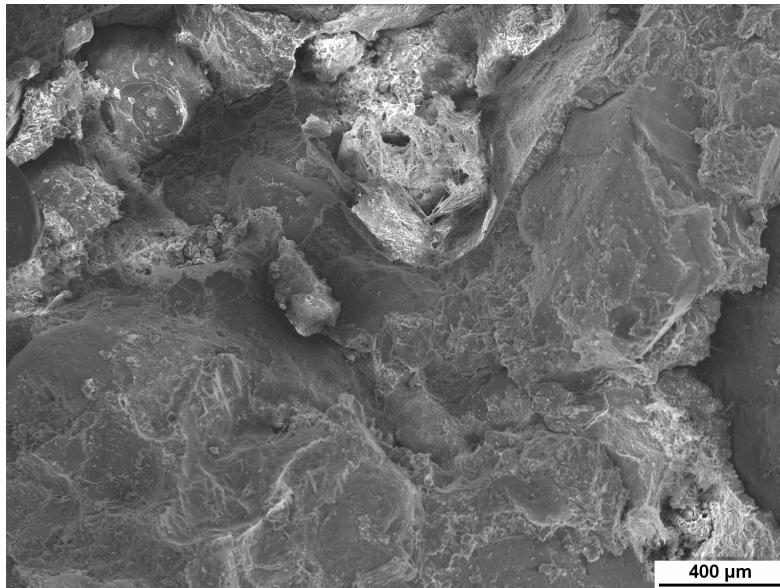
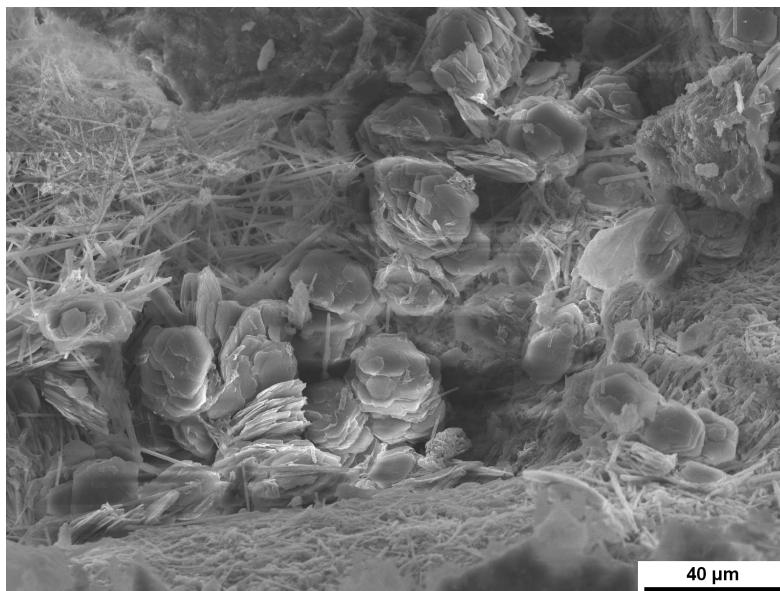
Figure 5.25 Concrete fracture surface taken in the depth of 20-40 mm
(sample L2) of the hydroplane hangar reinforced concrete column

Figure 5.26 Concrete fracture surface taken in the depth of 20-40 mm
(sample L2) of the hydroplane hangar reinforced concrete column

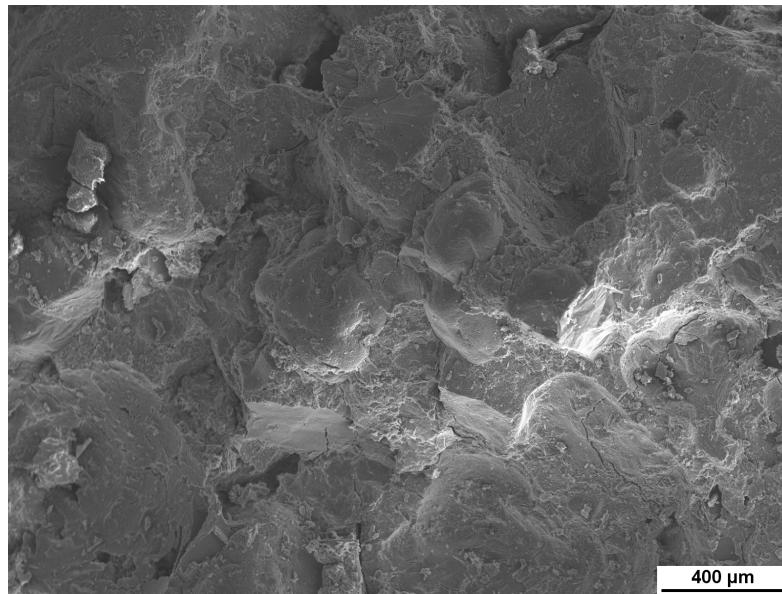
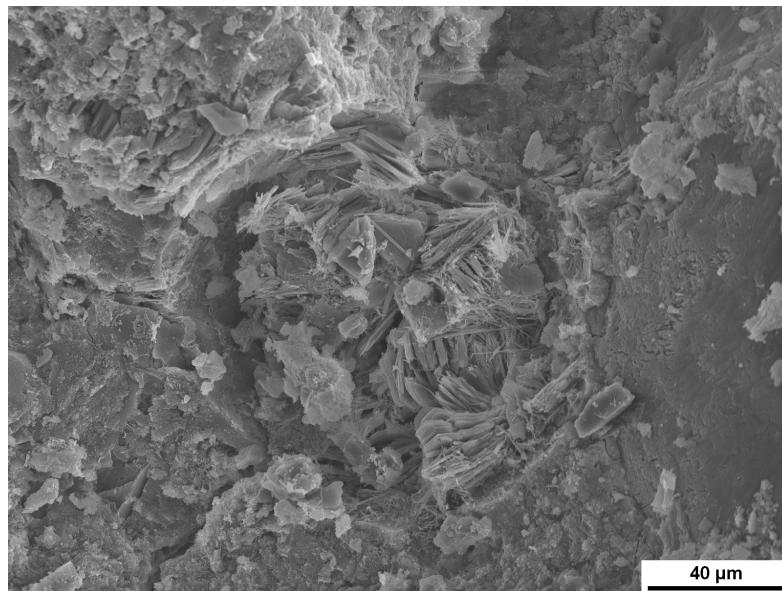
Figure 5.27 Concrete fracture surface taken in the depth of 80-100 mm
(sample L5) of the hydroplane hangar reinforced column

Figure 5.28 Concrete fracture surface taken in the depth of 80-100 mm
(sample L5) of the hydroplane hangar reinforced concrete column

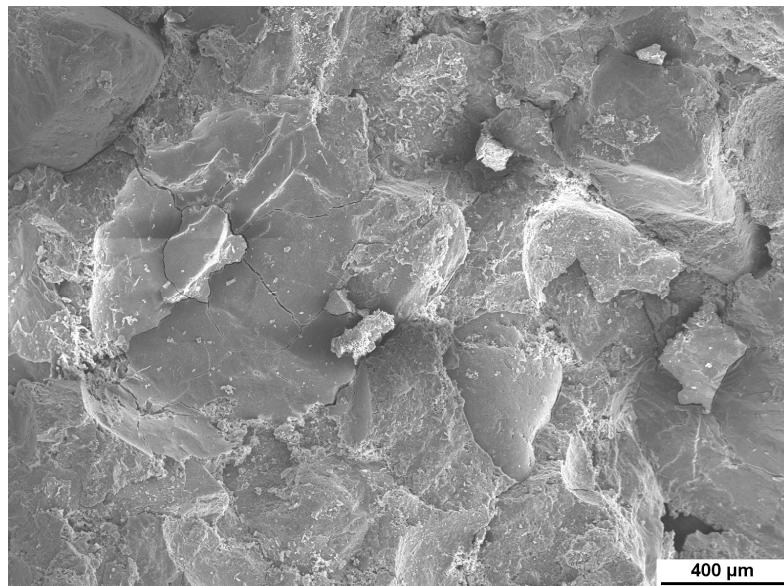
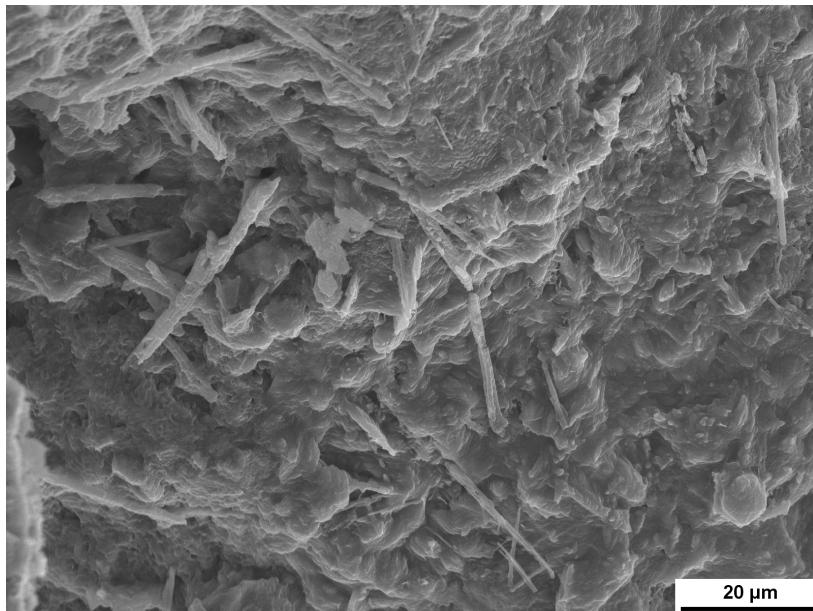
Figure 5.29 Concrete fracture surface taken in the depth of 20-40 mm
(sample P2) of the Papisaare hydroplane hangar reinforced concrete column

Figure 5.30 Concrete fracture surface taken in the depth of 20-40 mm
(sample P2) of the Papisaare hydroplane hangar reinforced concrete column

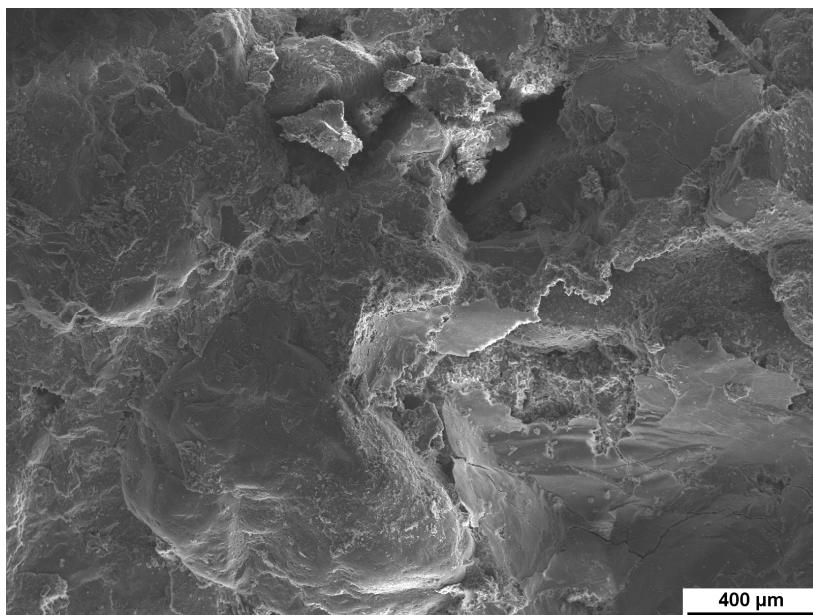
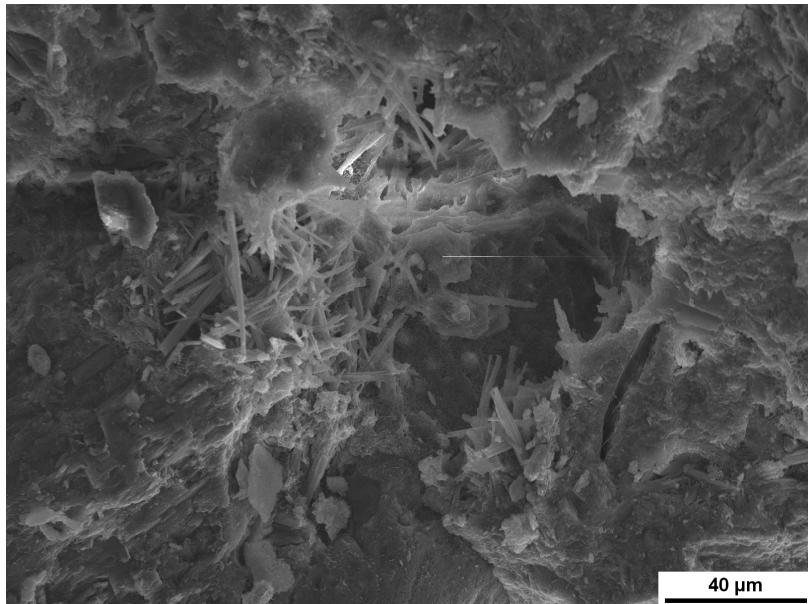
Figure 5.31 Concrete fracture surface taken in the depth of 80-100 mm
(sample P5) of the Papisaare hydroplane hangar reinforced concrete column

Figure 5.32 Concrete fracture surface taken in the depth of 80-100 mm (sample P5) of the Papisaare hydroplane hangar reinforced concrete column
