Investigation of the causes of deterioration of old reinforced concrete constructions and possibilities of their restoration

THESIS ON CIVIL ENGINEERING F20

TALLINN UNIVERSITY OF TECHNOLOGY
Faculty of Civil Engineering
Department of Structural Design

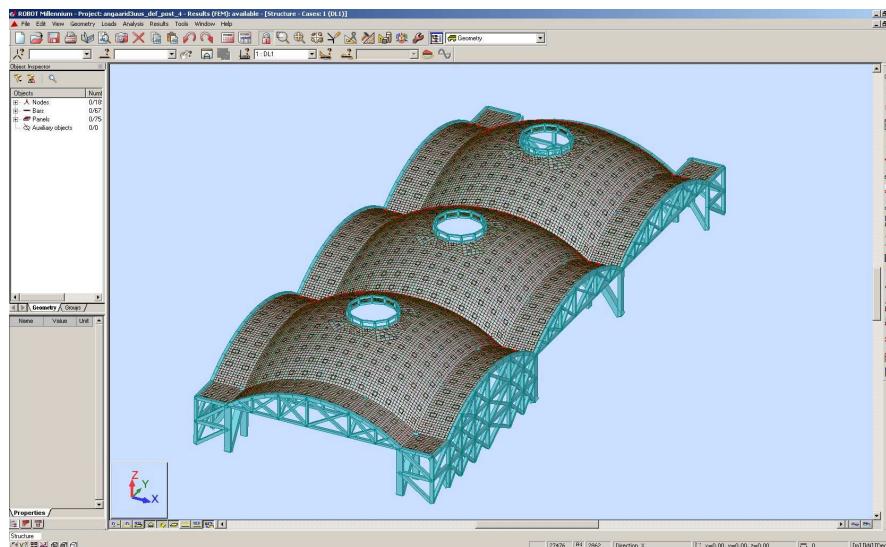
Figure 6.1 Calculation scheme of Tallinn hydroplane hangars in the Robot Millennium program

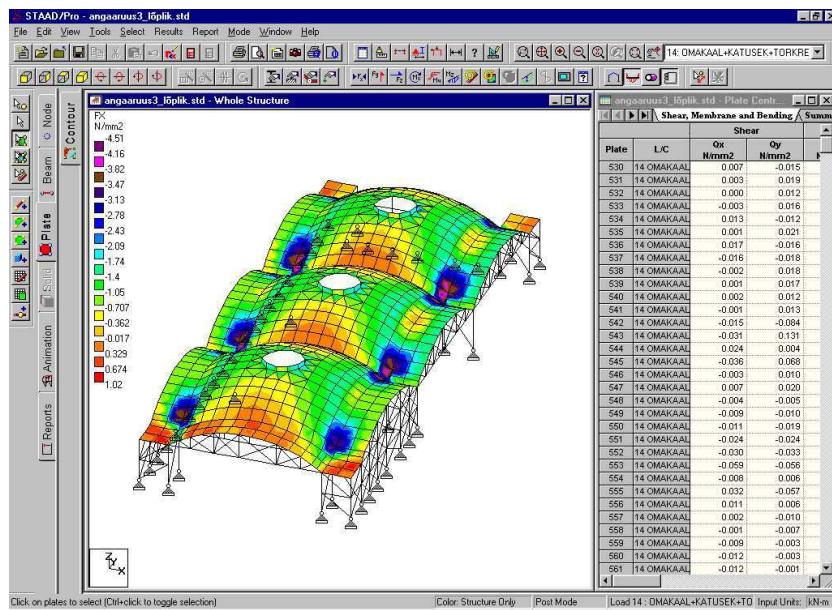
Figure 6.2 Calculation scheme of Tallinn hydroplane hangars in the Staad/Pro program

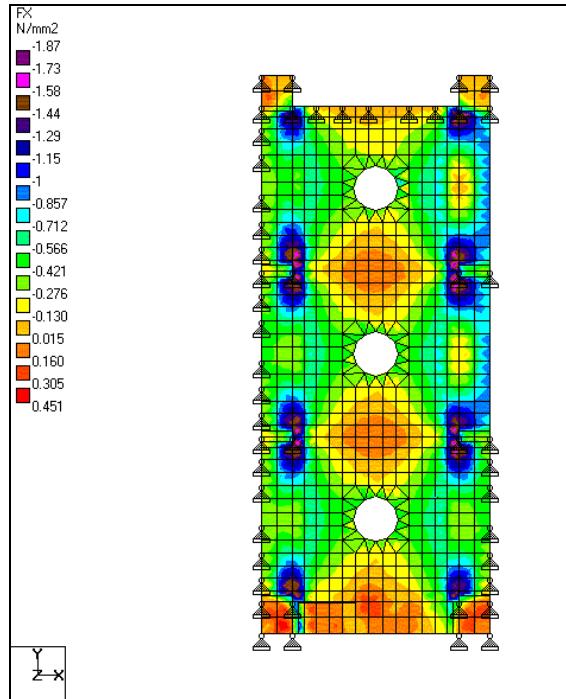
Figure 6.3 Diagram of the normal stresses f_x

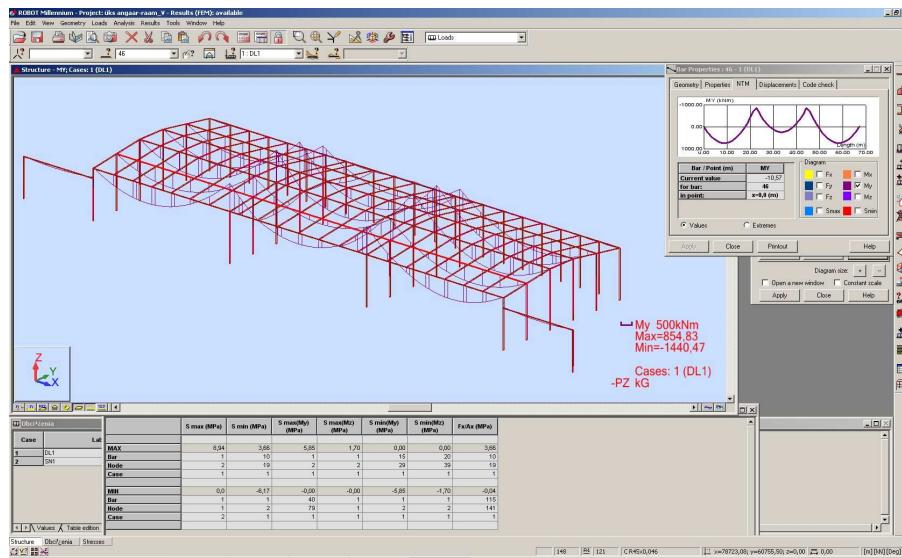
Figure 6.4 Calculation scheme of Papisaare hydroplane hangars in the Robot Millennium program
