# **Renovation Need and Performance of Envelopes of Concrete Apartment Buildings in Estonia**

SIMO ILOMETS

TALLINN UNIVERSITY OF TECHNOLOGY  
School of Engineering  
Department of Civil Engineering and Architecture  
Nearly Zero Energy Buildings Research Group

Ilomets, S. (2017) **Renovation need and performance of envelopes of concrete apartment buildings in Estonia**. Doctoral thesis, Tallinn University of Technology.

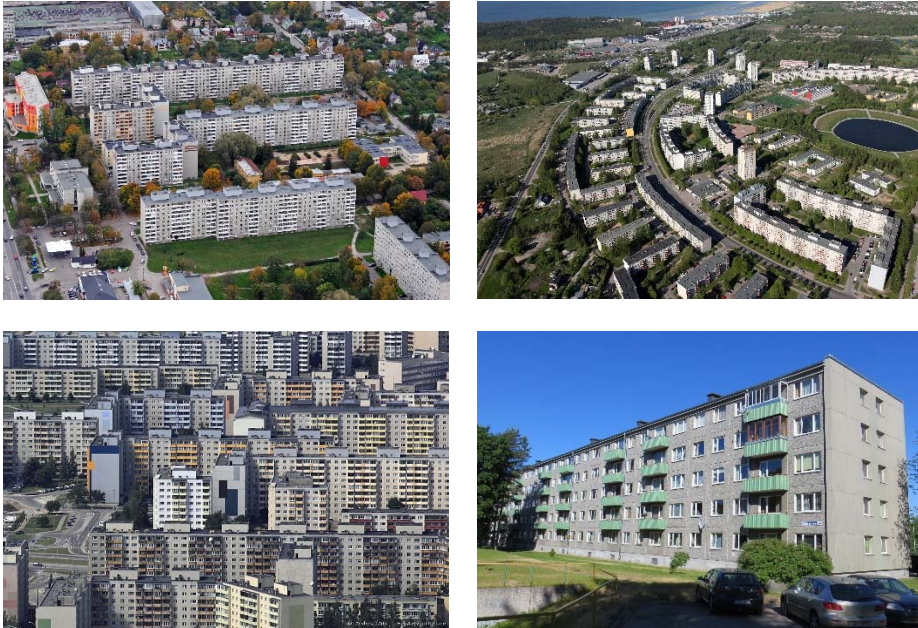
Figure 2.1. Concrete apartment buildings in districts of Tallinn – Mustamäe (top left), Õismäe (top right), Lasnamäe (bottom left), all from [www.taevapiltnik.ee](http://www.taevapiltnik.ee), and a typical 1-464 series building from Mustamäe (bottom right).

Although there are a few such buildings elsewhere, large-panel apartment buildings are concentrated mainly into three districts of Tallinn called Mustamäe, Õismäe and Lasnamäe, see Figure 2.1.

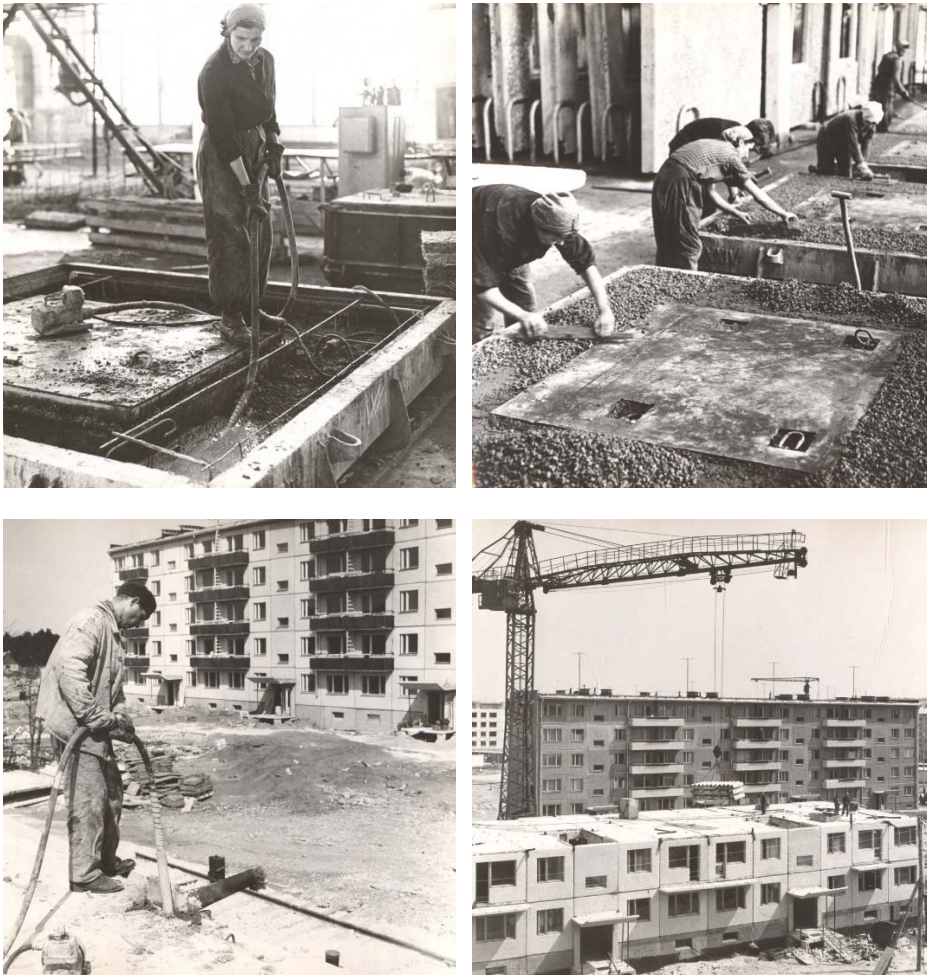
Figure 2.2. Casting the internal layer of concrete into the formwork with steel reinforcement (top left), levelling the rubble bulk of the incoming facade (top right), casting the concrete into the junction in situ (bottom, left) and mounting the panels by crane (bottom right), all from the private collection of Prof. Emer. Karl Öiger.

Large-scale industrial construction of RC apartment buildings in Estonia began in the early 1960s in Tallinn (Gritsenko, 2008), see Figure 2.2. The production technology was imported from France but the panels were first designed in the central design institute in Moscow and later locally in Estonia. There were two factories in Tallinn, which had the production capacity of 200 000 m<sup>2</sup> of living area annually.

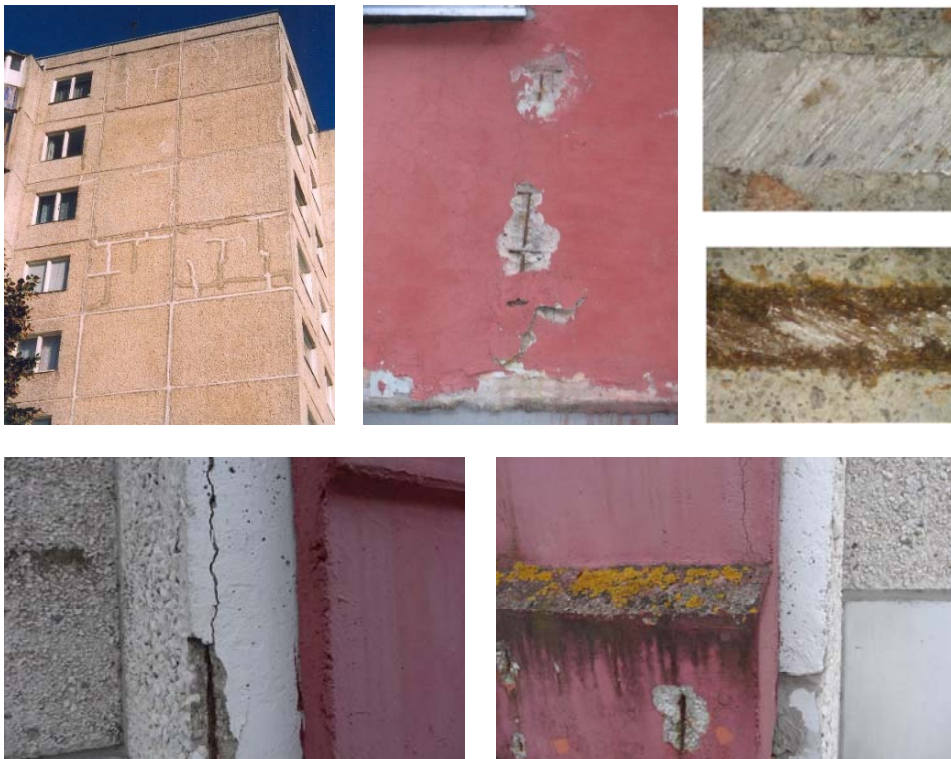
Figure 2.4. Reinforcement corrosion of the facade, top left and middle (private collection of Prof. Emer. Karl Öiger). Corrosion studied with microscope in laboratory – no corrosion yet, top right, and corroded reinforcement, middle right (Ilomets et al., 2011).

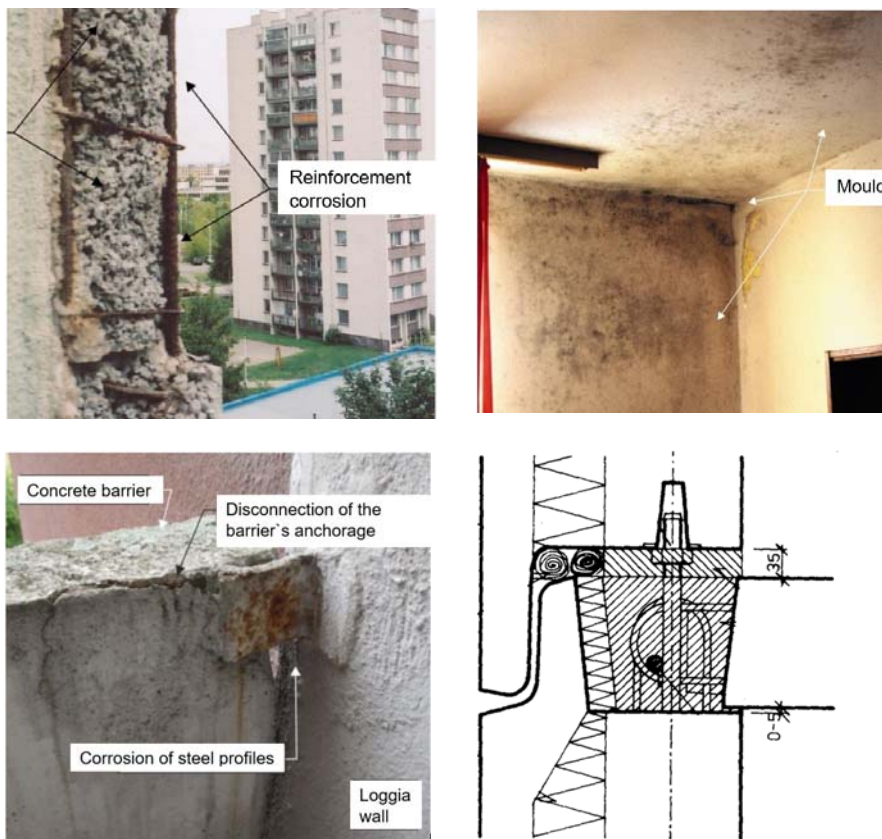
Figure 2.5. Extensive reinforcement corrosion and the concrete cover dropped off (top left) and extensive mould growth on the interior surface of the building envelope (top right). Corroded anchoring detail of the RC loggia barrier (bottom left) and a vertical junction of two external wall panels and the floor slab (bottom right), all from (Witzany, 2016).

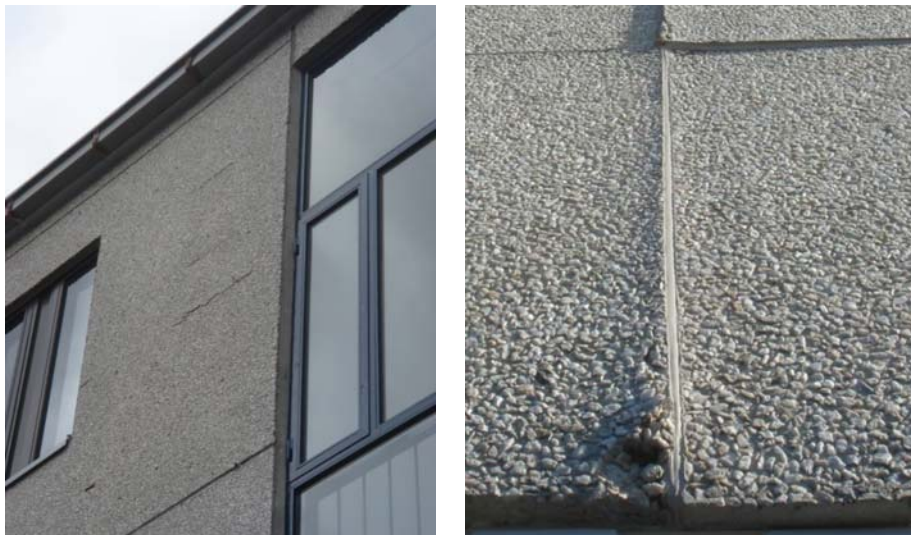
Figure 2.7. Typical carbonation induced corrosion on the left and local frost damage at the edge of an exposed aggregate RC panels on the right (Lahdensivu et al., 2013).

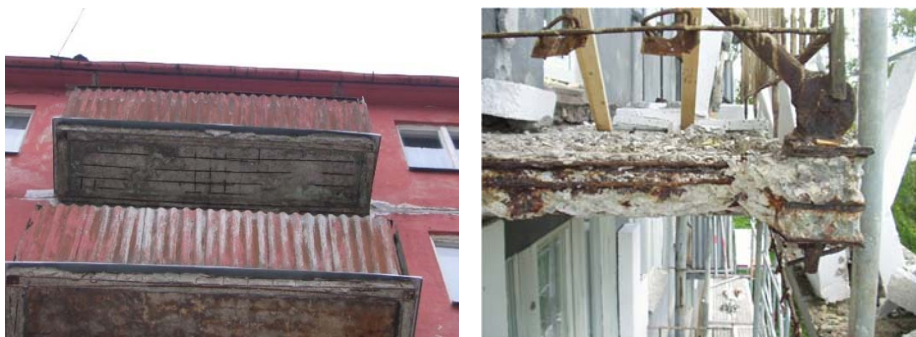
Figure 2.8. Severe corrosion propagation of reinforced concrete balconies (Õiger, 2006).

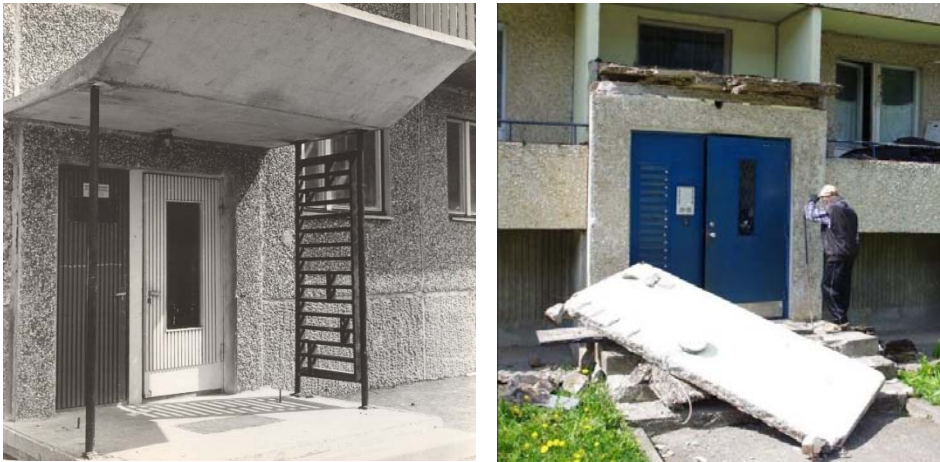
Figure 2.9. Reinforced concrete awning panel above an entrance door from the 1960s on the left (private collection of Prof. Emer. Karl Õiger) and a collapsed awning panel at Keila near Tallinn (Postimees, 2016).

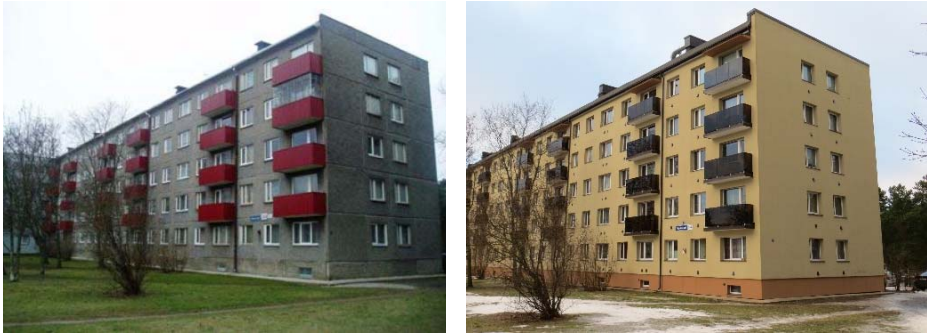
Figure 3.1. Reinforced concrete external wall of a case-study building before (left) and after (right) the external thermal insulation composite system was installed.

For detailed hygrothermal performance of the external wall, a typical prefabricated RC large-panel wall was used (see Figure 3.1 for illustration and Figure 1.1, Figure 4.2 and Section 2.3 for specific description in addition to publications IV and VI).

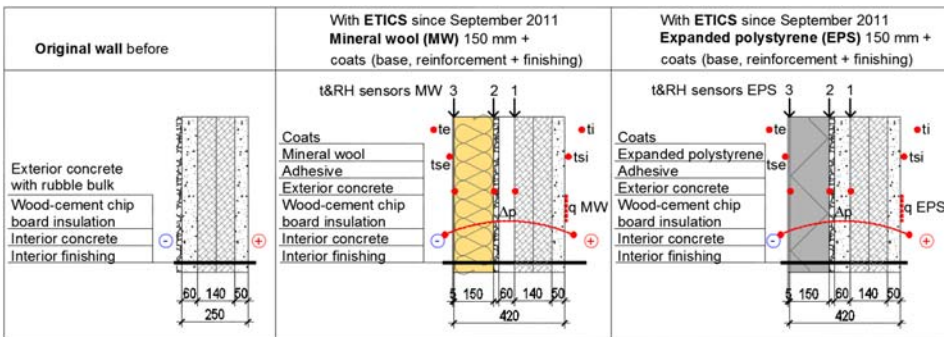
Figure 4.2. Test-wall schematics and measurement points (red dots). ETICS – external thermal insulation composite system; *t&RH* – temperature and relative humidity.

Figure 5.10. Measured and calculated temperature  $t$ , °C in the wall additionally insulated with the EPS-ETICS. See numbers of measurement points (p) in Figure 4.2. Temperature in point 2 (not shown for clarity's sake) is similar to that in point 1.

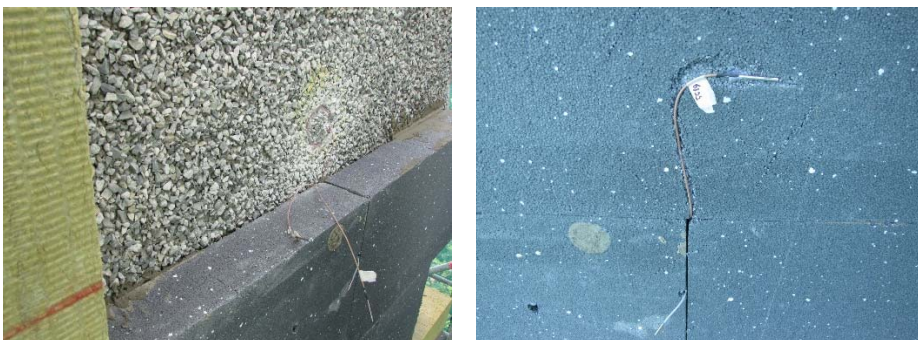
Figure 4.3. Illustration of the case study measurements: original reinforced concrete wall covered with rubble bulk and the wiring (left) and the temperature and relative humidity sensor (right).

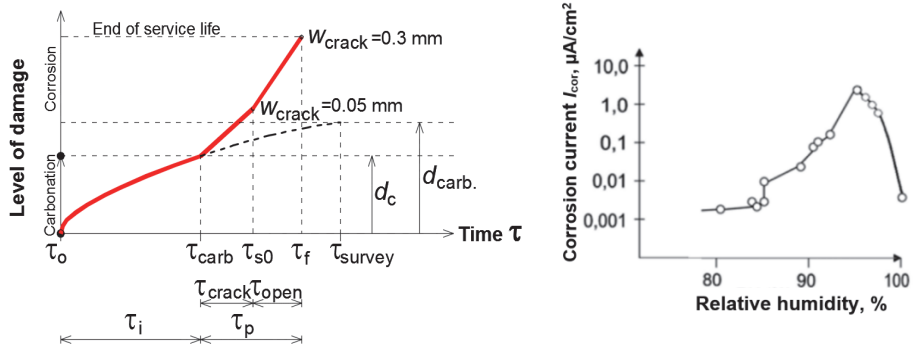
Figure 4.4. Scheme of service life, comprising periods of the initiation ( $\tau_i$ ) and propagation ( $\tau_p$ ) of corrosion (left). On the right, corrosion current depending on the relative humidity (RH) of concrete (valid for a temperature of +5 °C), based on Tuutti (1982).

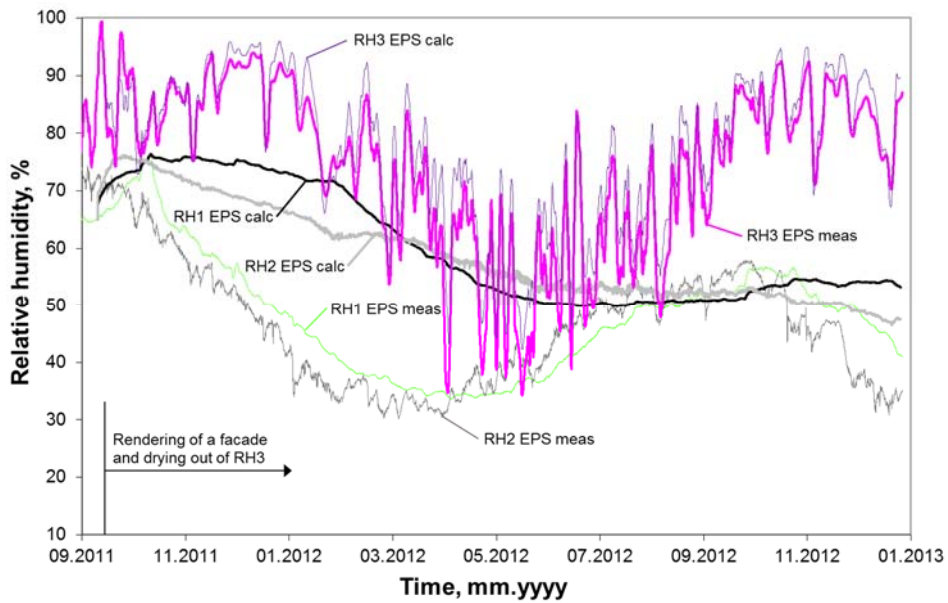
Figure 5.11. Comparison of measured and calculated relative humidity (RH) only by diffusion of the EPS-ETICS.

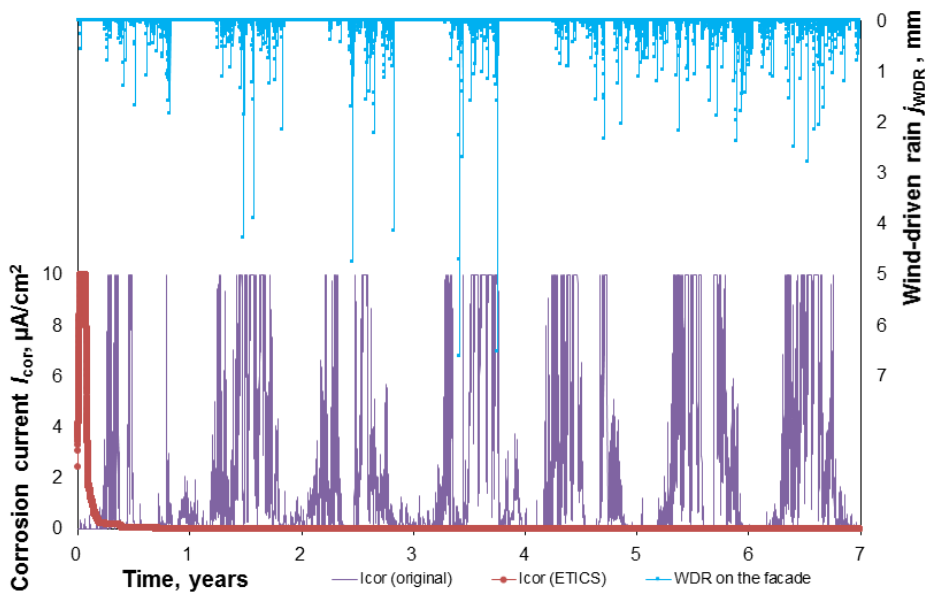
Figure 5.15. Corrosion current of an original wall before renovation and the impact of applying an external thermal insulation composite system (ETICS).

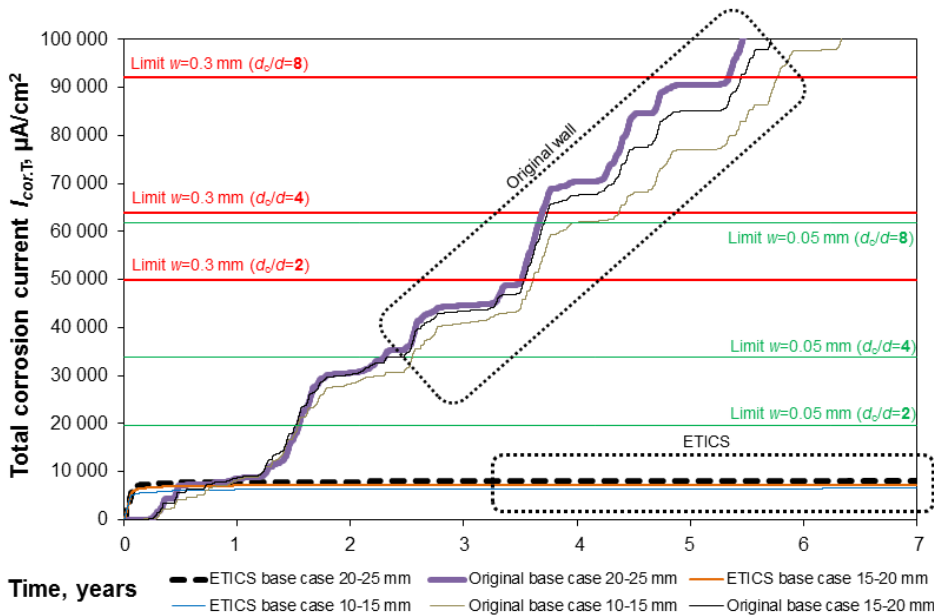
Figure 5.16. Total corrosion current at different depths from the surface without ETICS (original wall) and after applying ETICS. Horizontal lines stand for the limit criteria for different ratios of concrete cover depth  $d_c$  against reinforcement diameter  $d$ .

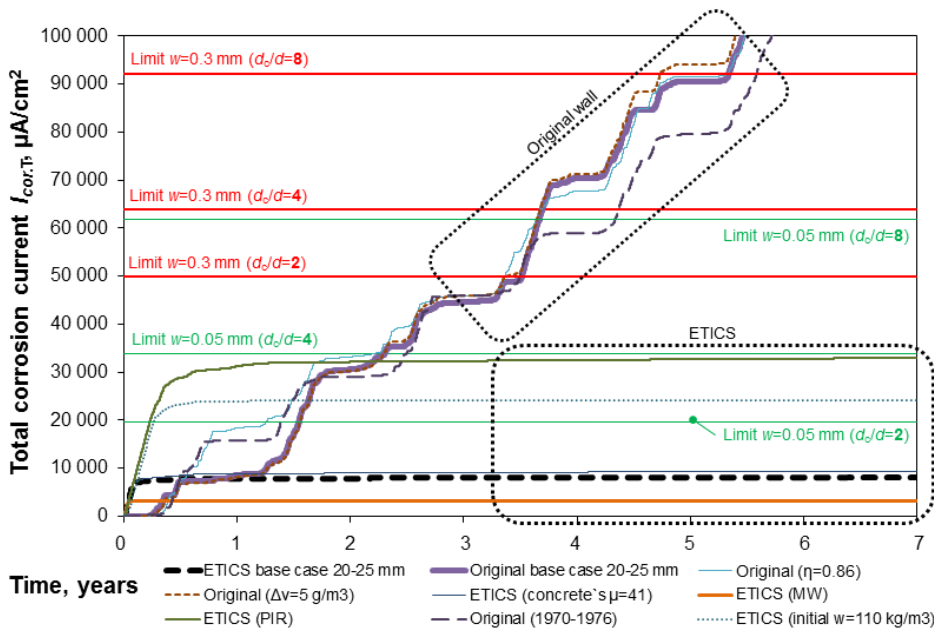
Figure 5.17. Total corrosion current of different calculation cases against the limit criteria and the impact of applying ETICS at a 20–25 mm cover depth. Each calculation case represents one deviation from the base case – changed parameter named in the parentheses.

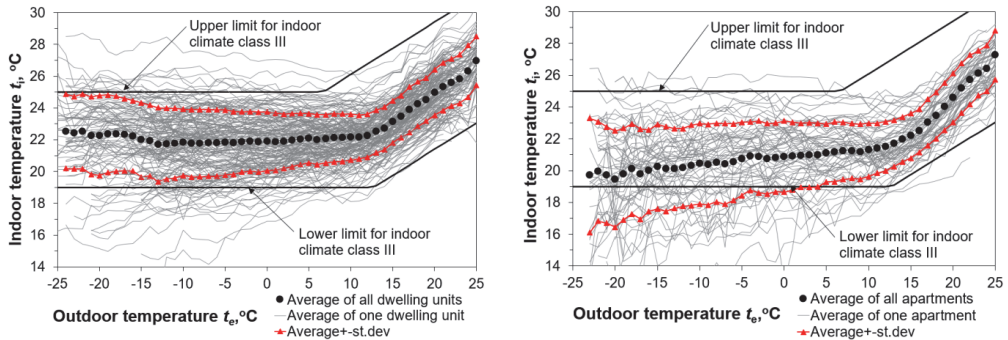
**Figure 1.** Indoor air temperature for 190 dwelling units with central heating (left) and 66 units using a stove or combined heating system (right)

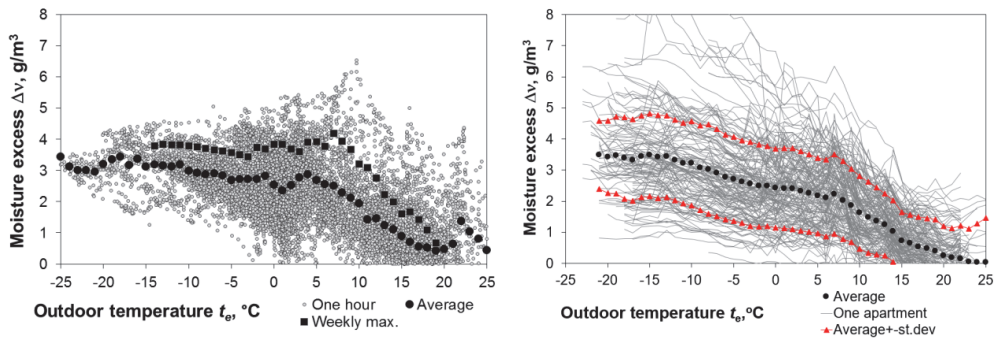
**Figure 2.** Hourly data for moisture excess levels for one dwelling (left) and weekly data for all 237 dwellings (right)

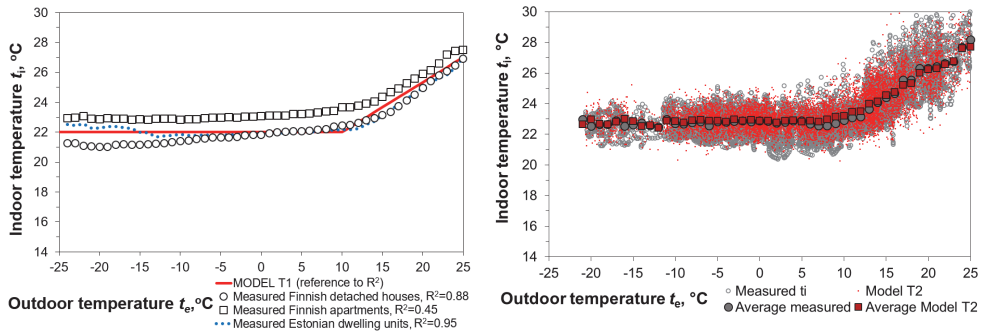
**Figure 8.** Indoor temperature model T1 and measured average of different dwelling groups with central heating (left) and a comparison of the measured hourly data against calculated values within one dwelling unit using model T2 (right)

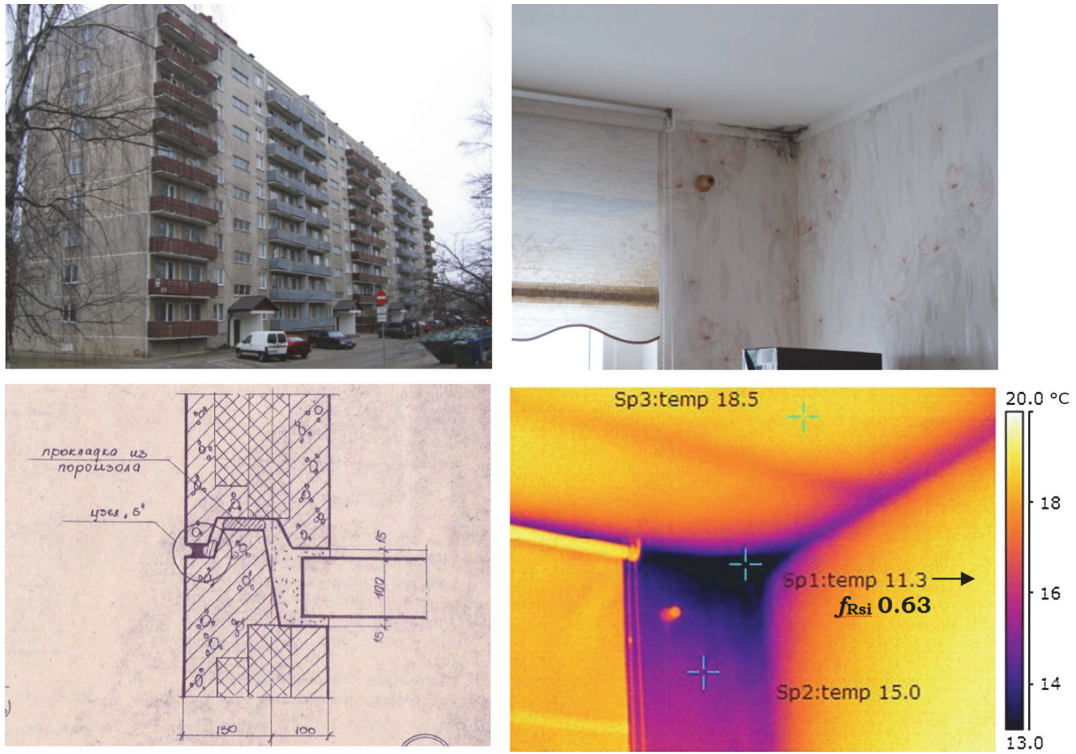
**Fig. 4** Example of a precast concrete large-panel apartment building (upper left) with discontinued insulation in the junction of the external wall and floor (lower left). Visible mould growth at the corners of a

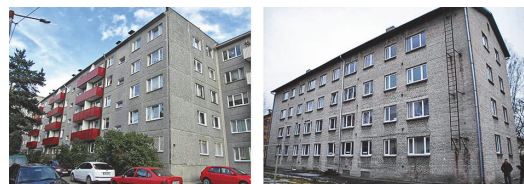
Fig. 1. Typical prefabricated reinforced concrete large-panel element apartment building (left) and brick apartment building (right)

Based on the main construction material, four different building types were analysed: prefabricated reinforced concrete large-panel element (hereafter: concrete element) (13 example buildings), brick (15 buildings), wood (log 20 buildings), and autoclaved aerated concrete (AAC) large-blocks (1 building). Typical buildings with different construction, service systems, ages and number of storeys were selected. External walls of concrete element buildings (Fig. 1 left) are composed of two layers of reinforced concrete (50–130 mm inner load-bearing layer and 50–80 mm outer core) and 100–150 mm thick insulation layer in between (fibrolite, mineral wool, phenolic foam or expanded polystyrene). Different elements are welded and concreted together in-situ. Thermal transmittance of walls varies between  $U = 0.5\text{--}1.0 \text{ W}/(\text{m}^2\cdot\text{K})$  and that of roofs  $0.7\text{--}1.0 \text{ W}/(\text{m}^2\cdot\text{K})$ . Thickness of the inner load-bearing layer in brick buildings (Fig. 1 right) is 250–630 mm (typically calcium silicate brick), 60–120 mm mineral wool thermal insulation, and 120 mm of external layer (calcium silicate or ceramic brick). Also, thick brick walls without insulation material were analysed. Thermal transmittance of brick walls varies between  $0.5\text{--}1.2 \text{ W}/(\text{m}^2\cdot\text{K})$  and that of roofs  $0.7\text{--}1.0 \text{ W}/(\text{m}^2\cdot\text{K})$ . In general, slabs on the ground and cellar ceilings are uninsulated.

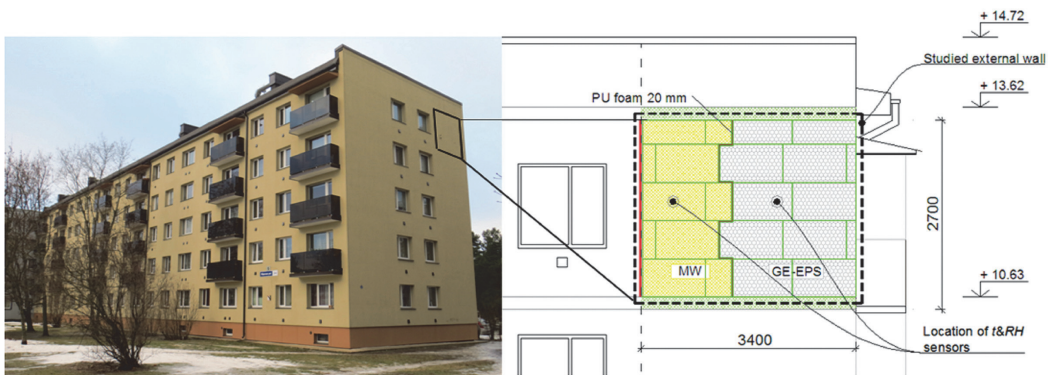
Figure 1 View to the external wall with measurement areas of ETICS.

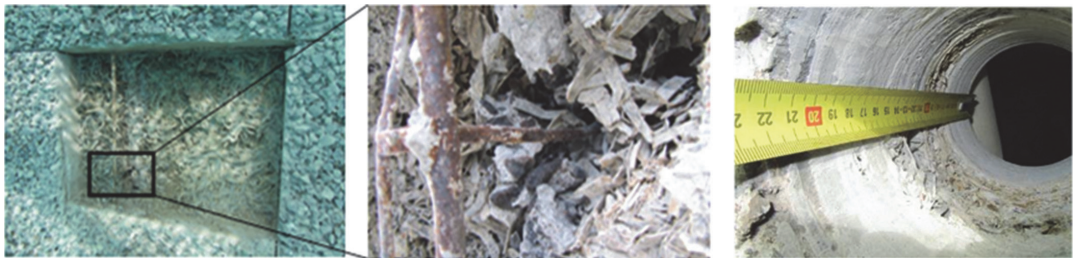
**Figure 5** Reinforcement steel between layers of concrete has started to corrode (left and middle). In principle, this steel should be cast into expanded clay concrete, but in reality it is often not so. Cross-section of a concrete wall element (right).

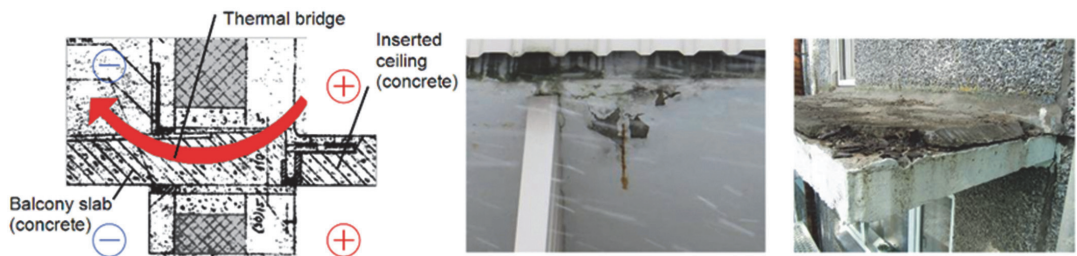
**Figure 6** Original drawing of an external wall/console balcony junction with a thermal bridge (left) and a picture of a degrading balcony (middle and right).

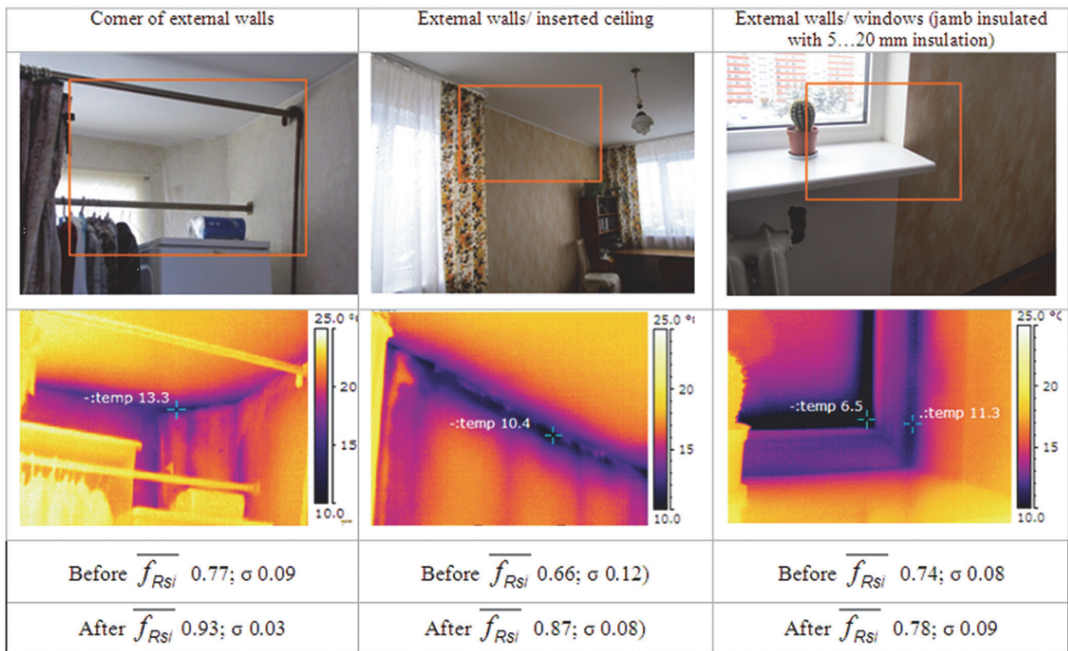
Figure 8 Measured range of temperature factor  $f_{Rsi}$  of thermal bridges with average and standard deviation  $\sigma$ . Pictures were taken before the renovation.

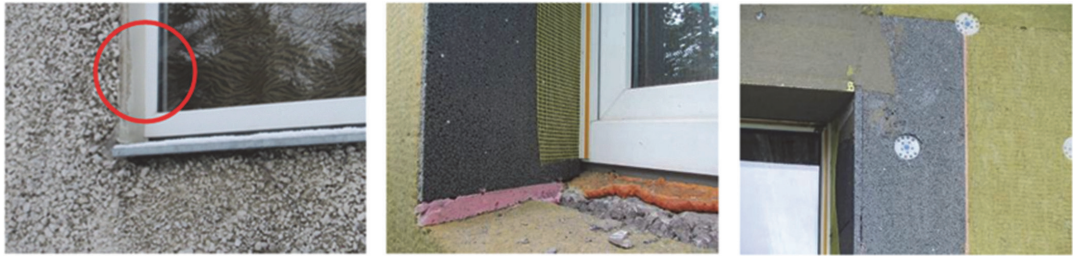
**Figure 10** Picture of an old window (left) and of new windows placed at their original position. Most of the jamb is covered and only a thin layer of insulation (5...20 mm) can be attached to the jamb.
