TALLINN UNIVERSITY OF TECHNOLOGY

# **ASSESSMENT OF STRENGTH AND STIFFNESS PROPERTIES OF AGED STRUCTURAL TIMBER**

MASTER THESIS

Tallinn 2023

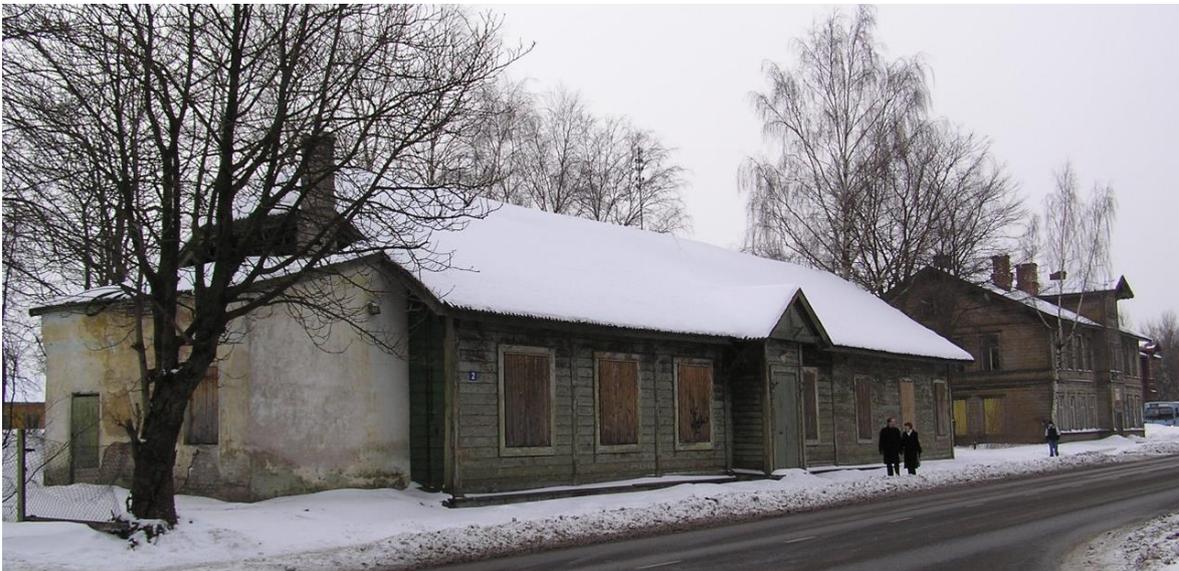
Photo 3.1-1 Vaksali 2e building before destruction [22]

The old timber used in testing originated from a building located on Vaksali street, Tartu, Estonia. The design of this building was based on standard architectural projects from St. Petersburg, which were then adapted to suit the specific location of the structure. The first mention of said building, on a smaller scale, has been recorded in Tartu's city plan since 1906. Although upon examination of the building's architectural details, it is highly likely that the structure was completed before 1900, as the facades of adjacent buildings built in the late 19th century exhibit common features with the given buildings architectural elements, especially the rafter ends, that are tested in current research. The building has served various purposes throughout its history, for example a cinema screening room and a library, but has remained unused since 1990. [22]

Unfortunately, due to the lack of available historical records before 1940, it is challenging to determine the precise construction date of this building with complete accuracy and it has not been possible to uncover more detailed information regarding its exploitation and state of structure. Nonetheless, the timber specimens used in this research seem to be about 120 years old. [22]

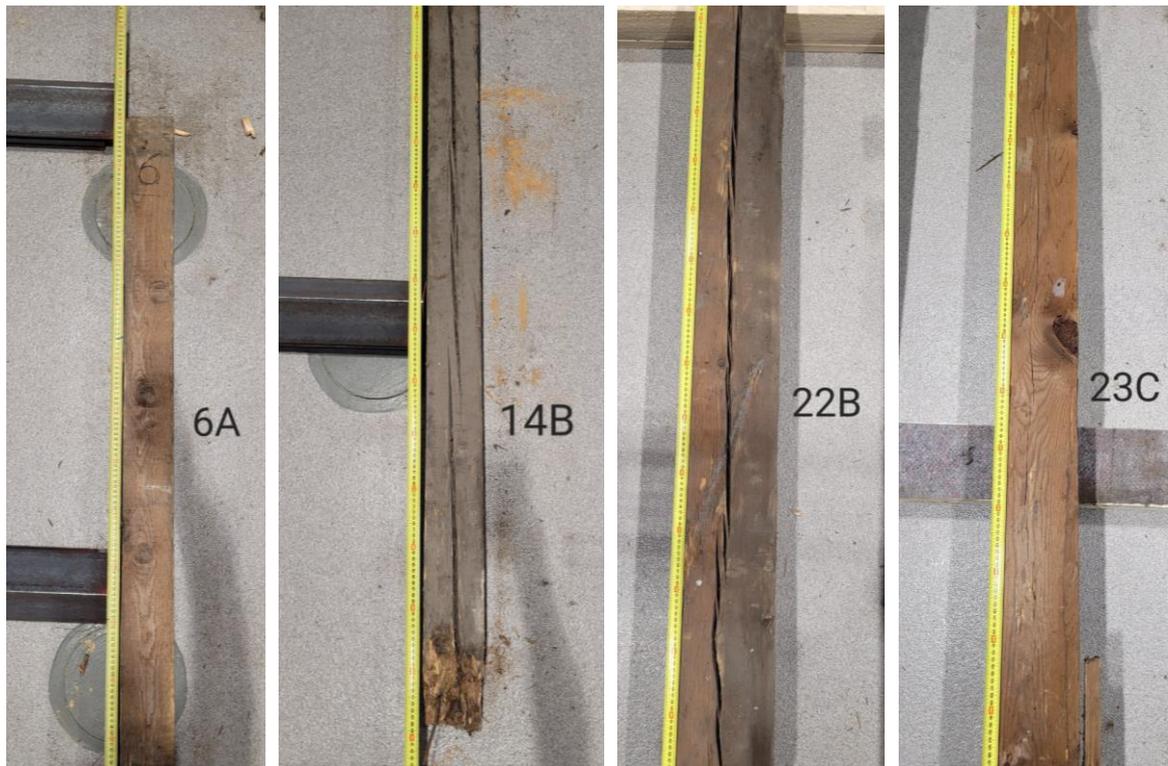
Photo 2.3.7-1 Example photos of marking of specimens

All of the specimens were photographed, given a number and each face was marked with a letter A...D (as shown in Photo 2.3.7-1 and APPENDIX 7). The letter given to the beam's face indicates its location being on compression side during the 4-point bending test. Every non-destructive (ND) bending test was carried out on all four sides of the specimen. The purpose of this approach was to establish a clear connection between the visual assessment of the specimen and its actual performance under stress. By conducting tests on each side, it was possible to gain a better understanding of the correlation between different deformations in addition to groups of knots, and the specimen's overall strength characteristics. This method allowed to identify patterns and trends in the data, which in addition to analysis of the bending behavior of the specimen, provide valuable insight into how various factors contribute to its strength and resilience.

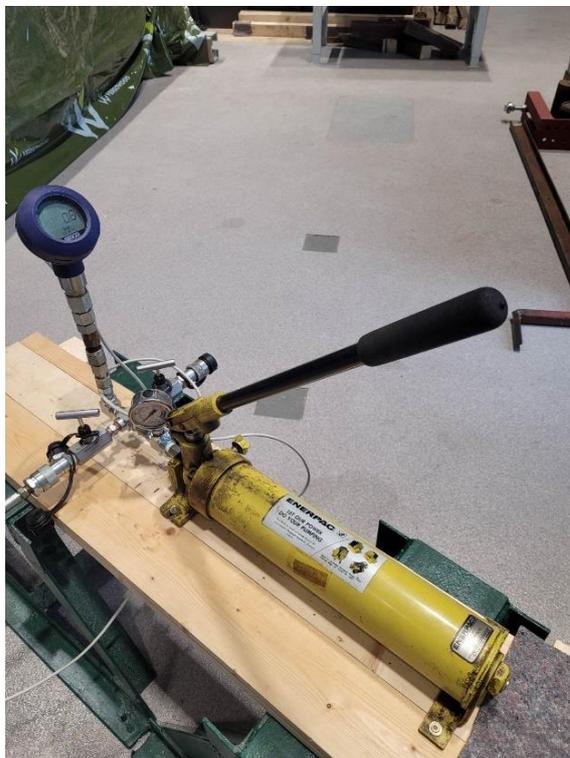
Photo 3.4.1-1 Enerpac P80 Hydraulic Hand Pump

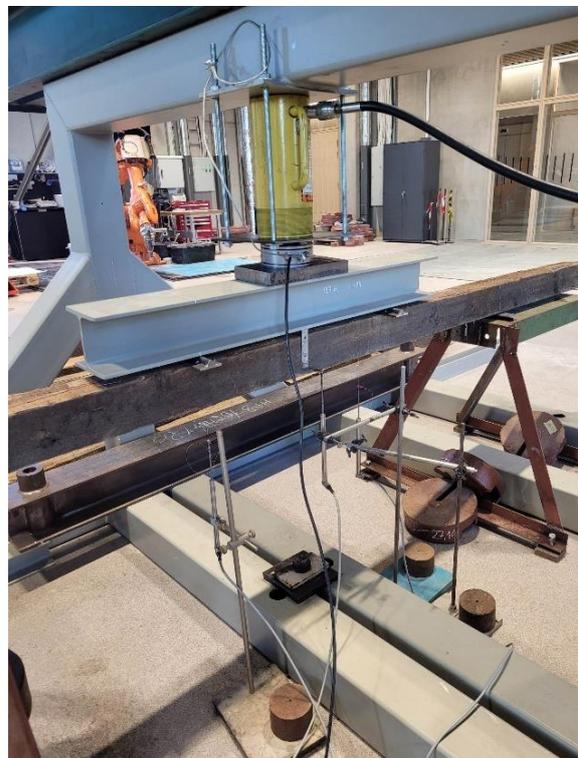
Photo 3.4.1-2 Enerpac Hydraulic Silinder RC506

The additional weight from steel beam (19,7 kg) and plate (6,7 kg) as seen in Photo 3.4.1-2 has been taken into account in calculations.

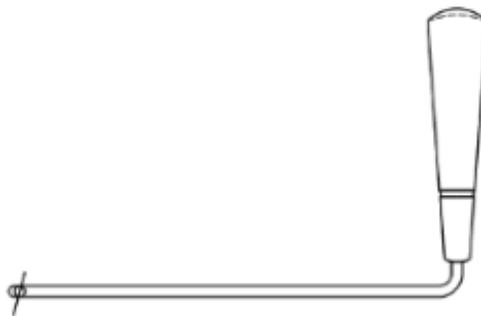
Figure 3.4.4-1 Scribe

The scribe (see Figure 3.4.4-1) is a tool that consists of a cranked rod with a swivel handle at one end and a needle set to a slight trailing angle at the other. By drawing the scribe along the piece of timber in the apparent direction of the grain and applying sufficient but not excessive pressure, a line will be scribed that accurately represents the direction of the grain. To verify the accuracy of the scribed line, it is recommended to draw several adjacent lines with the direction of pull diverging slightly to the left and right, while ensuring that the scribe continues to follow the correct direction, as shown in Figure 3.4.4-2.

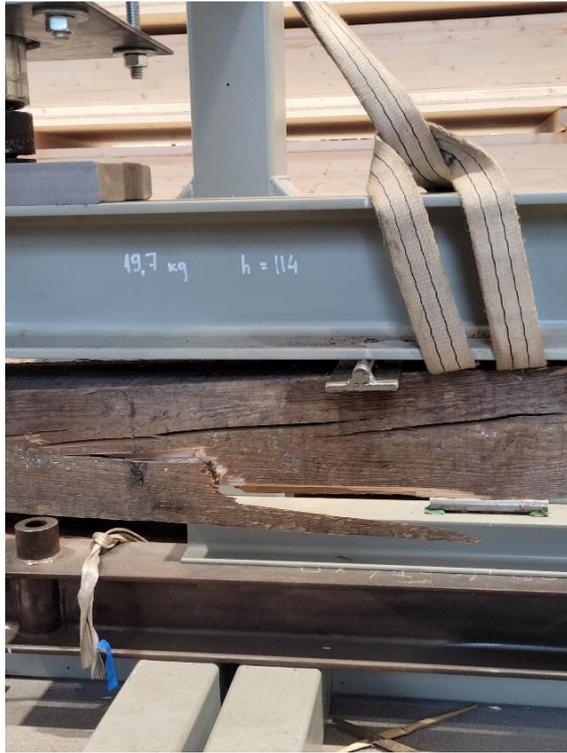
Photo 3.4.4-1 Example 1 of fracture image

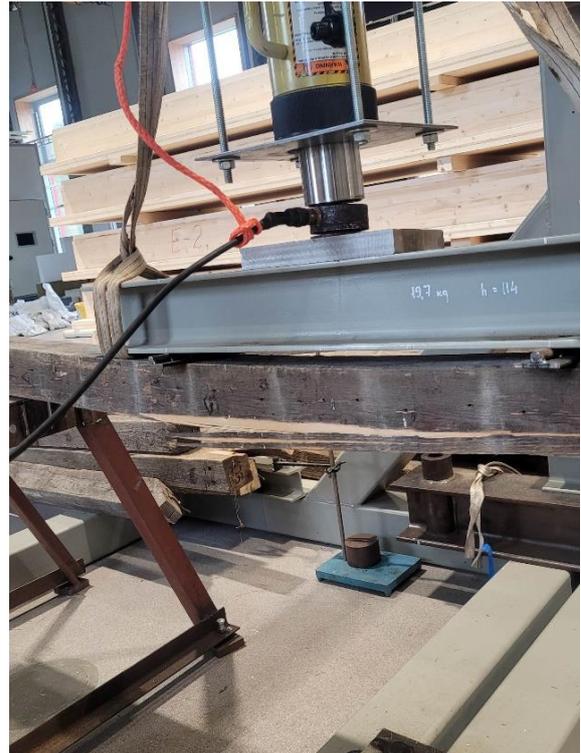
Photo 3.4.4-2 Example 2 of fracture image

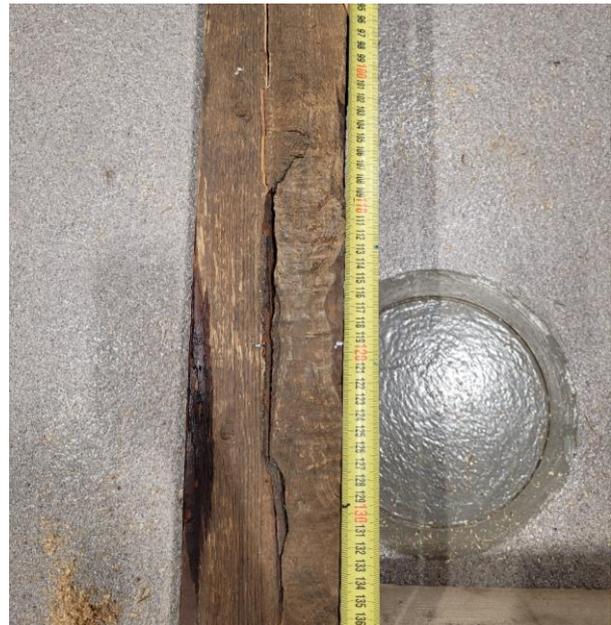
Photo 5.1.1-2 Specimen 21B with visible curly grain

A total of 15 specimens were analyzed, but specimens number 1 and 21 were deemed unsuitable for further analysis due to exceeding wane proportions, insect damage (see Photo 5.1.1-1) and curly grain (see Photo 5.1.1-2). While UNI 11119 allows for specimens with localized insect damage to be considered if degraded areas are excluded from the effective section, this was not possible in the current situation.
