TALLINNA TEHNIKAÜLIKOOL
TALLINN UNIVERSITY OF TECHNOLOGY

**AIR PERMEABILITY PROPERTIES OF CROSS
LAMINATED TIMBER EXTERNAL WALL**

MASTER'S THESIS

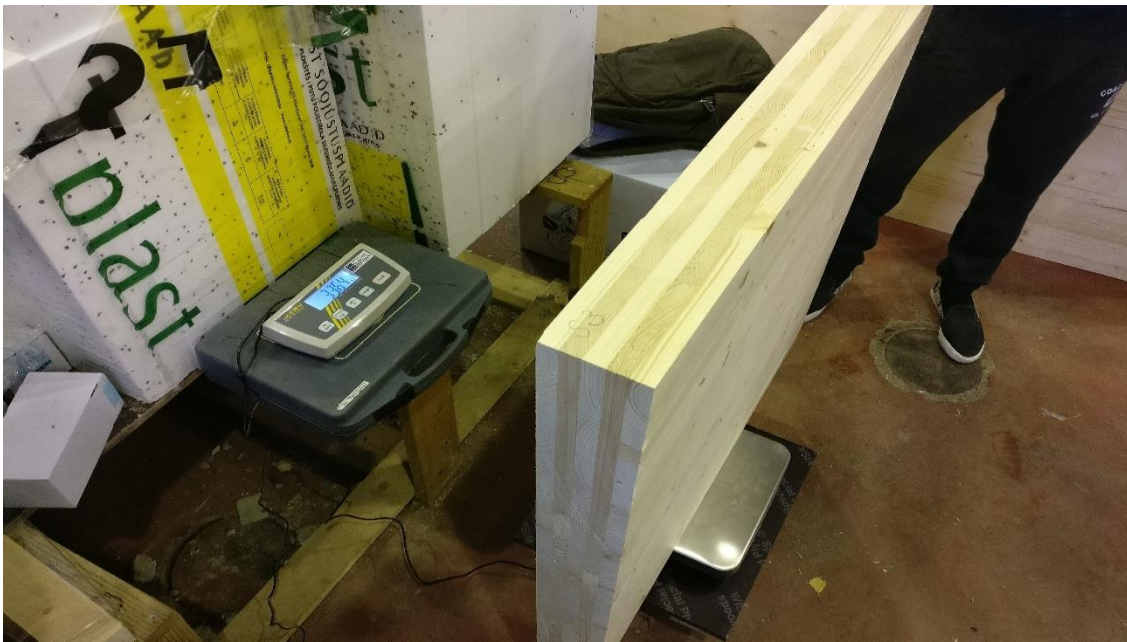
The test specimens in this research consist of 12 CLT panels in total. The specimens (Figure 2.1) are arranged into three different test walls which would be further described in details in the next sub chapter. The specimens are 5 layer CLT panels made from spruce (*Picea abies*) boards (19 x 120mm) and have bonded connections with 1K PUR (one-component polyurethane adhesives) adhesives. All 12 CLT panels were supplied directly from the manufacturer with the dimension 850x850x100 mm.

Figure 2.1: CLT specimen used for the research

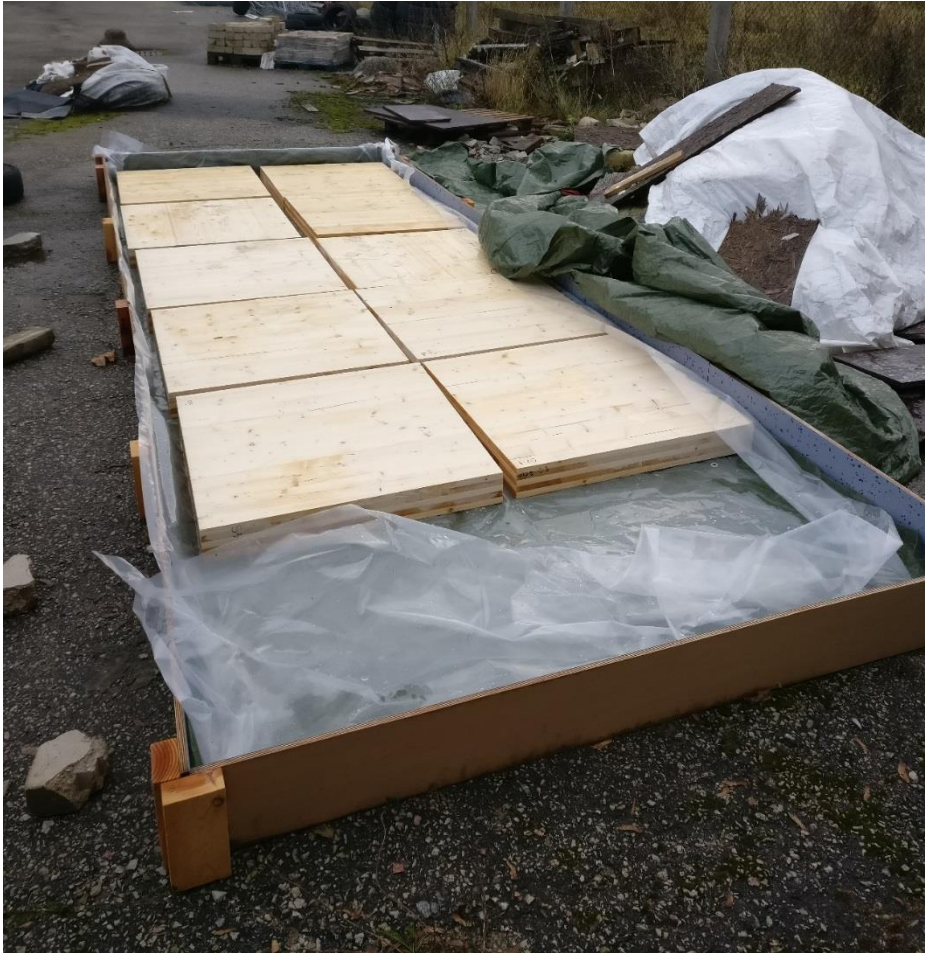
Transferring to the pool: Having completed the building of the pool and the amount of water required for wetting, CLT test panels were transferred to the pools for wetting. After transferring, the panels were wetted with the quantity of water that had been calculated beforehand and then finally covered with a nylon in order to ensure the M.C intake is equally distributed between all the CLT panels placed into the pools. For consecutive period of time, the panels were checked and MC measured in order to confirm if the panels had gotten to the required M.C.

Figure 2.5: Arrangement of CLT panels inside the pool

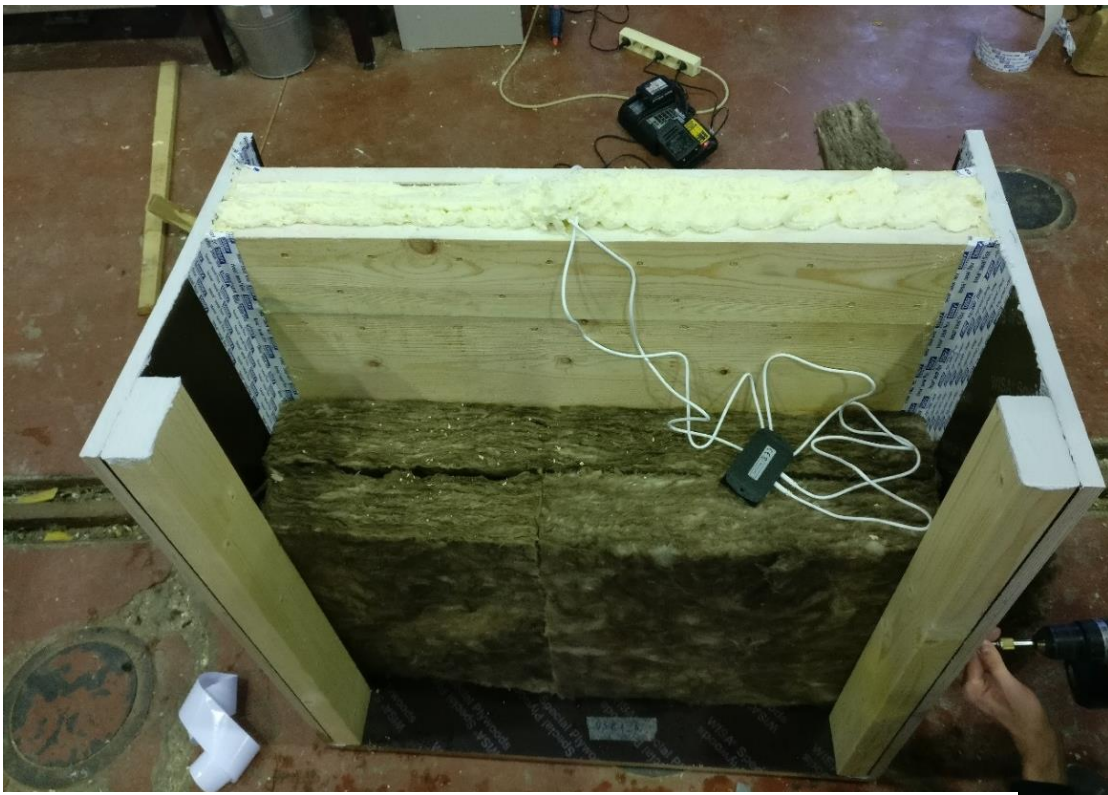
completely sealed along the corner with a sealing tape. An 18mm water proof (film faced) plywood was used to create a wall for the test sample as shown in Figure 2.6

Figure 2.6: *One of the test wall used in the research with mineral wool as insulation*

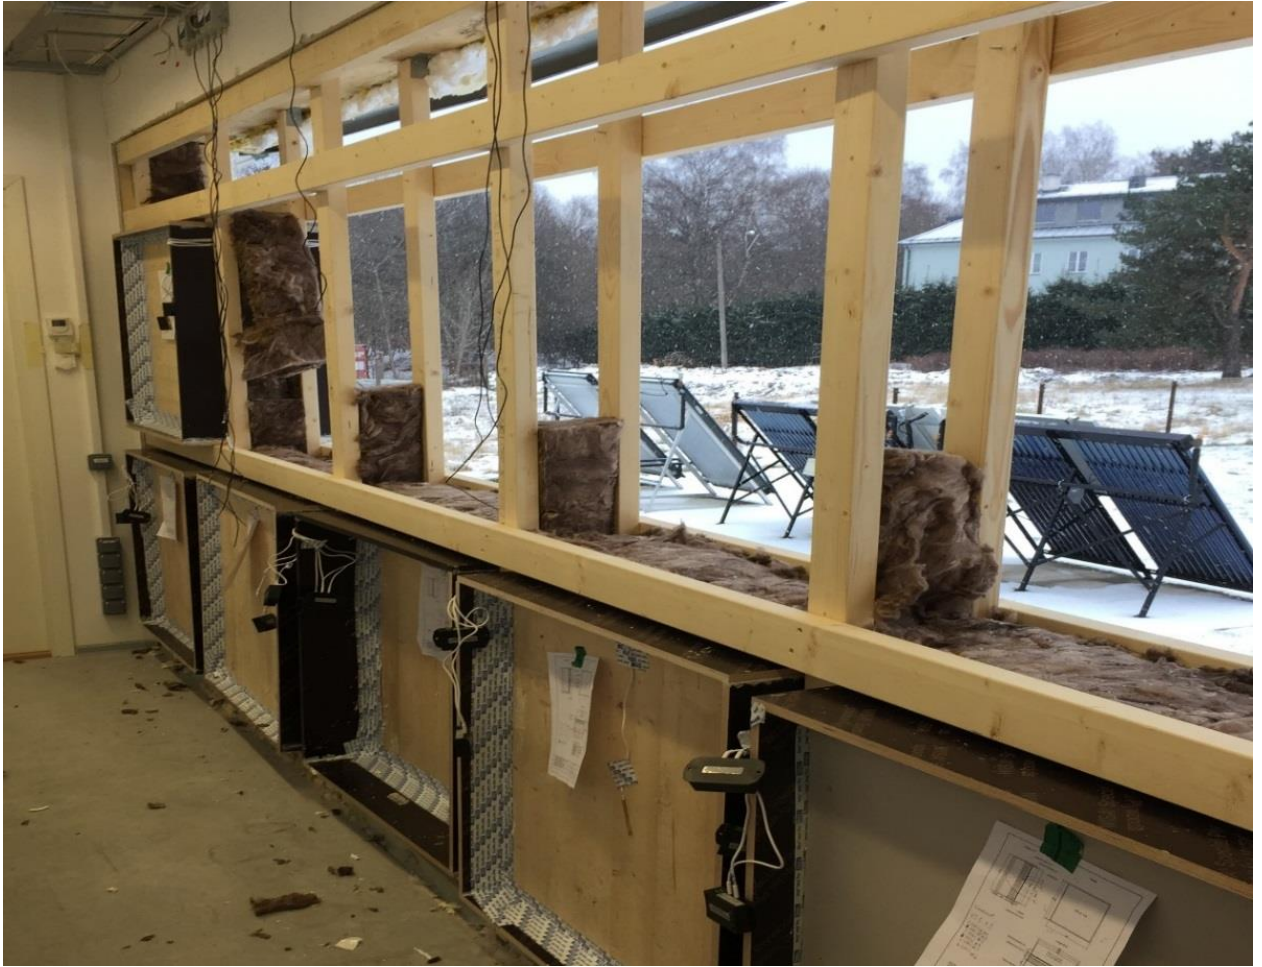
The mounting of the test walls was achieved with frames and beams already constructed as shown in Figure 2.8, hence all that was needed was to transport the test walls from the TTU civil engineering laboratory to the nZEB technological test facility shown in appendix . All the 12 test walls were mounted on both North (six test walls) and South side (six test walls) as shown in Figure 2.8 with the 12-14% M.C test walls arranged at the top while the 25-27% M.C arranged below.

Figure 2.8: Picture showing test walls already mounted in technological test facility

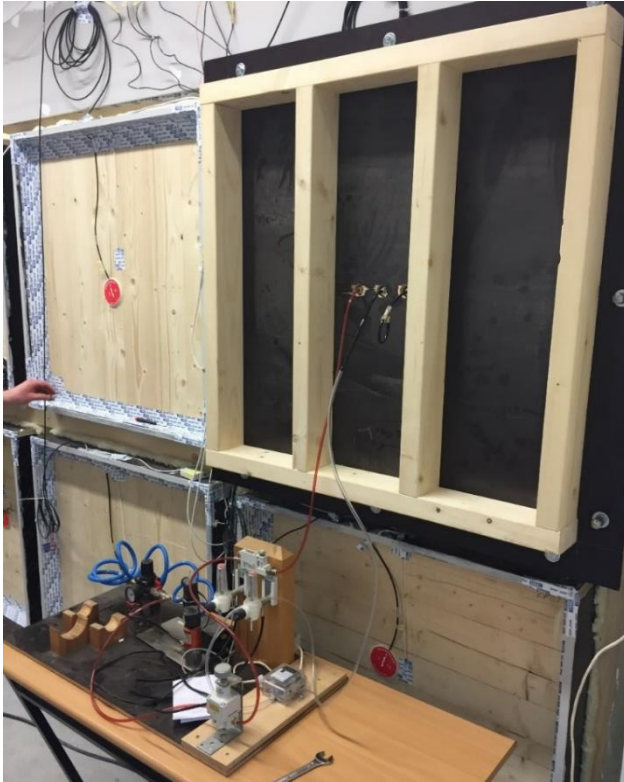
Figure 2.10: A scheme of the apparatus to be used for the air permeability test

For this research, test was carried out at the TTU nZEB technological test facility at positive pressure differences with the apparatus provided for in Figure 2.9 and 2.10. The ambient temperature and humidity in the apparatus is between 15 °C to 30 °C and 25% to 75% RH as specified in EVS-EN 12114: 2000.
