TALLINN UNIVERSITY OF TECHNOLOGY
SCHOOL OF ENGINEERING
Department of Civil Engineering and Architecture

ANALYSIS AND MODELLING OF FIRE TESTS WITH I-JOISTS

MASTER THESIS

Tallinn 2023

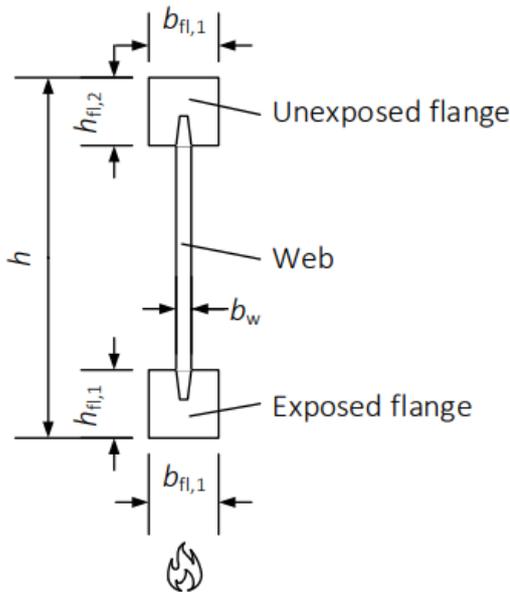
Figure 2.1. The naming of the parts of an I-joist. [2]

Figure 2.1 displays the labels of the parts of an I-joist in the context of fire design.

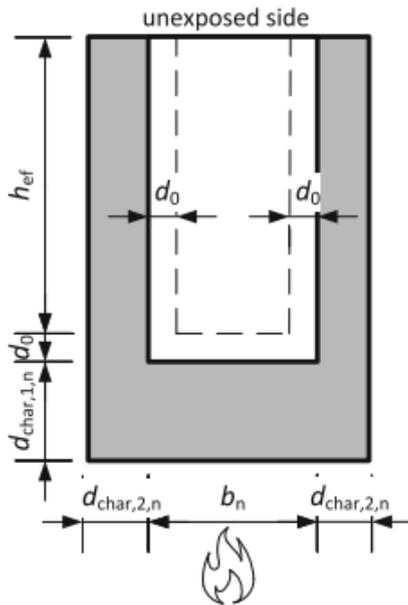
Figure 2.2. Principles of the new design model for a rectangular member [6].

Explanations of symbols shown in Figure 2.2:

b_n	notional width of the cross-section
d_0	zero-strength layer depth
$d_{char,1,n}$	notional charring depth at fire exposed side
$d_{char,2,n}$	notional charring depth at lateral side
h_{ef}	height of the effective cross-section

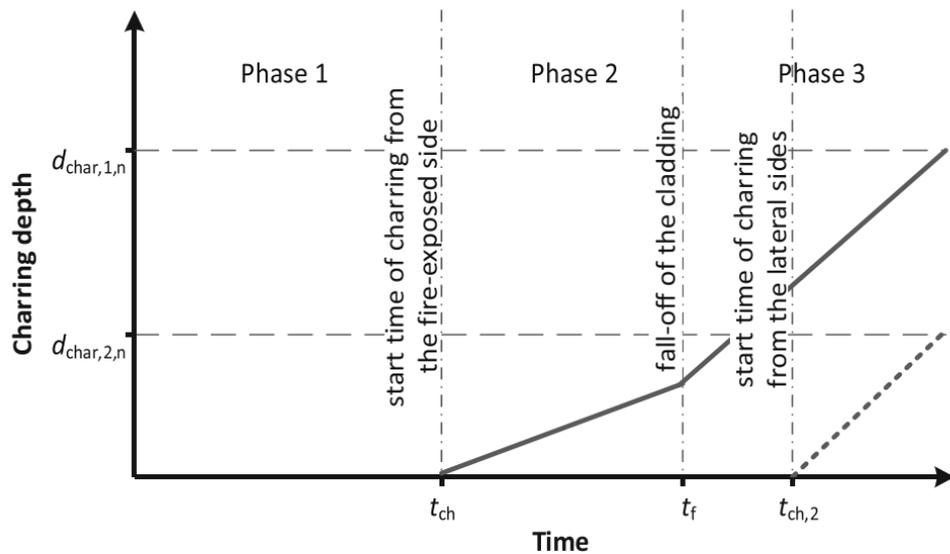
Figure 2.3. Charring phases for rectangular members [6].

Timber elements with rectangular cross-sections have three distinct charring phases. The first phase, known as the encapsulation phase (Phase 1), refers to the period where no charring takes place. Phase 2 corresponds to the slow charring that occurs behind the protective panelling. Phase 3 signifies the rapid charring phase that follows the removal of protection. For visual representation see Figure 2.3.

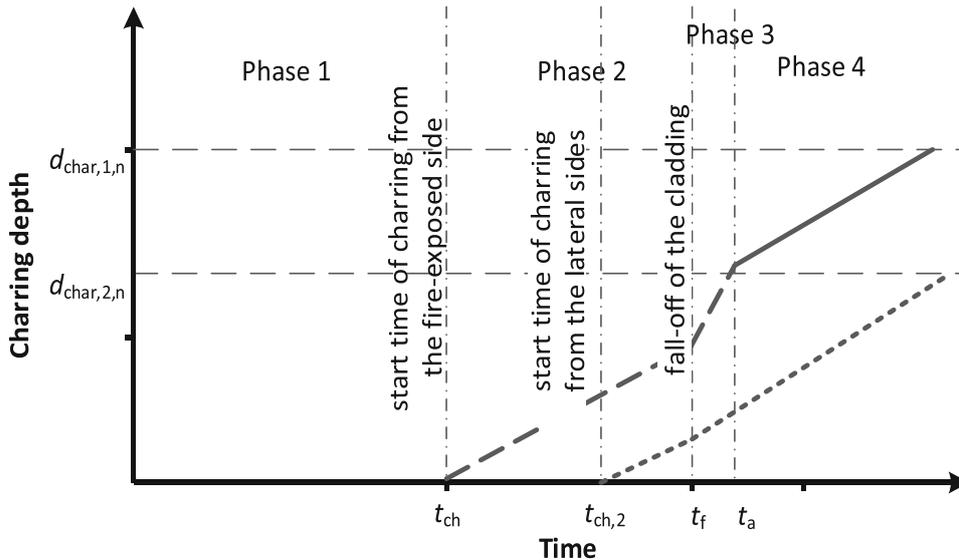
Figure 2.4. Charring phases for exposed flange of an I-joist [6].

When dealing with wooden I-joists, there are typically four charring phases for the fire-exposed side of the flange. The charring phases are seen in Figure 2.4.

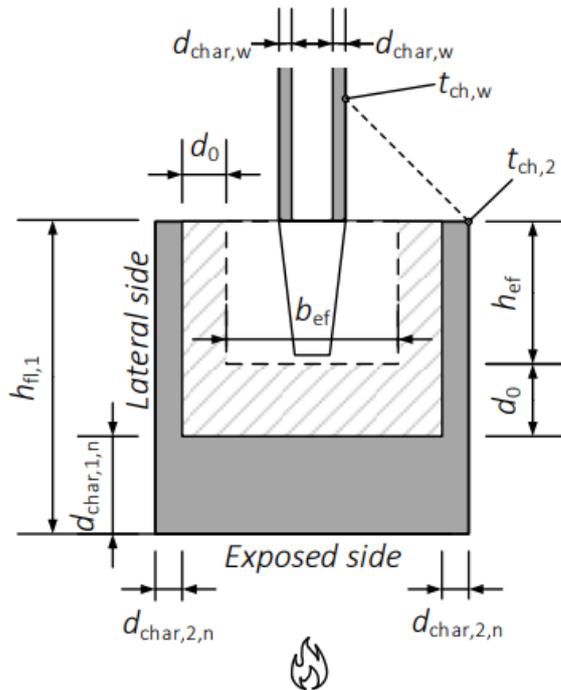
Figure 2.5. Principles of the new design mode for an I-joist [6].

I-joists may char on the fire exposed side of the exposed flange and on the lateral sides of the exposed flange. The start time of lateral charring ($t_{ch,2}$) is considered as the time from the beginning of the fire exposure until the top corner (see point $t_{ch,2}$ in Figure 2.5) reaches 300 °C. Charring may occur on the web. Start time of charring on the web is considered as the time to reach 300 °C at the point marked with $t_{ch,w}$ in Figure 2.5. The principles of the design method for I-joists are shown in Figure 2.5.

In the draft of the new Eurocode 5 standard [4], formulas are given in Table I.3, according to which maximum values of zero-strength layer depth for I-shaped members can be found. Zero-strength layer is subtracted from three sides of the fire exposed flange as shown in Figure 2.5.

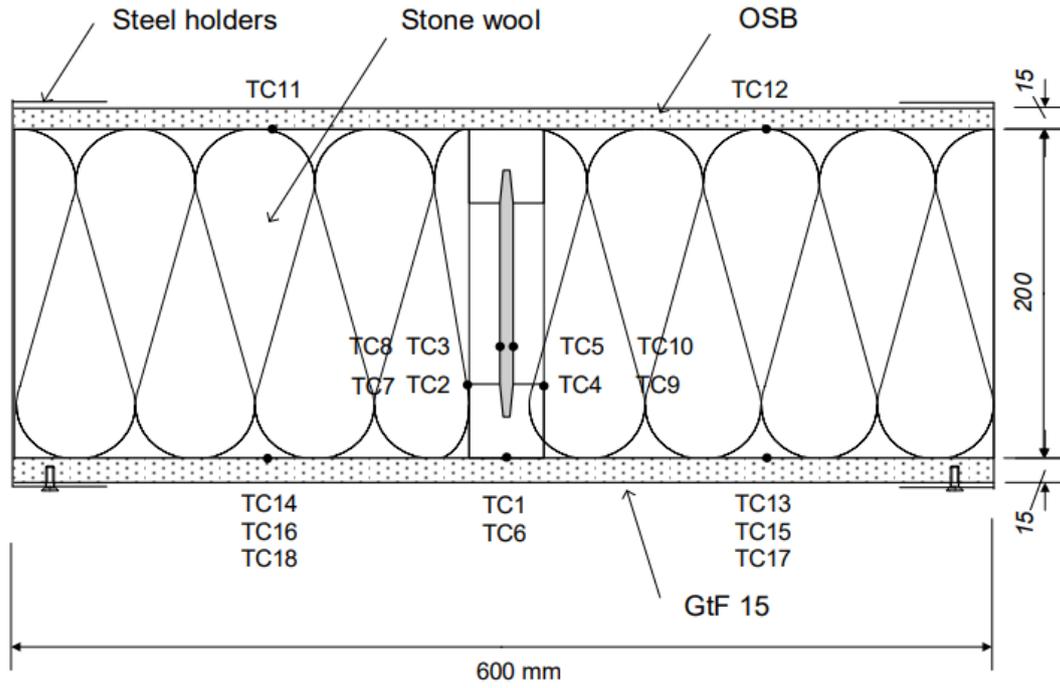
Figure 3.1. Section of the specimen. Location of thermocouples. [10]

Type K thermocouples were used to measure temperatures in the assembly during the testing. The placement of the thermocouples is displayed in Figure 3.1. The thermocouple wires were stapled to the joists and guided towards the unexposed side.

All simulated I-joists had a height of 200 mm, the flange width and depth were both 47 mm. The specimens were protected by gypsum plasterboard, Type F (15 mm) on the fire exposed side. The unexposed side was covered by a 15 mm thick wooden fibreboard. The cavities were filled with stone wool insulation with a density of 26 kg/m³. A cross-section of the test specimen from the test report is shown in Figure 3.1.

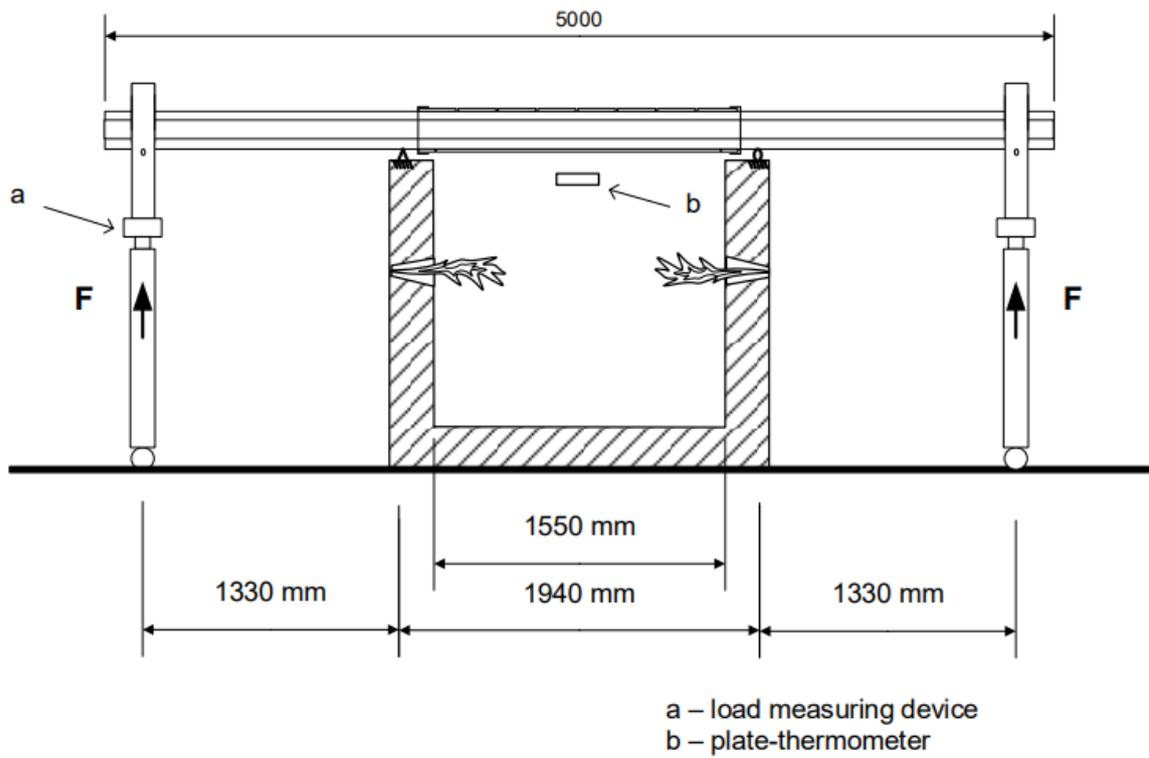
Figure 3.2. Test setup. [10]

Blanks were glued with all 11 adhesives and then cut in half longitudinally. I-joists were produced with each half as the middle part of the tension flange. One of the I-joists in each pair was tested until rupture in bending tests at ambient temperature, while the other I-joist was tested in fire, with its strength predicted according to the trendline of relations between MOE and bending strength. The specimen length was 4.6 meters for all tests. The cavity insulation used was stone wool with a density of 30 kg/m³, and the fire-exposed side was covered with 15mm Type F gypsum board. The gypsum boards were connected to the assembly using steel elements at the edges, but were not fastened to the I-joist. The section of the specimen can be seen in Figure 3.1 and the test setup in Figure 3.2.

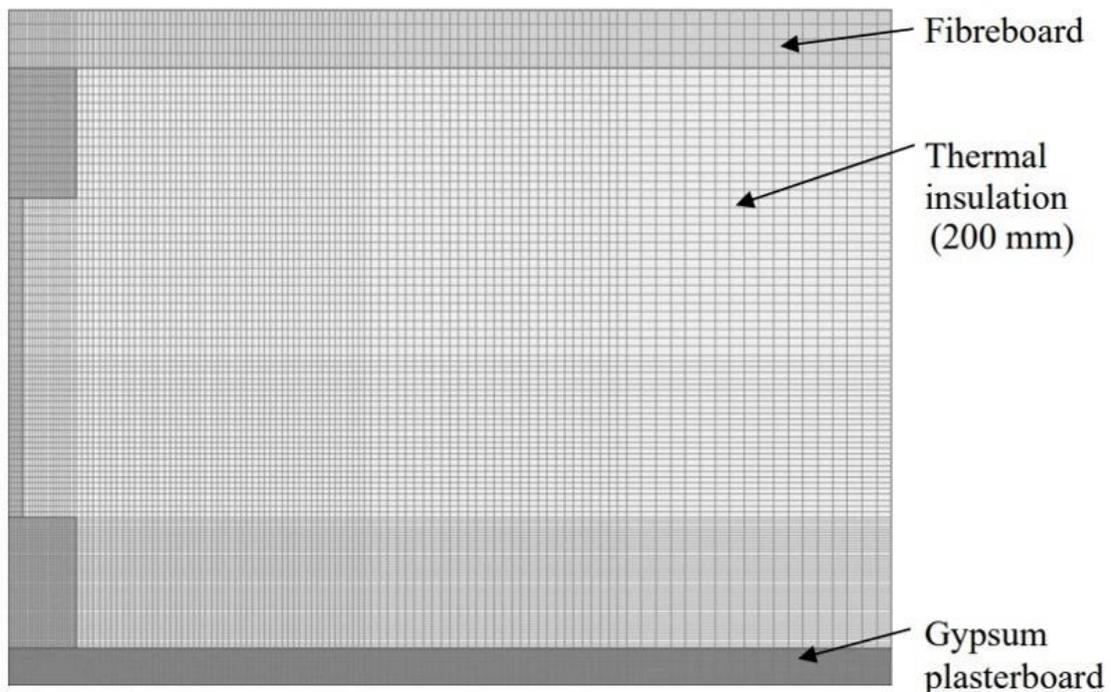
Figure 3.3 Rectangular elements with varying sizes of simulated sections [light timber frames].

The simulated sections were divided into rectangular elements. The sizes of the elements were varied between 1x1 mm and 5x5 mm. The rectangular elements with a size of 1x1 mm were located on the fire exposed side of the I-joist, whereas on the opposite side, referred to as the "cold side", the size of the elements increased to 5x5 mm.

Differently sized elements are displayed in Figure 3.3. The time intervals were set at a maximum of 5 seconds. A simulation was performed on half of a frame assembly. Distance between the centres of the beams was 600 mm. The sides of the simulated structure were adiabatic surfaces.

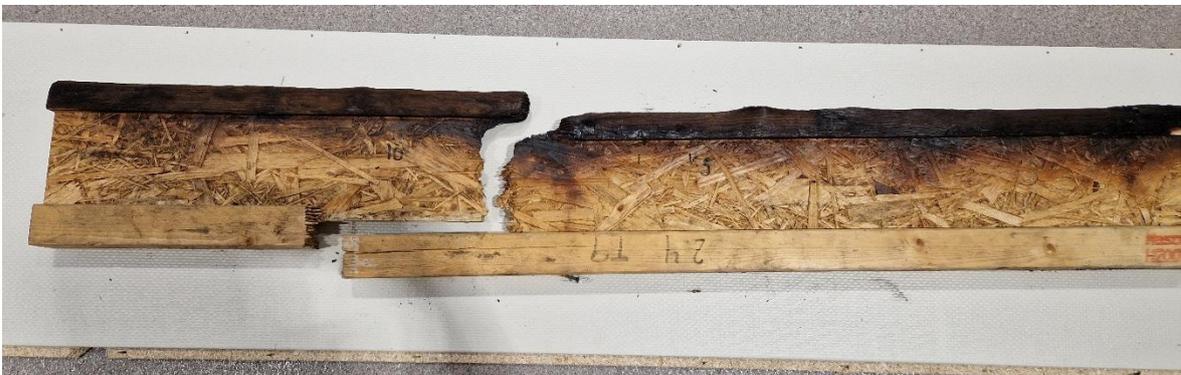
Figure 4.1. Broken I-joist 2.4 in full length.

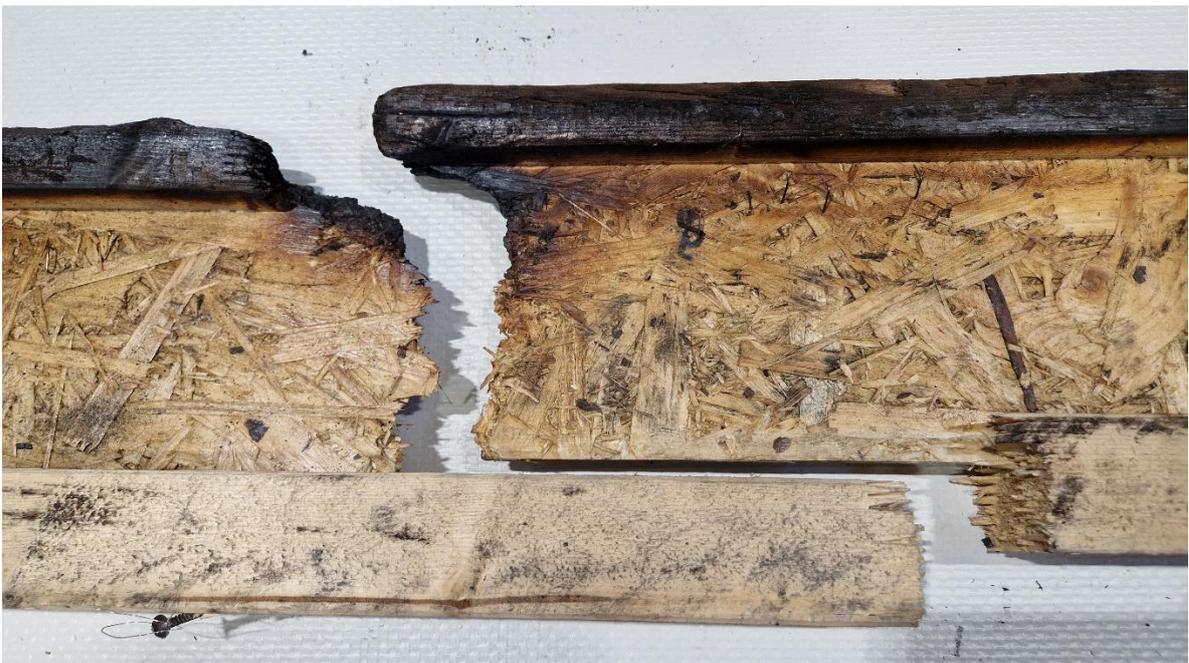
Figure 4.2. Broken I-joist 2.4, position where the wood breakage took place.

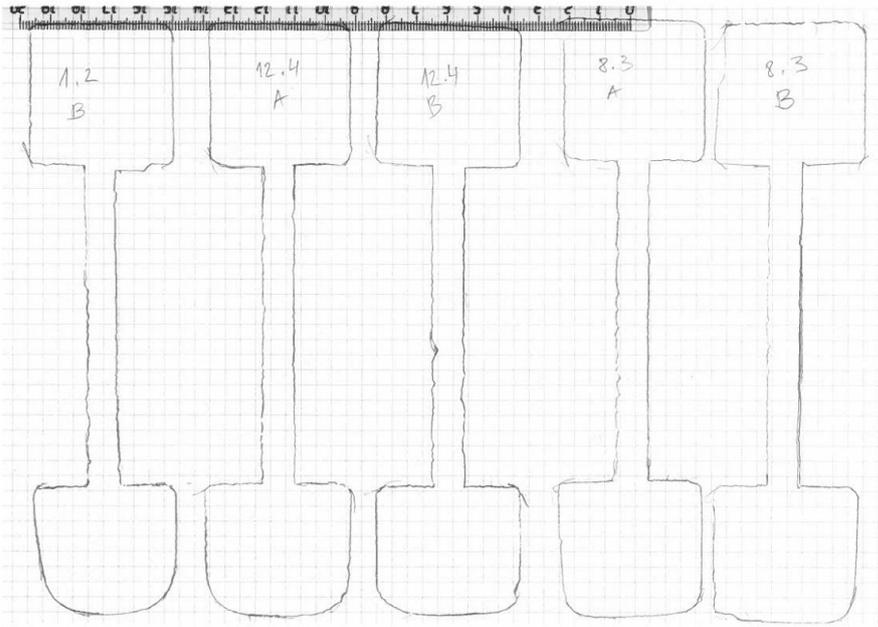
After conducting the tests, the cross-sections were cleaned of loose coal with a steel brush. All broken I-joists were then documented in full length and from the places where the breakage occurred. On the example of the beam 2.4, fracture images are presented in Figure 4.1 and Figure 4.2. About 5 cm long pieces were cut from the I-joists, perpendicular to the longitudinal axis of the I-beam, close to the breaking point. Both sides of these pieces were drawn on paper and scanned with a ruler next to them. At least two contour lines were scanned for each tested beam. The drawn cross-sections are seen in Figure 4.3.

Figure 4.3. Contour lines of the scanned remaining cross-sections.

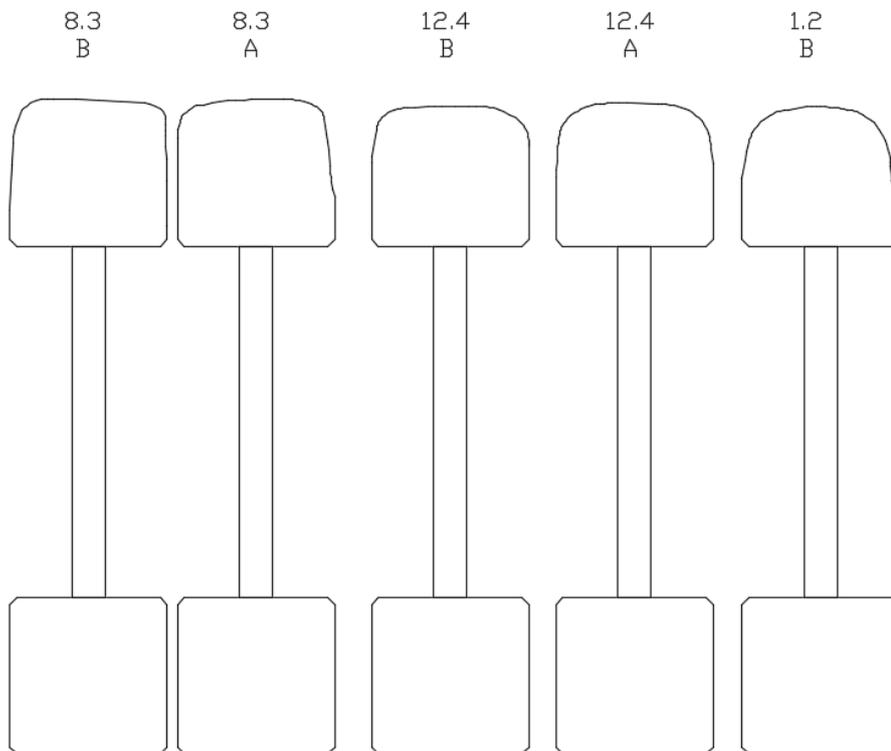
When the contours were redrawn in the AutoCAD program and were then ready for further use for all the I-joists, it was possible to find further necessary cross-section properties based on them. The redrawn contours are seen in Figure 4.4 using a few I-joists as an example.

Figure 4.4. I-joist contours drawn based on the scans.

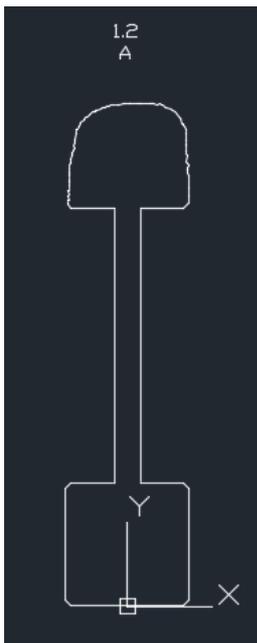
The charred cross-section contours were converted into closed polylines. The resulting contours were one by one moved to the starting point of the coordinates so that the centre under the cold flange was at the zero point. Further, it was possible to turn the polyline into a region, from which all the necessary cross-section properties could be retrieved with the command 'massprop'. As a result of this work, the cross-sectional area, the moment of inertia around the x-axis and the centroid in relation to the y-axis were obtained. The diagram showing the obtained contour and data output are shown in Figure 4.5 and Figure 4.6.

Figure 4.5. Contour of the cross-section of beam 1.2 at the origin of the coordinates.

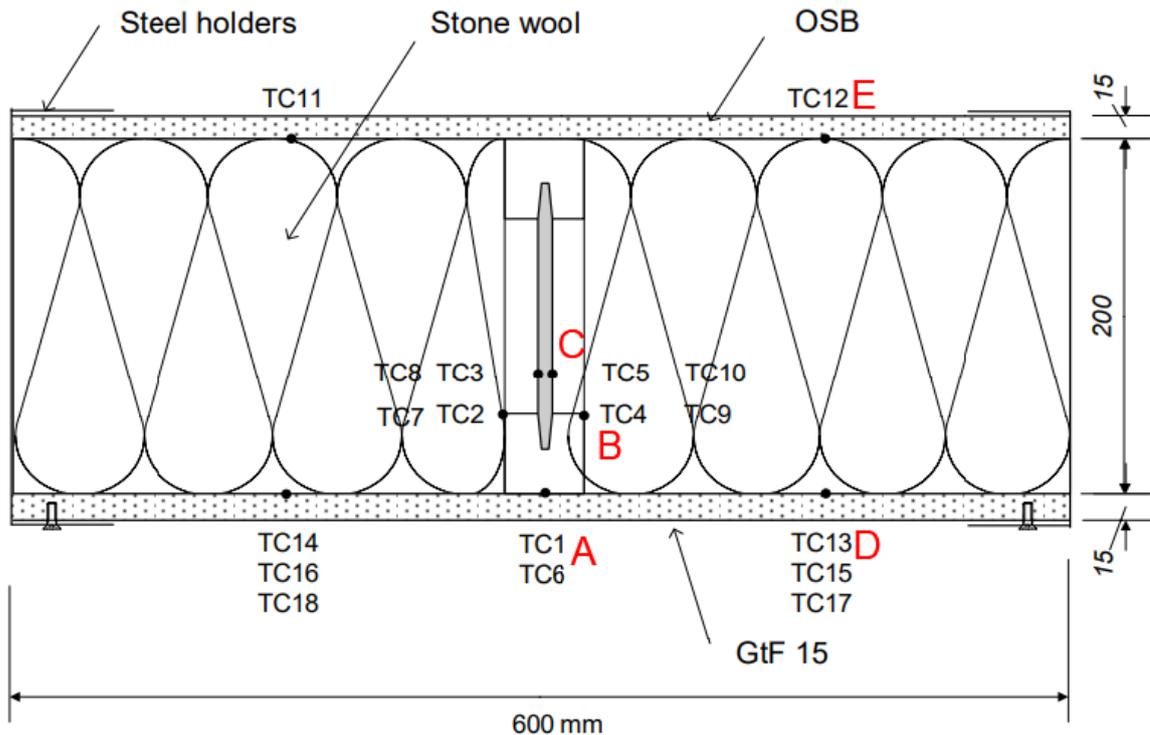
For comparing the actual test temperatures recorded by thermocouples with the ones from the simulations, five points were picked, where there had been thermocouples positioned during the tests. For the same points there was exported temperature data from all 14 simulations. The location of the points is seen in Figure 4.7.

Figure 4.7. The location of the points A to E, where temperatures were compared.

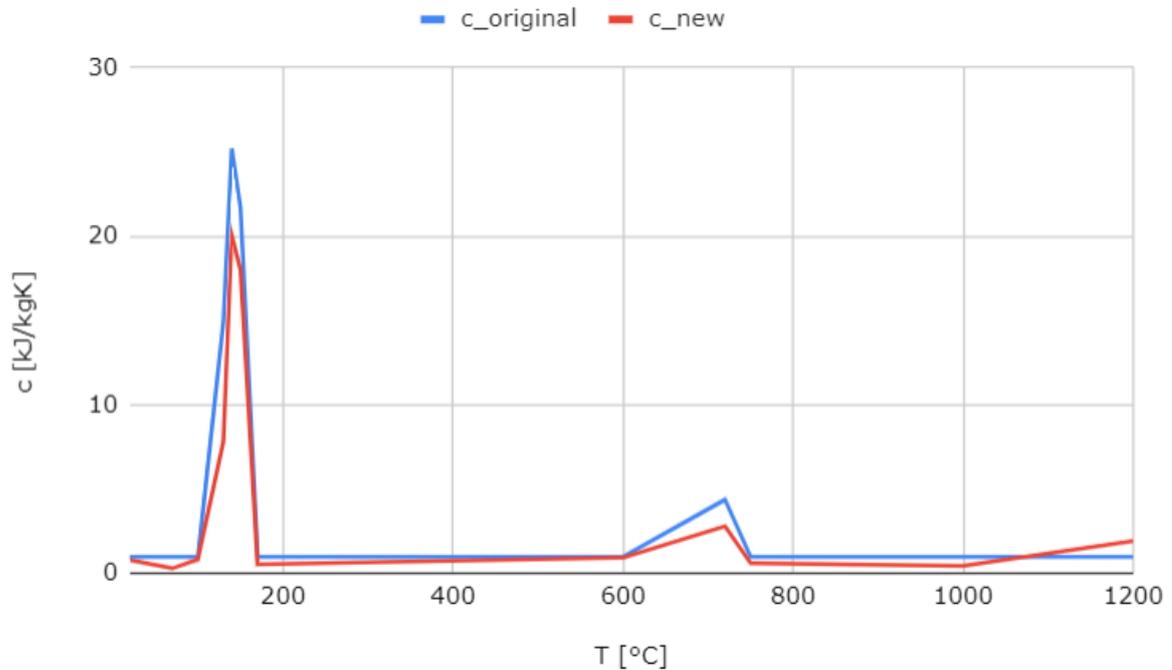
In order to improve the similarities, the fire protection system parameters were modified by changing the values of gypsum plasterboard's specific heat capacity (c). The comparison of the values originally stated in the guide and the updated values can be seen in Figure 4.8. The values taken from the guide "Fire safety in timber buildings" are marked as c_{original} and the changed new values as c_{new} . Other important gypsum plasterboard parameters needed for the simulations, like density and thermal conductivity, were taken from the guideline „Fire safety in timber buildings" [13].

Figure 4.8. The comparison of values of specific heat capacity before and after recalibrating.

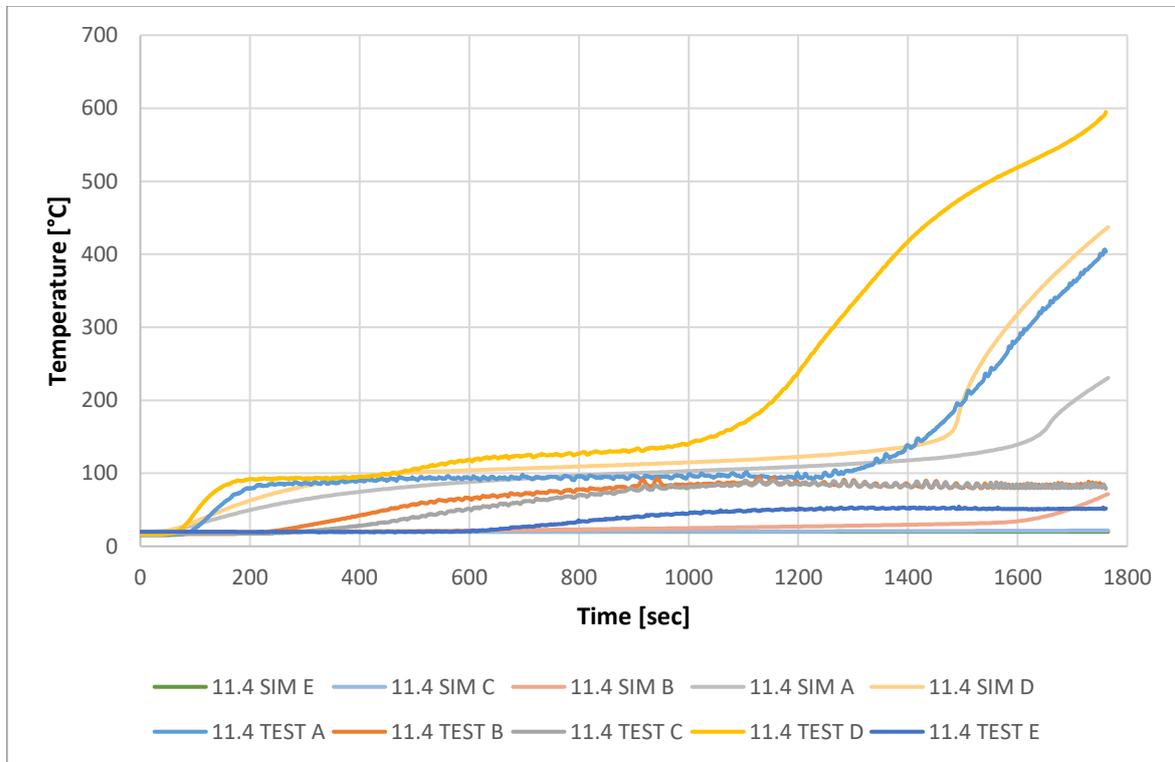
Improvement of the results in the simulations after recalibrating the base values in the example of test beam 11.4 are shown in Figure 4.9 and Figure 4.10. In the test with beam 11.4, there was no gypsum plasterboard fall-off.

Figure 4.9 The comparison of simulation and test results of test beam 11.4 before recalibrating the base values.

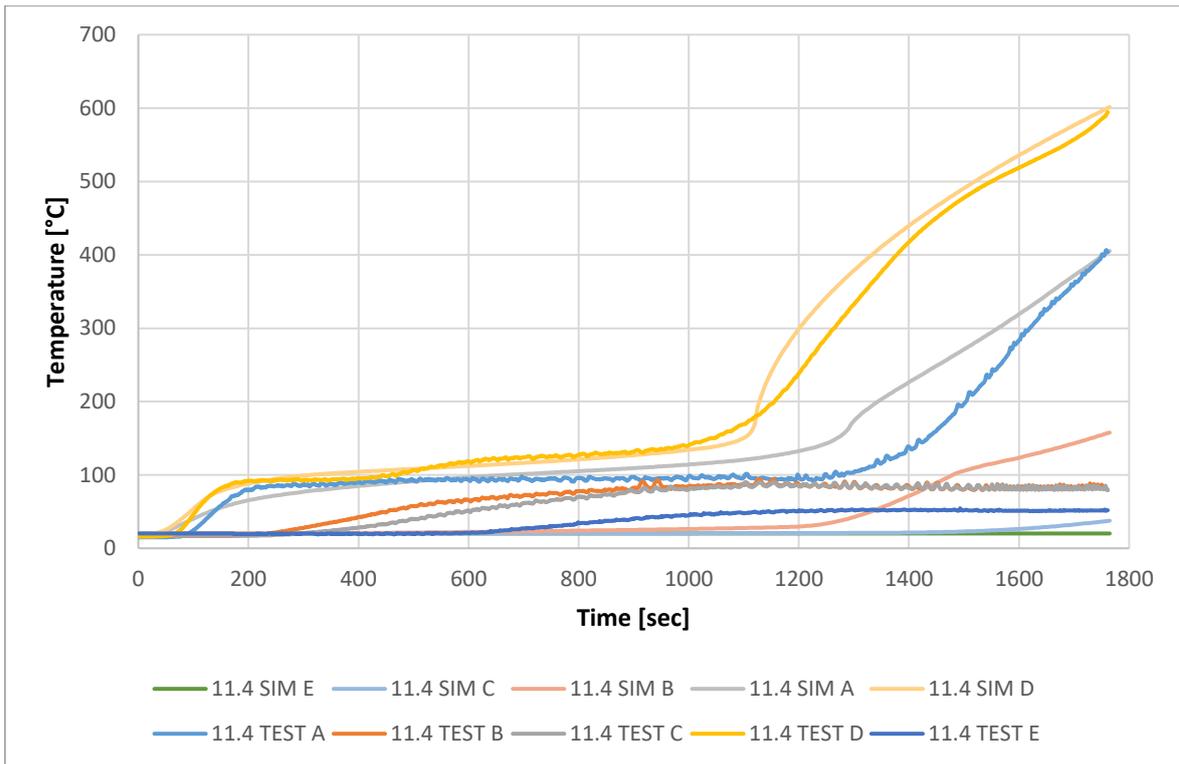
Figure 4.10. The comparison of simulation and test results of test beam 11.4 after recalibrating the base values.

After changing the characteristics of the gypsum plasterboard, the outcome was, that now the simulation results were on the „safe side“ of the chart compared to the actual test results. The notion that the simulation data is now "on the safe side" compared to the experimental results means that, to a large extent, the line of the simulated experiment either coincides with that of the experiment or describes the course of the experiment more conservatively than it actually occurred.

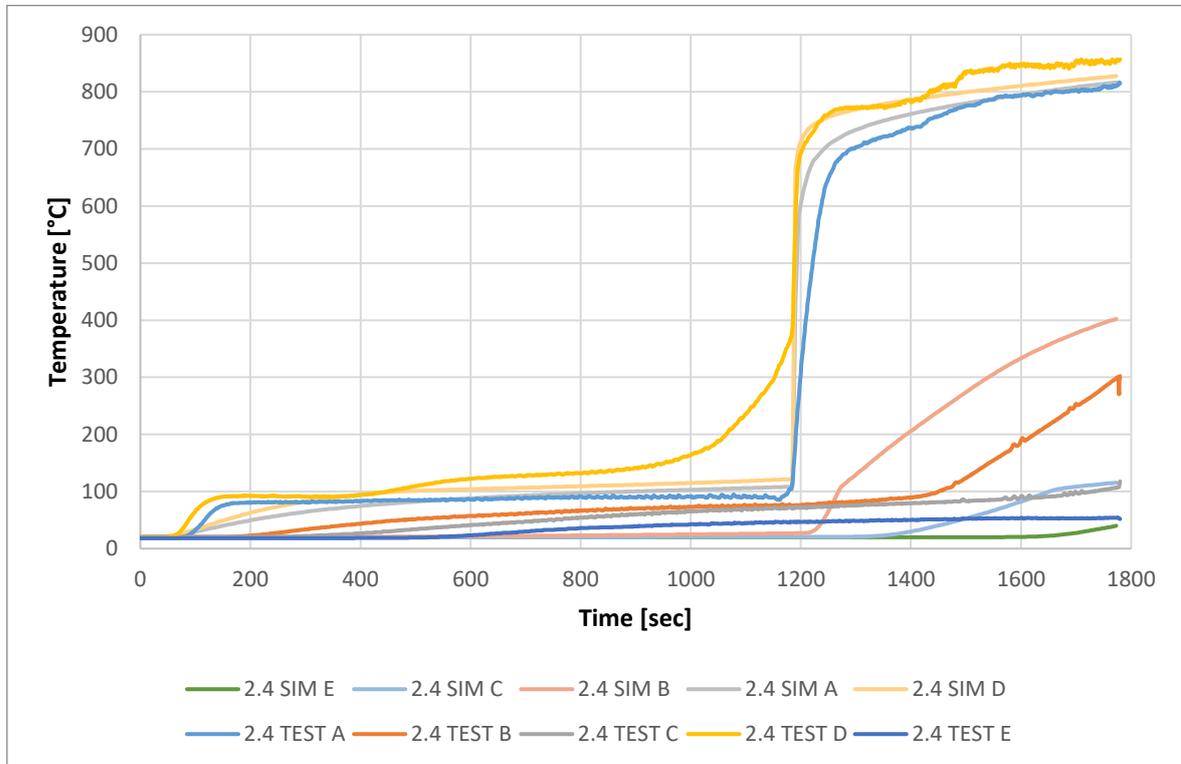
Figure 4.11. The comparison of simulation and test results of test beam 2.4 before recalibrating the base values.

Looking at the graph seen in Figure 4.11, when the plasterboard thermal properties had not been changed yet, it can be seen that the lines of simulations and experiments are located quite similarly when comparing the points A to E. At first, the temperature lines of the tests rise faster than those of the simulations. Also, in the time period 500-1000 seconds, the actual temperatures are higher than the ones obtained from the simulation. At 1200 seconds, the temperature lines of the simulations and test results largely overlap when viewing the points A and D. By the end of the experiment, both lines when viewing the point A are at a very similar height. Similarly, at lower temperatures, the lines of the simulations are on the safe side. At point D, however, the temperatures in the simulation do not rise as high as in the experiment.

From the graphs of the temperature of the beam 2.4, it can be seen that the test has a rather short fall-off time. Comparing the graphs seen in Figure 4.11 and Figure 4.12, it is seen that the temperature lines of the simulation have largely changed during the long fall-off time. It can be noticed that already at the beginning of the experiment, the temperature lines of the simulation and of the actual experiment are now much more similar. Comparing the temperatures, the rise of the lines at points A and D in the simulations are almost as steep as the lines of the actual results. If before changing the gypsum plasterboard data, the temperature lines of the test were quite different from those of the simulation in the period 500-1000 seconds, then after the change, the similarity is much greater. However, there is still room for improvement, so that the lines of the simulations would overlap those of the test or even better be on the safe side. Temperatures in the last few hundred seconds of the experiment were generally unchanged. At lower temperatures, the lines of the simulations are mostly on the safe side.

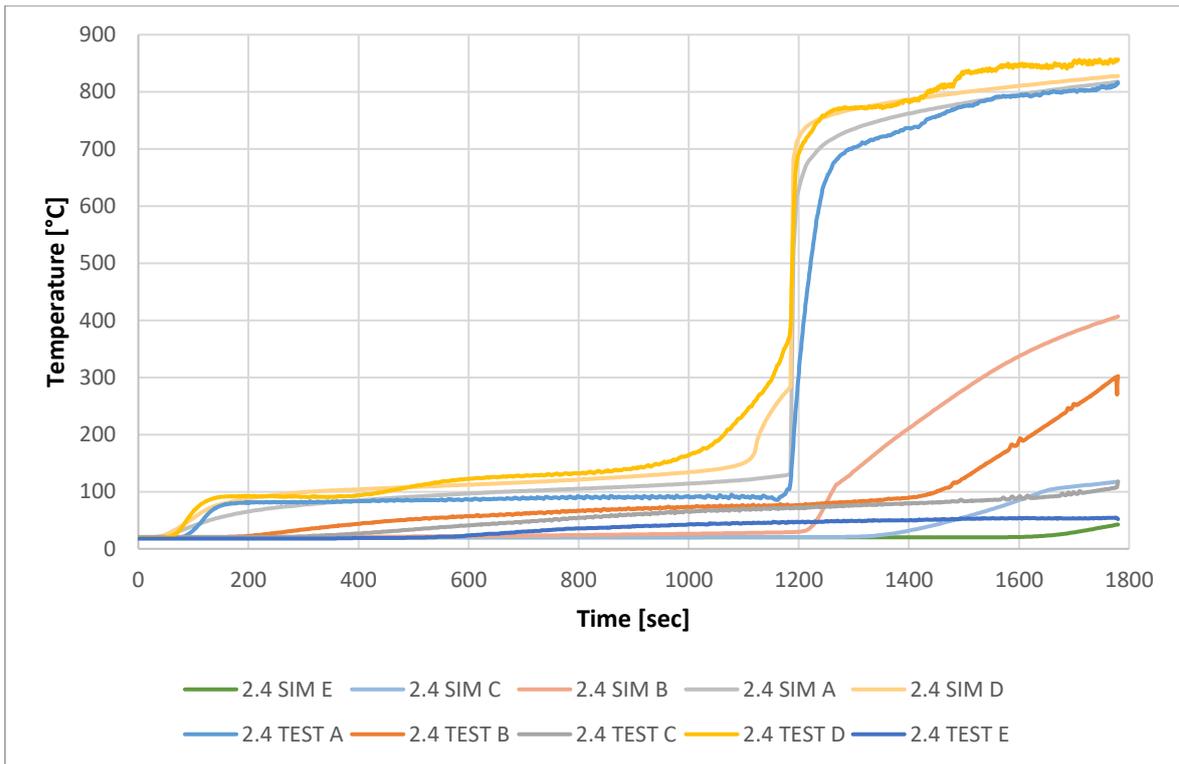
Figure 4.12. The comparison of simulation and test results of test beam 2.4 after recalibrating the base values.

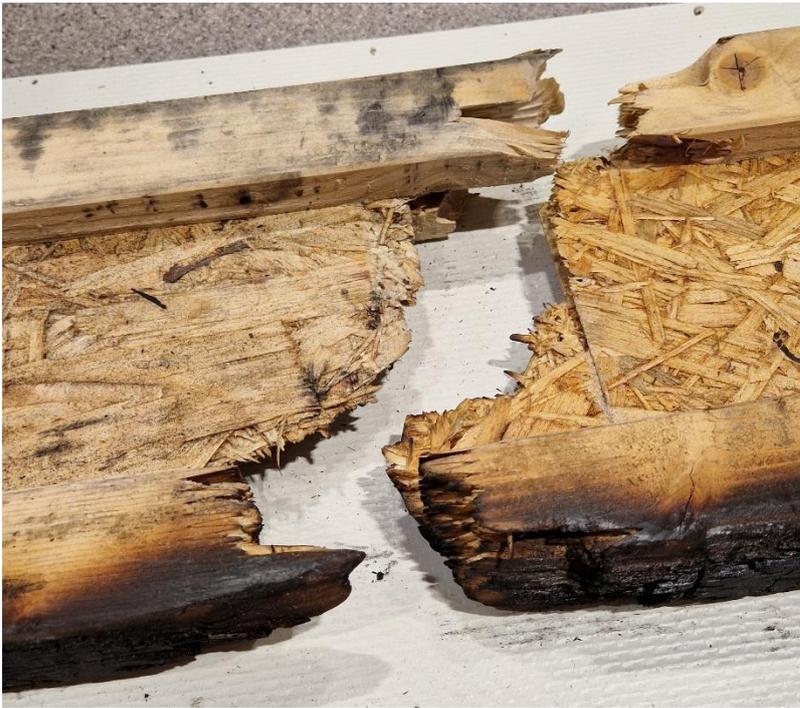
Several types of breakage occurred in the tests. The main ones were the failure due to reaching the bearing capacity of the wood and the failure of the glue. In Figure 5.1 there is shown beam failure due to wood breakage. Adhesive failure can be seen, for example, in Figure 5.2.

Figure 5.1. Failure due to reaching the bearing capacity in the example of beam 2.2.

Looking at the photos of the different test beams after testing, there is a noticeable trend that beams broken due to glue are noticeably less charred than those that failed due to wood breakage. Glues which soften at elevated temperatures lead to earlier loss of load-bearing capacity.

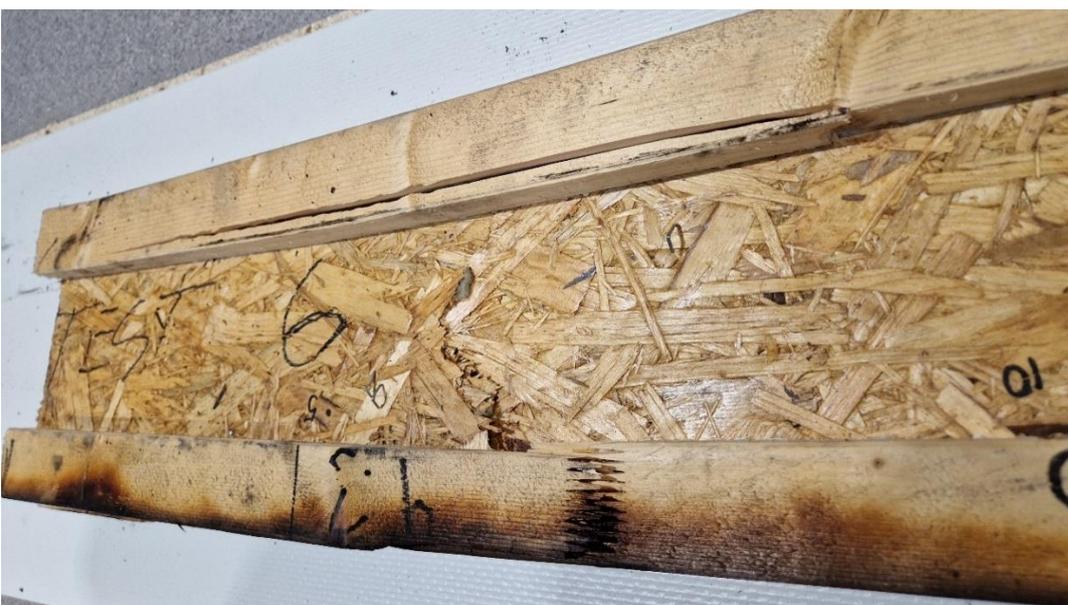
Figure 5.2. Adhesive failure of a I-joist flange in the example of beam 4.3.

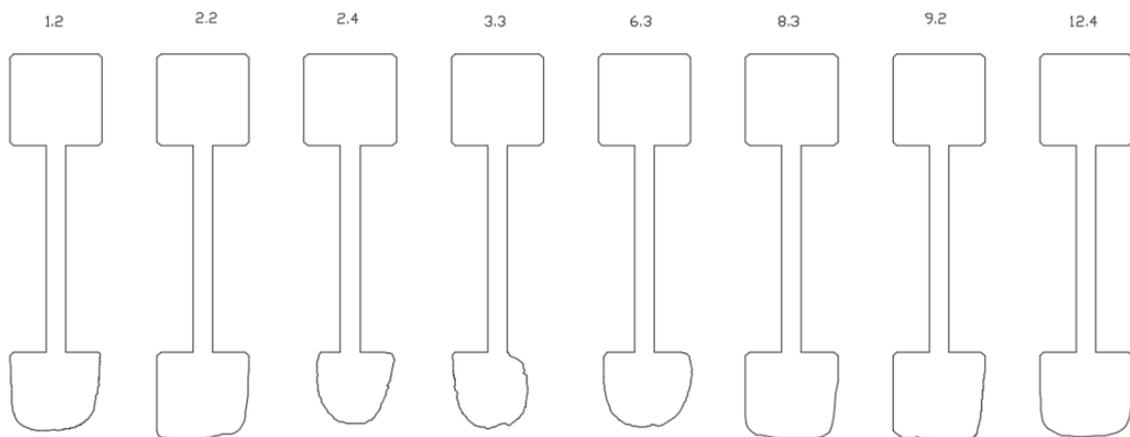
The various cross-sections, on which charring took place and from which it was possible to trace the outline of after testing, are shown in Figure 5.3. The following Figure 5.4 shows the theoretical cross-sections of the same I-joists in the same order.

Figure 5.3. Actual I-joist contours from the tests performed.

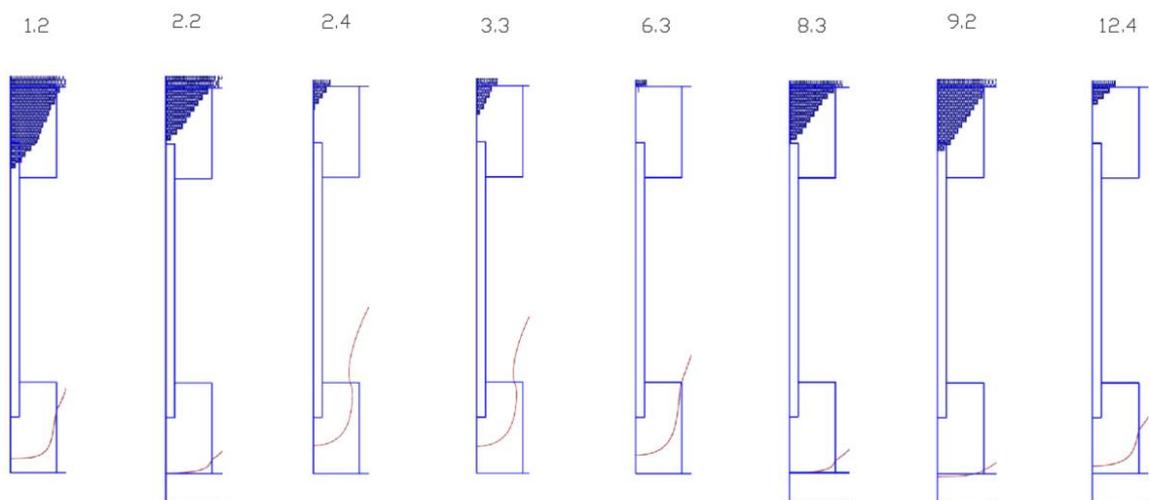
Figure 5.4. Cross-sections obtained from simulations with a marked charring line. Blue triangles on the top flange are visual noise from the post processor.

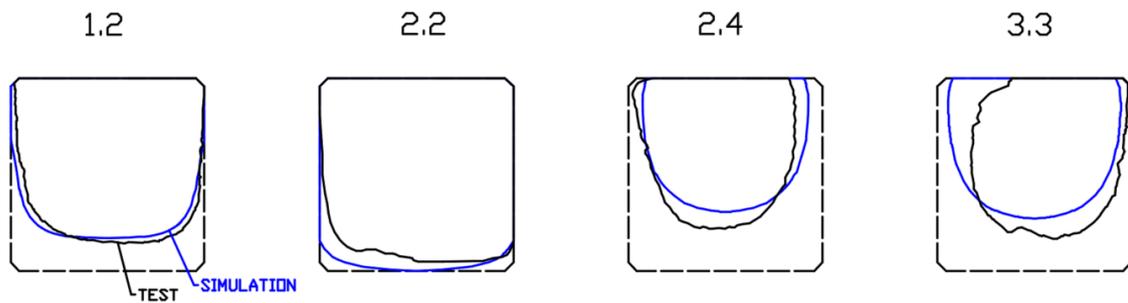
drawn into the AutoCAD program. Afterwards it was possible to move the contours of the cross-sections from the actual tests and from the simulations on top of each other, which simplified the comparison of different contours. In the following, the fire exposed flanges are shown, with the fire exposed side on the bottom.

Figure 5.5. The comparison of measured and simulated residual cross-sections for the beams 1.2, 2.2, 2.4 and 3.3.

The residual cross-sections obtained from the simulations are largely similar to the actual measured cross-sections. In the case of beams 1.2, 2.4, 6.3 and 12.4, the differences are minimal, and based on the simulations, it is possible to correctly describe the temperature and cross-section changes during the test.

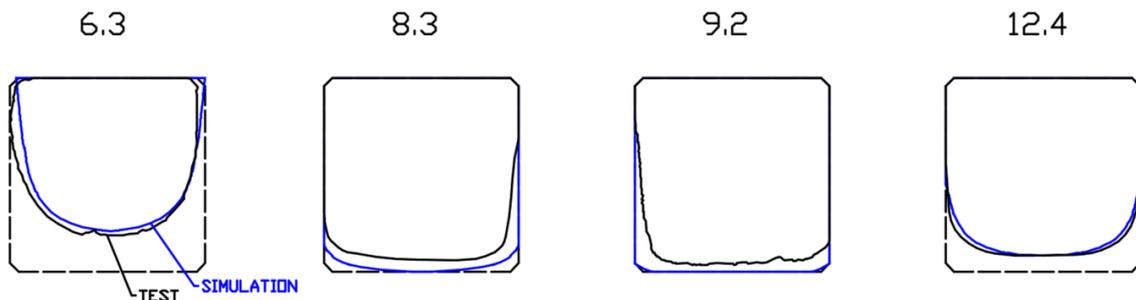
Figure 5.6. The comparison of measured and simulated residual cross-sections for the beams 6.3, 8.3, 9.2 and 12.4.

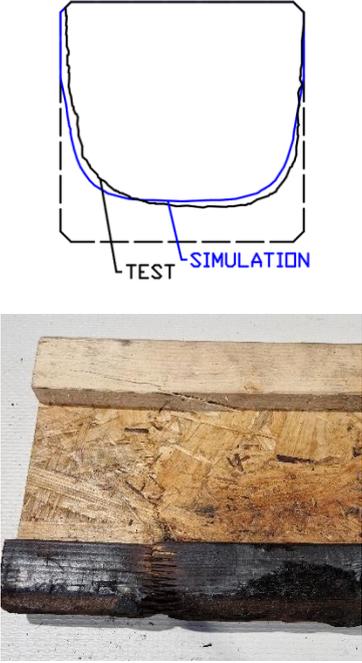
Residual cross-section of the fire exposed flange and a picture of the location of the failure	Description and analysis
<p style="text-align: center;">1.2</p>

<p>The contour of the residual cross-section from the simulation is very similar to the actual cross-section measured after the experiment. The simulation can correctly describe the actual course of the experiment.</p> <p>Looking at the photos, it can be seen that the beam failure was caused by the wood breaking at the finger joint.</p>
<p style="text-align: center;">2.2</p>

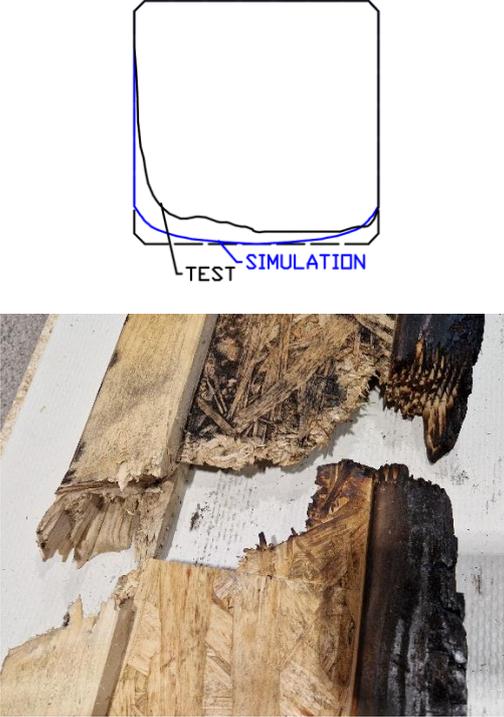
<p>The contour obtained as a result of the simulation is somewhat similar to the real one, but on one side of the cross-section, the actual charring depth was much greater than the simulated contour.</p> <p>The difference may come from the difference in temperature rises. The comparison graph of the temperature lines of the simulation and the test shows that the temperature rise between the gypsum and the I-joist in the final stage of the test was much steeper in the actual test than in the simulation.</p> <p>Upon examining the photographs, it is visible that the failure of the beam occurred due to the wood fracturing specifically at the finger joint.</p>

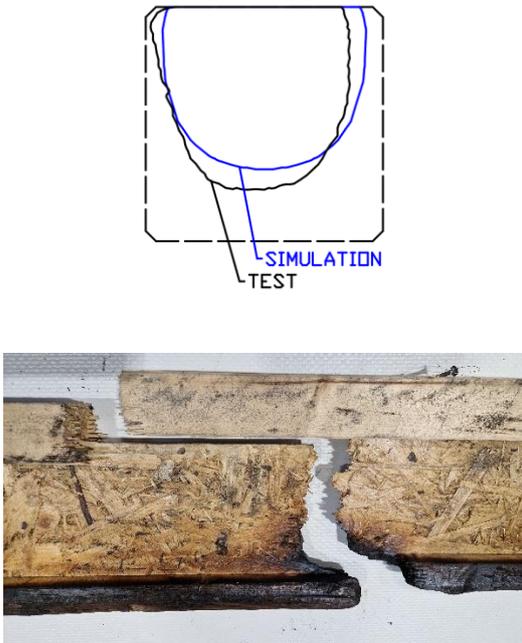
Residual cross-section of the fire exposed flange and a picture of the location of the failure	Description and analysis
<p data-bbox="470 365 531 405">2.4</p>

<p data-bbox="799 304 1378 465">The cross-sectional contours obtained from the test and simulations are quite similar. The simulation describes the course of the experiment correctly and conservatively.</p> <p data-bbox="799 510 1386 801">The flange on the fire side of the beam failed due to wood breakage. However, there is also a visible problem with the effectiveness of the glue, as it is noticeable that the web of the I-joint has come unglued from the non-fire-side flange as a secondary effect due to increased deflections.</p>
<p data-bbox="464 1178 525 1218">3.3</p>

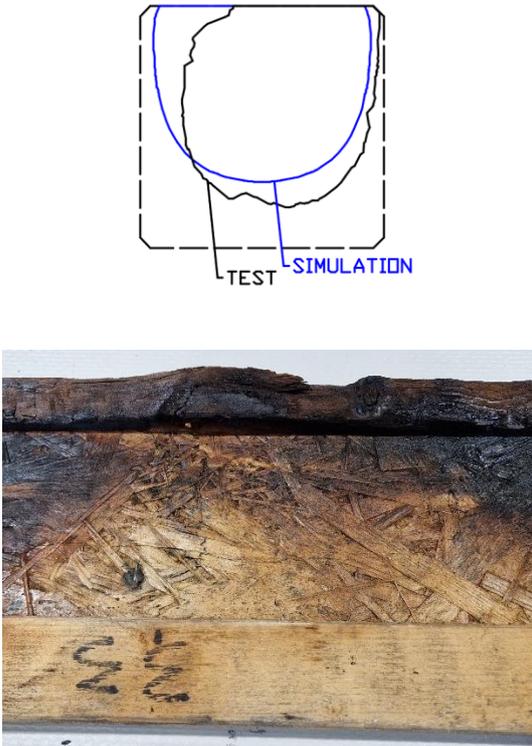
<p data-bbox="799 1120 1331 1281">The simulation describes the course of the experiment satisfactorily, but there are still differences with the actual charred cross-section.</p> <p data-bbox="799 1326 1378 1662">The differences can be explained with the comparison graph of the temperature lines. It can be seen from the graph that in the last few hundred seconds before the end of the experiment, the temperatures of the actual experiment reached almost 900 °C, but according to the simulation, the higher temperatures remained slightly above 800 °C.</p> <p data-bbox="799 1706 1267 1778">The beam failure was caused by wood breakage.</p>

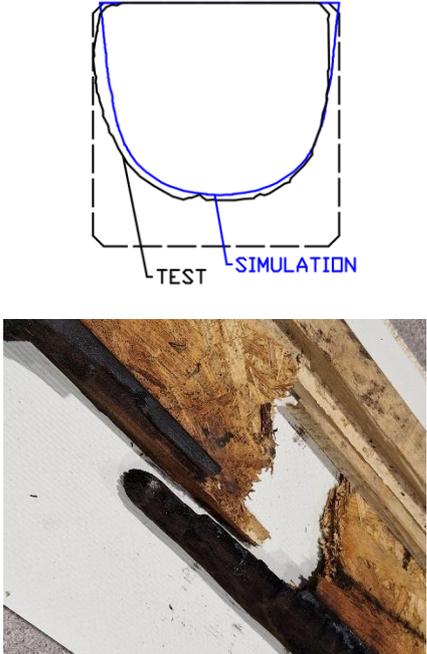
Residual cross-section of the fire exposed flange and a picture of the location of the failure	Description and analysis
<p data-bbox="427 331 491 371">6.3</p>

<p data-bbox="715 304 1385 465">The contour of the residual cross-section from the simulation is very similar to the actual cross-section measured after the experiment. The simulation can correctly describe the actual course of the experiment.</p> <p data-bbox="715 510 1385 846">Based on the photos, it can be said that the fire-side flange failed due to the wood breaking. The glue withstood the test load and there are no noticeable problems with glue resistance in the lower flange. Some longitudinal cracking of wood has also occurred during the test in the fire-side flange. Again, similar to experiment 2.4, it can be noticed that the web has come unglued from the non-fire-side flange.</p>
<p data-bbox="427 1131 491 1171">8.3</p>

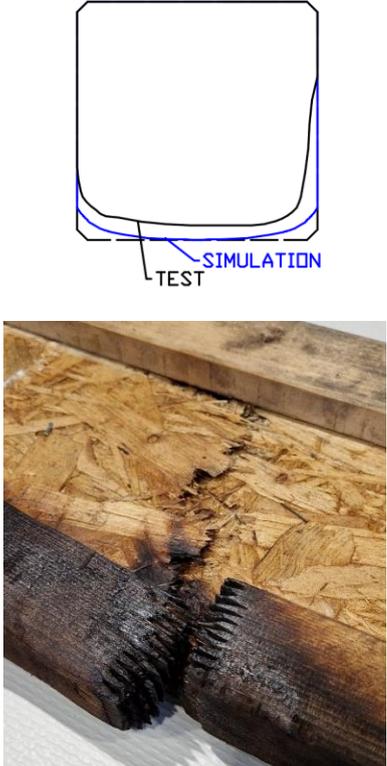
<p data-bbox="715 1104 1385 1350">The cross-sectional contour of the simulation shows much less charring than there actually occurred in the experiment. Looking at the graph of the temperature lines, it can be seen that the lines of the simulations are largely on the safe side. Therefore, the difference cannot be justified by differences in the graph.</p> <p data-bbox="715 1395 1385 1641">From the photos taken of the test object after testing, it is possible to assume that the location of the knot in the fire-side flange played an important role in the failure. It was likely located too close to the finger joint and caused additional stress concentration in the flange.</p> <p data-bbox="715 1686 1385 1809">The simulation describes an average ideal charring. During the actual test, charring, deeper than average has locally occurred at the beam breaking point.</p>

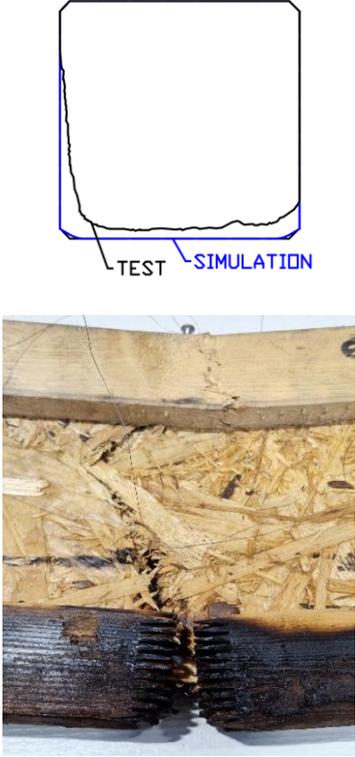
Residual cross-section of the fire exposed flange and a picture of the location of the failure	Description and analysis
<p data-bbox="427 309 488 349">9.2</p>

<p data-bbox="715 309 1394 510">The simulation underestimated the actual charring. Analysing the temperature graph, it is visible that the temperature lines describe the actual situation conservatively. Therefore, it is necessary to look at the pictures and find the reason for the greater charring.</p> <p data-bbox="715 555 1394 757">The pictures show that the finger joints are quite clean, i.e. the parts of the wood glued together have not visibly stuck to each other, we can conclude that the breakage occurred mainly due to the softening of the glue.</p> <p data-bbox="715 801 1394 1003">There has been localized, deeper than average charring near the failure point. Most likely, the density of the fracture site was lower than the average density of the beam, which caused the failure and greater charring.</p>

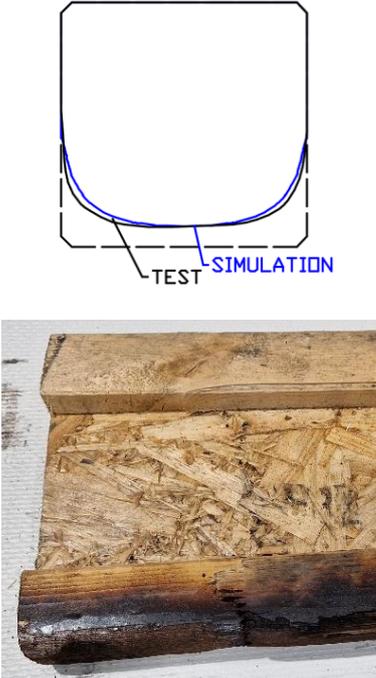
<p data-bbox="411 1205 488 1245">12.4</p>

<p data-bbox="715 1182 1394 1339">The contour of the residual cross-section from the simulation is very similar to the actual cross-section measured after the experiment. The simulation can correctly describe the actual course of the experiment.</p> <p data-bbox="715 1384 1394 1541">The beam failed due to wood breaking in the lower flange on the fire side. The breakage occurred near the finger joint. Some longitudinal cracking is also visible.</p>
