# Moisture Safety of Cross-Laminated Timber Construction

TALLINN UNIVERSITY OF TECHNOLOGY  
DOCTORAL THESIS  
44/2025

To answer the research questions, three general methods were used: 1) field studies in eight buildings, including analysis of project and procurement documentation, on-site observations, moisture measurements, and weather data analysis; 2) laboratory experiments on the wetting and drying of CLT; and 3) computer simulations using a novel two-dimensional (2D) anisotropic heat and moisture transfer (HAM) simulation method.

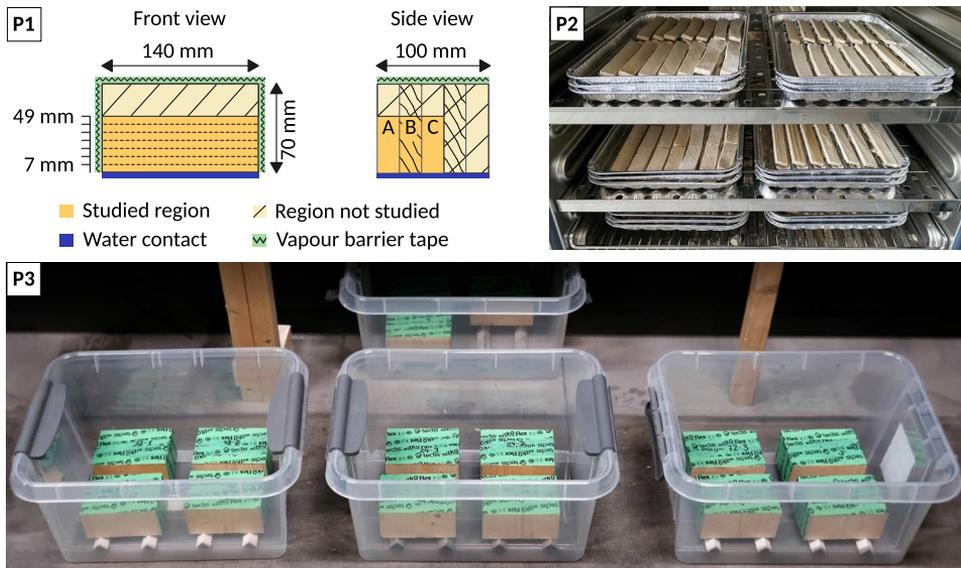
Figure 7. CLT TS dimensions and cutting scheme for the gravimetric MC measurements (P1); specimen ribbons in the drying oven (P2) and TSs in containers for water contact (P3). In P1, A is the outer (surface) longitudinal layer, B is the transverse layer, and C is the inner longitudinal layer.

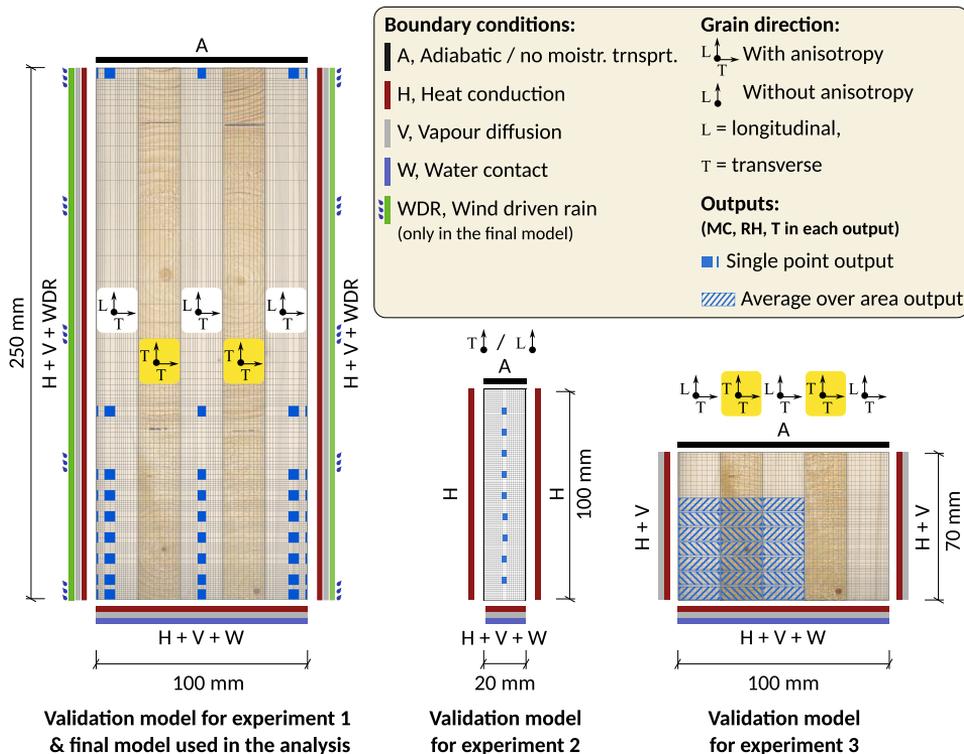
Figure 8. Modelled CLT geometry for each experiment and for the final analysis. The grain direction, boundary conditions, discretisation grid and output locations are shown. Descriptions of the Experiments 1, 2, and 3 are provided in Sections 3.3.1, 3.3.2, and 3.3.3 respectively.

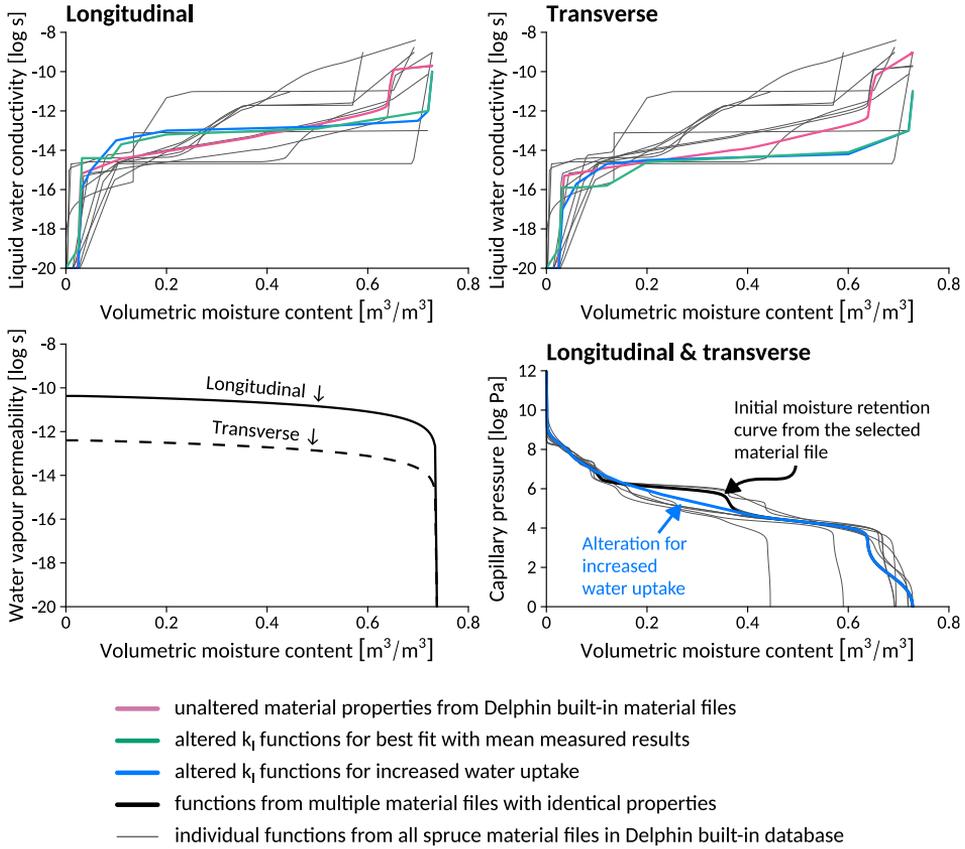
Figure 9. Material functions from the selected and optimised material files. The anisotropic material file referred to as “unaltered”, was based on files ID711 and ID713 from the hygrothermal simulation tool Delphin database.

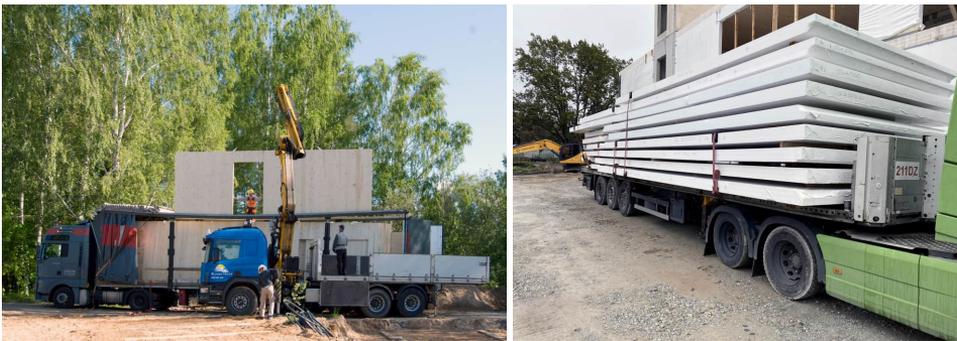
Figure 12. CLT panel transport in a dry freight trailer (left) and on a flatbed trailer (right).

The panels for the studied buildings were delivered either in a dry freight trailer, where they were mounted vertically on a stand and were entirely protected from the outside environment (Figure 12, left), or on a flatbed trailer, where the panels were lying on their sides and were protected from the elements only by packaging foil (Figure 12, right). In the latter variant, the CLT panels and packaging foils were susceptible to potential physical damage during transport. Nevertheless, no excessive MC was reported after transport with either option.

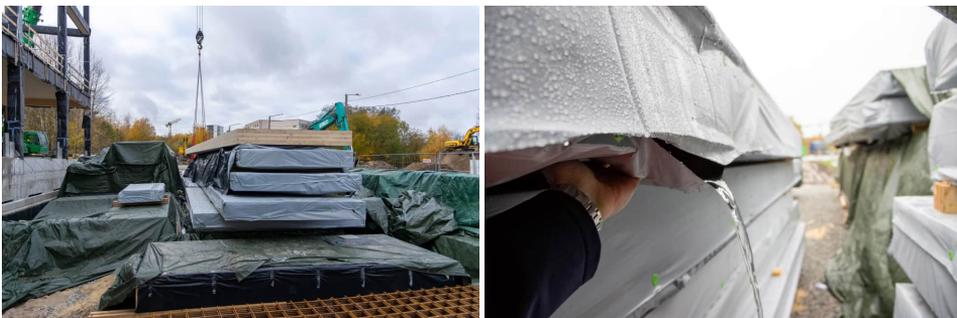
Figure 13. Interim storage of CLT on-site (left) which proved to be inadequate and allowed water to enter the package, as shown by water being poured out of the package (right).

If CLT was not delivered just in time and on-site storage was required, the risk of wetting arose. Typical packaging did not prevent the wetting of the panels during interim storage (Figure 13). Imperfections in the foil allowed water to enter the package where it remained unnoticed until specifically inspected (e.g., Figure 13, right). Also, damage (e.g., incisions, ripping, tearing) in the packaging foil became entering points for precipitation for panels already installed. Site observations indicated that opaque foils inhibited the detection of wetting, whereas translucent protection foils facilitated faster response to occurred problems.

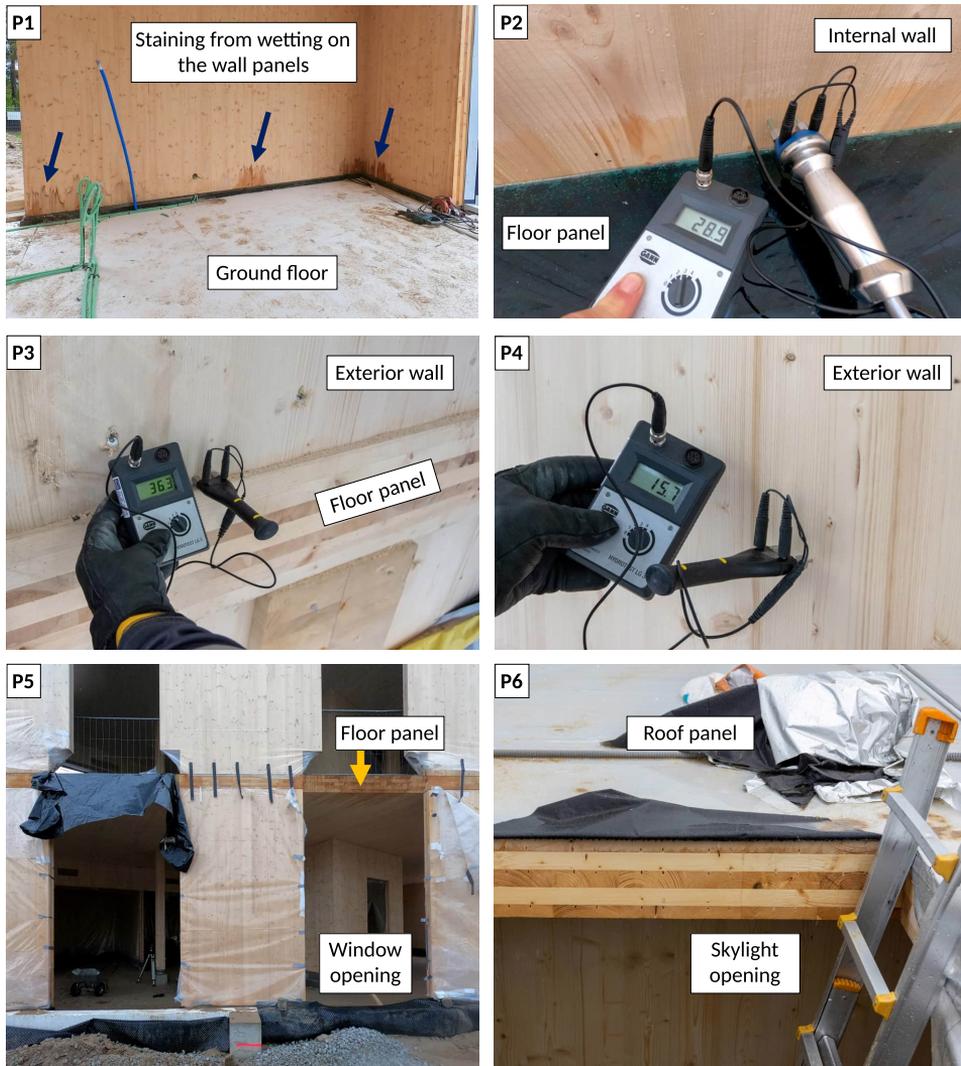
Figure 17. Photos of areas vulnerable to wetting in CLT construction. P1 depicts the wall-to-foundation connection, while P2 & P4 show the wall-to-floor panel connection. P4 illustrates that the same wall panel as in P3 remained dry further away from the floor panel connection. P5 shows window openings, and P6 shows a skylight opening.

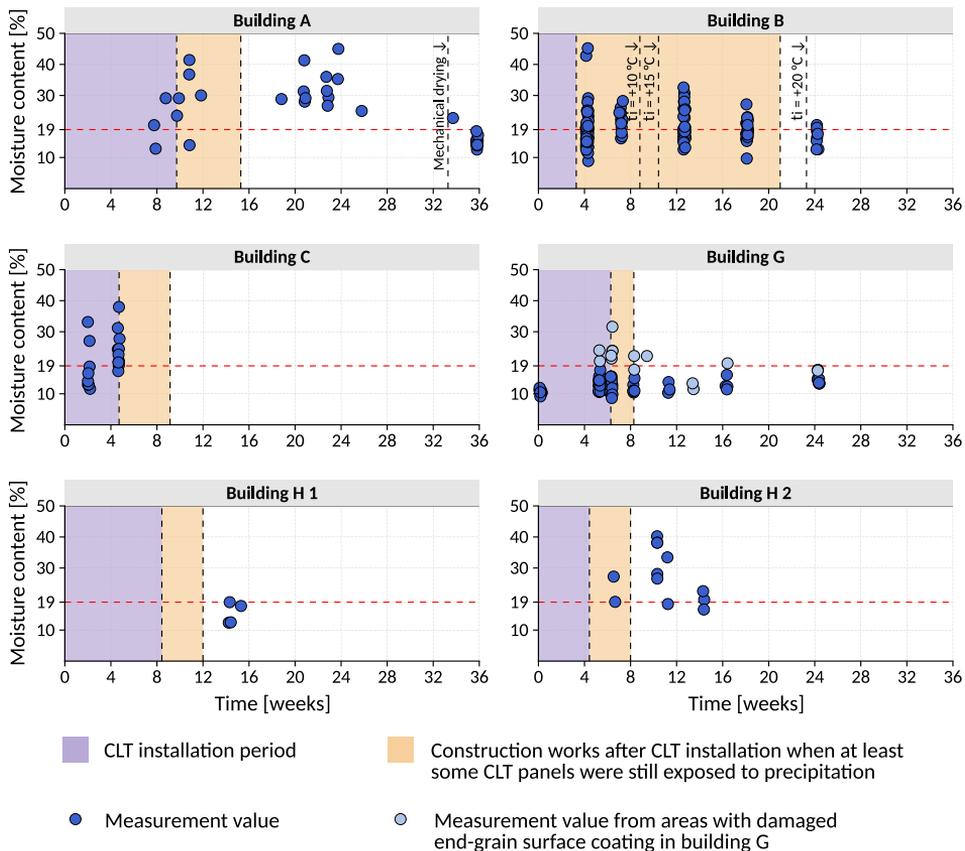
Figure 20. Measured MC in the CLT wall panels at the wall-to-floor or wall-to-foundation connection area in five of the studied buildings. For the building G, values are provided for both cases: with and without functioning end-grain protection. For building H, the measurement values are separated by floors (H1 = first floor, H2 = second floor);  $t_i$  = indoor temperature.

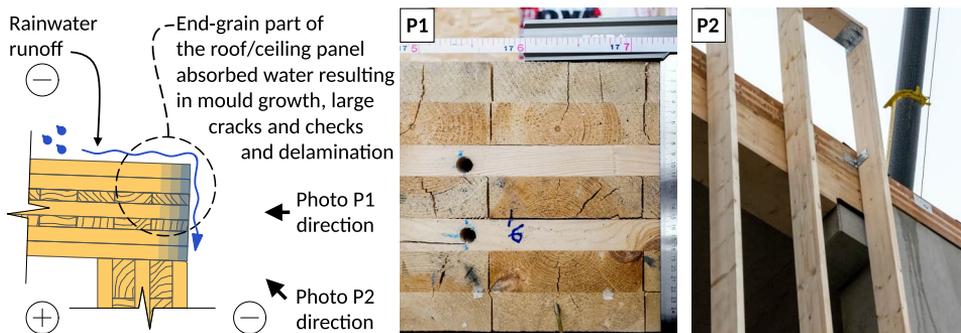
Figure 22. CLT roof panel connection, where large cracks (P1), delamination, and mould growth occurred after frequent wetting (P2) and moisture dry-out. Photos of the building A

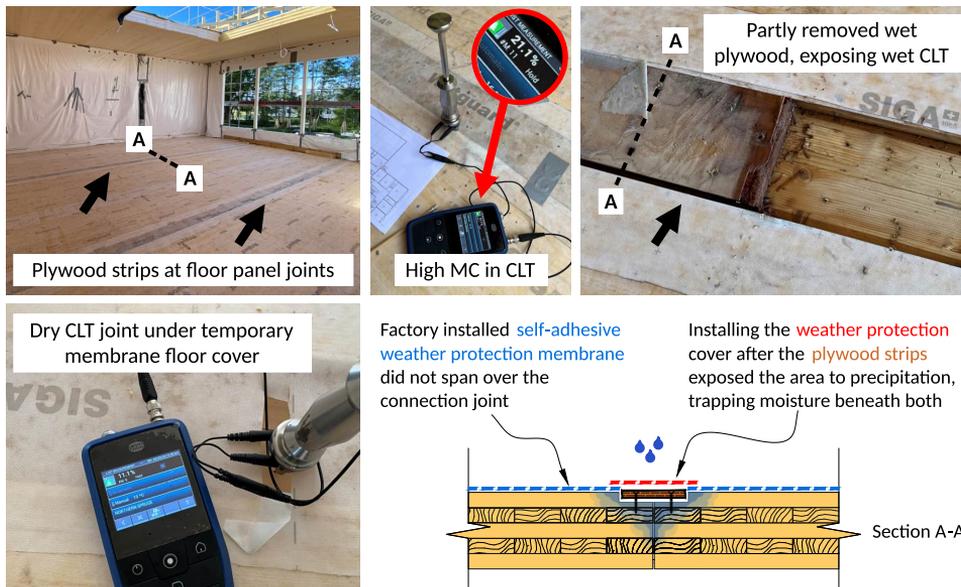
Figure 25. Problematic floor panel connection joint in building G. Water ingress to CLT floor joints raised CLT MC above 20%. Initially, a plywood strip was installed before the weather protection membrane, but in a revised method, the membrane was installed first, ensuring dry construction.

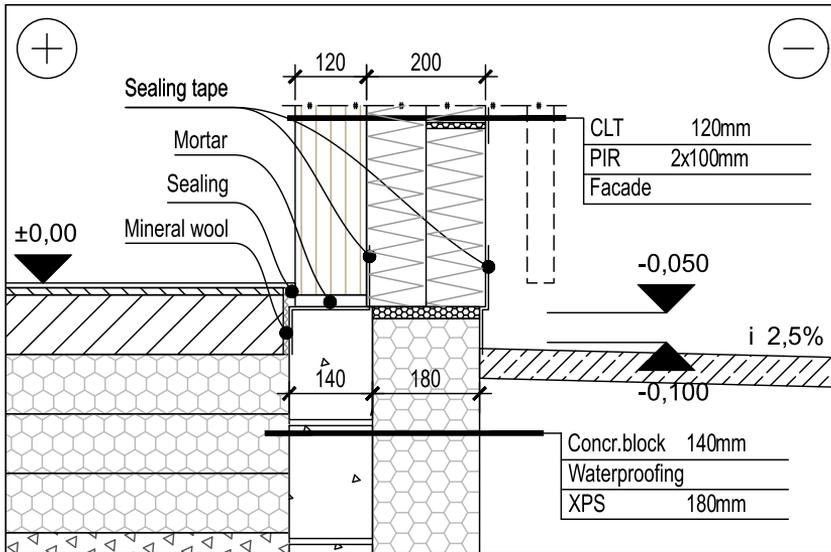
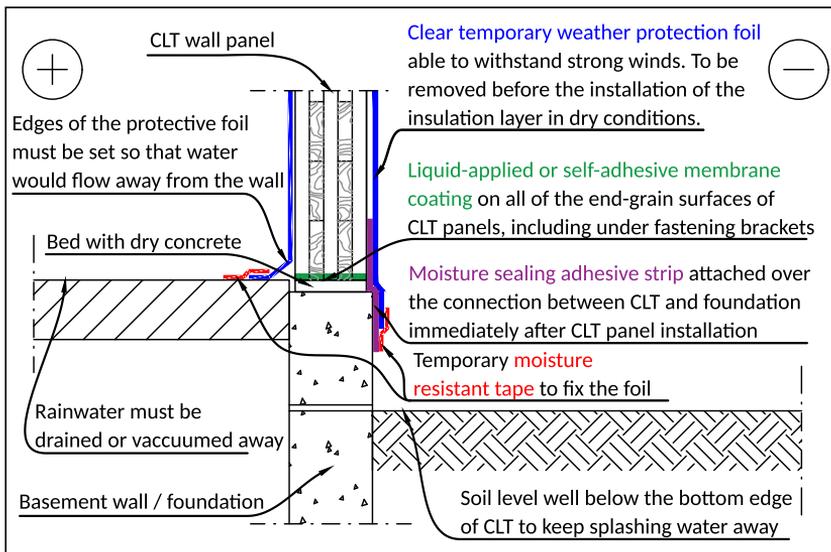
Figure 26. Design drawing (top) of the exterior wall to foundation connection and an example drawing (bottom) of the moisture safety design drawing for the same area.

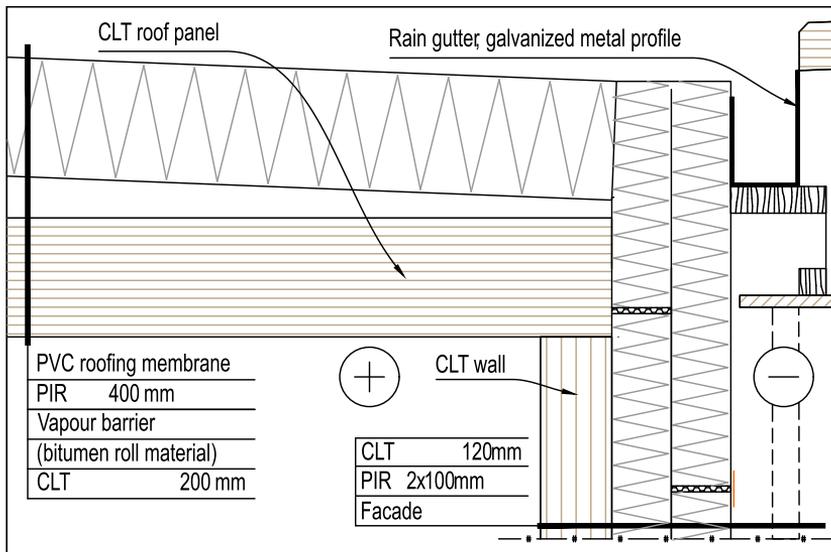
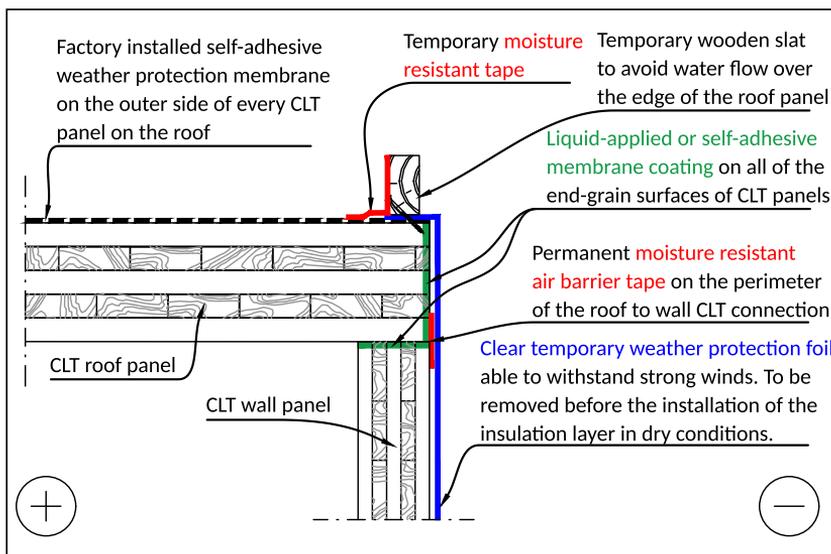
Figure 27. Design drawing (top) of the exterior wall to roof panel connection and an example drawing (bottom) of the moisture safety design drawing for the same area.

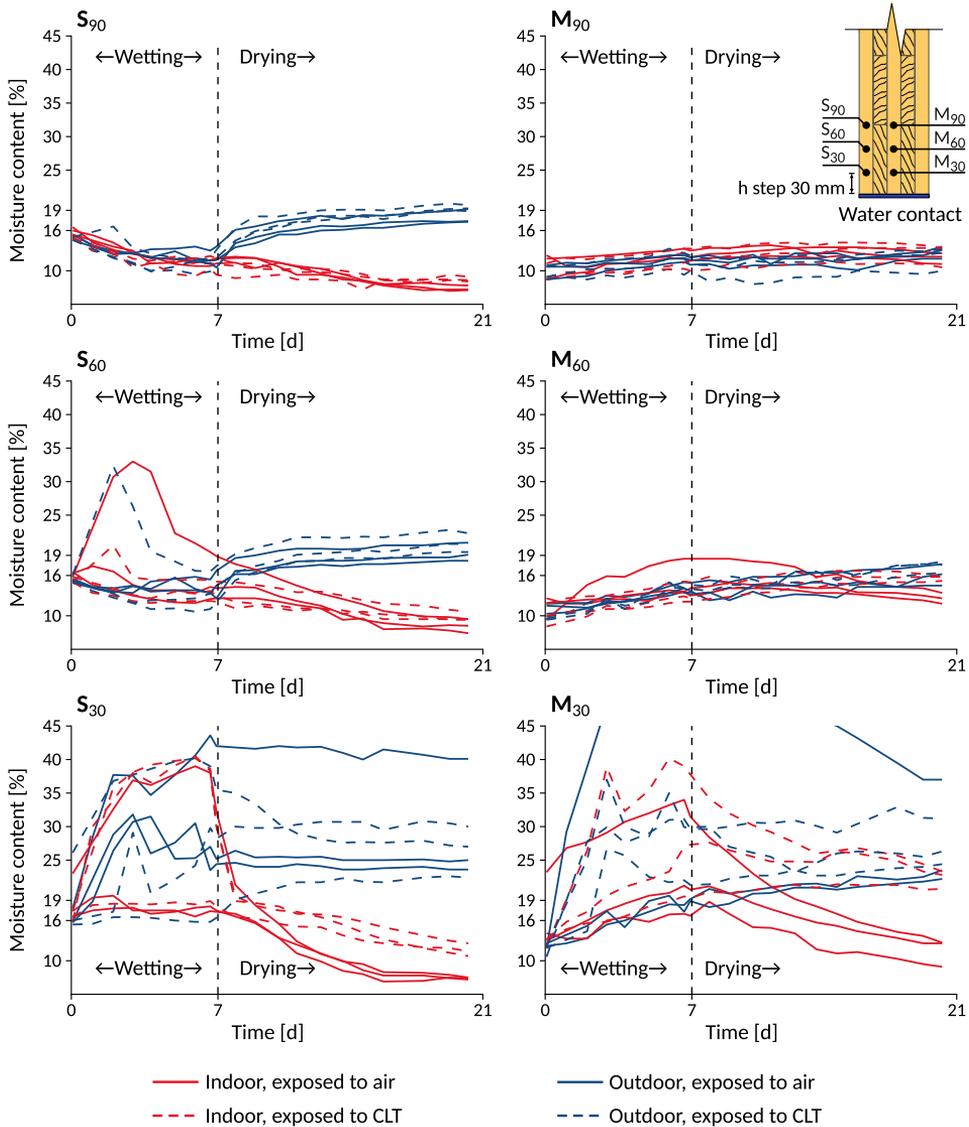
Figure 28. Measured MC during the wetting phase (0–7 days) and the drying phase (7–21 days). Measurements were taken at the depth of 5 mm ( $S_i$ : surface measurement points at a height of  $i$  mm), and at the depth of 50 mm ( $M_i$ : measurement points located in the inner longitudinal layer at a height of  $i$  mm). These results were published in Publication V.

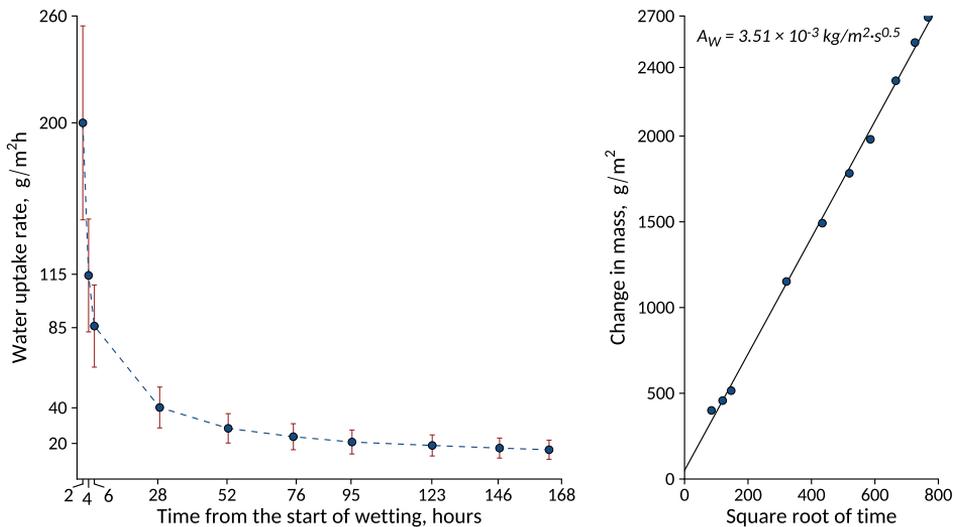
Figure 31. Water uptake rate during the test as an average of every TS (left) and change of mass against the square root of time for  $A_W$  calculations. These results are more detailed in Publication V.

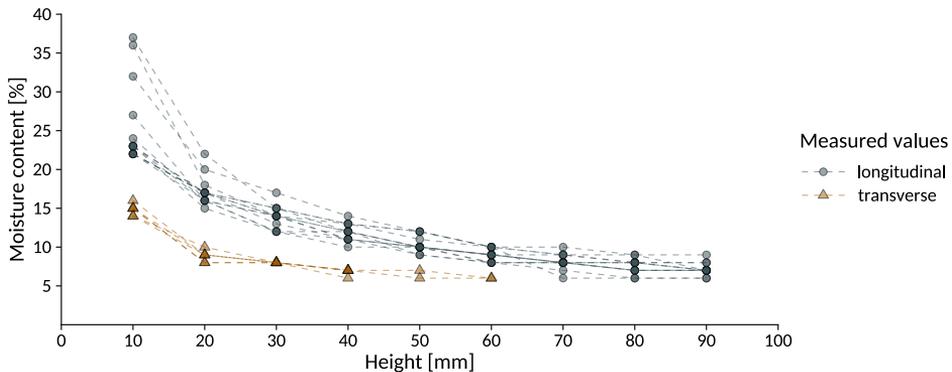
Figure 32. MC measurement results for timber boards subjected to continuous water contact via the end-grain surface (longitudinal) or side-grain surface (transverse).

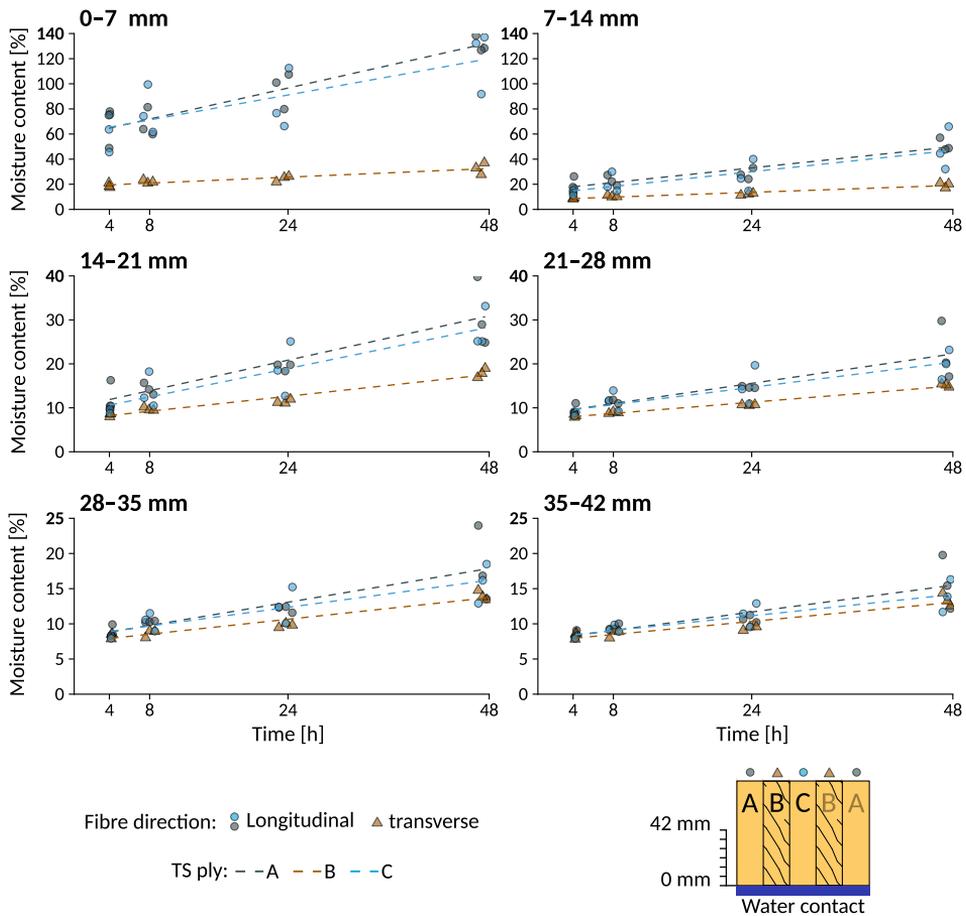
Figure 33. Gravimetric MC measurement results by  $\approx 7$  mm steps from the water contact surface in three layers of CLT test specimens which were subjected to water contact for 4, 8, 24 and 48 hours. Notice that the scale for the different plot facets varies from 25 % to 140 %.

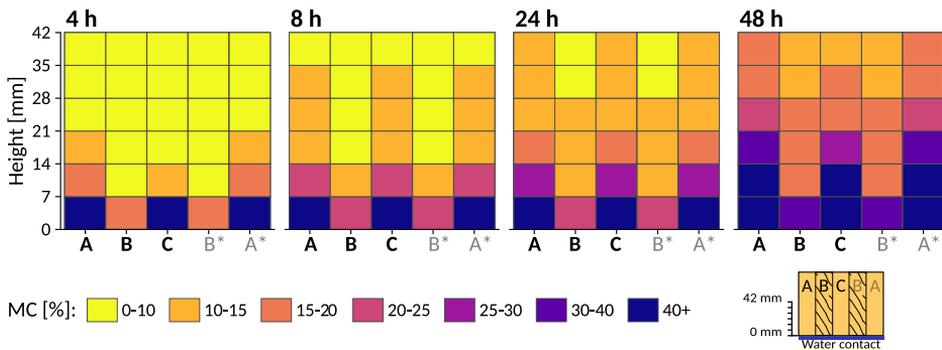
Figure 34. Average MC distribution in CLT after 4, 8, 24, and 48 hours of water contact.

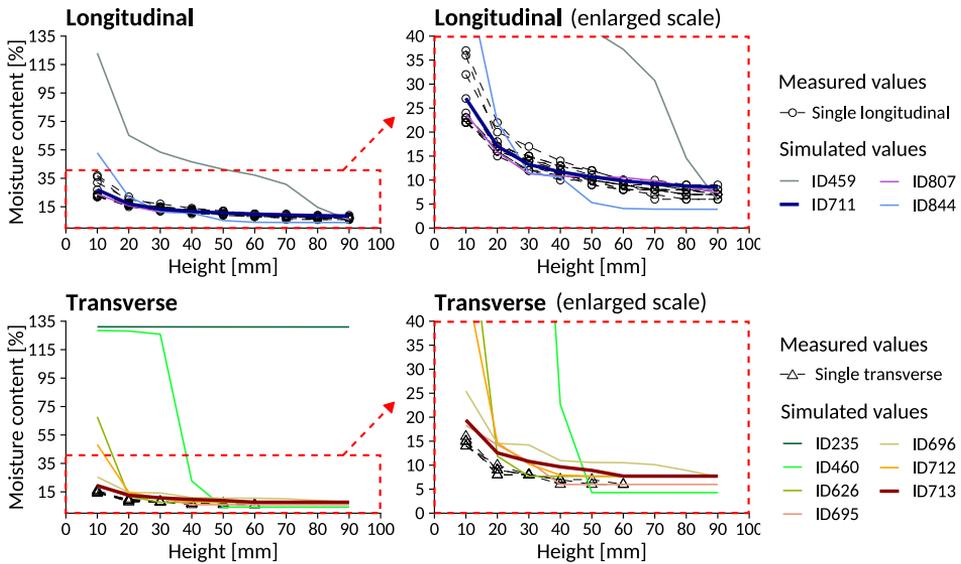
Figure 35. Comparison of MC measurements from Experiment 2 with simulations using spruce material files in the HAM simulation tool Delphin. ID codes refer to material file identification codes in the Delphin database. The left charts show MC values on a 135 % scale, while the right charts zoom in on the dashed box sections from the left for better readability (MC scale up to 40 %).

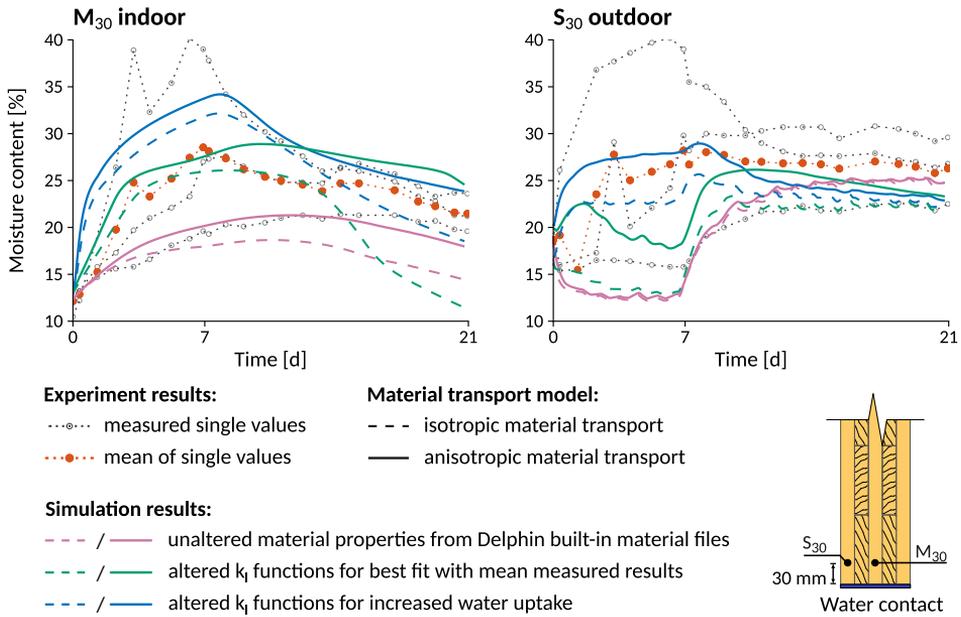
Figure 36. Comparison of simulated values for the isotropic material transport model (dashed lines) and for the anisotropic material transport model (continuous lines) with measured single values (dotted line & open circles) and the mean of the measured values (closed circles).

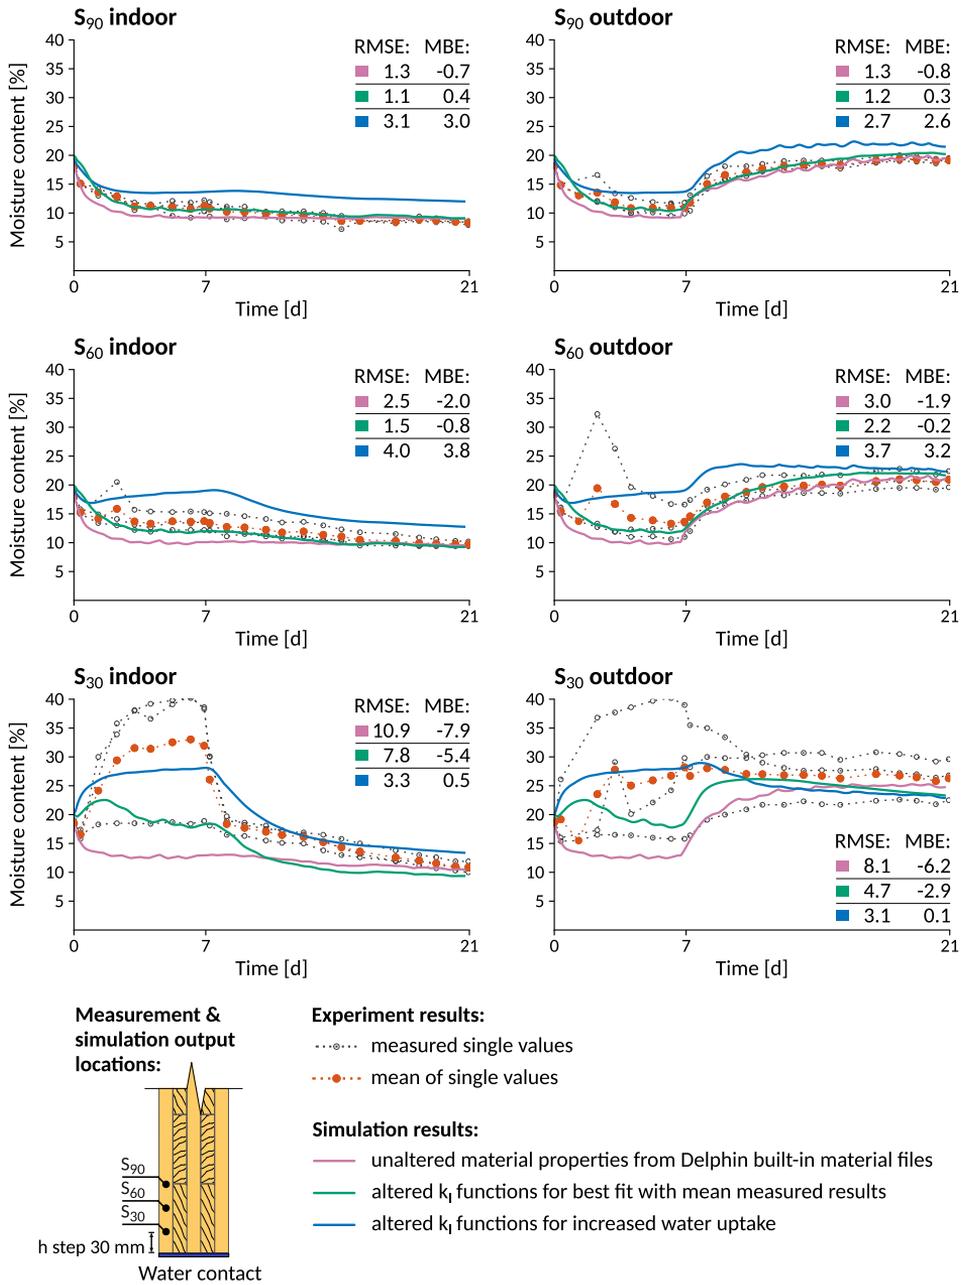
Figure 37. Comparison of simulated MC values (continuous lines) with measured single values (open circles) and the mean of measured values (closed circles). Measurement data from Experiment 1. Values for the outer longitudinal CLT ply.

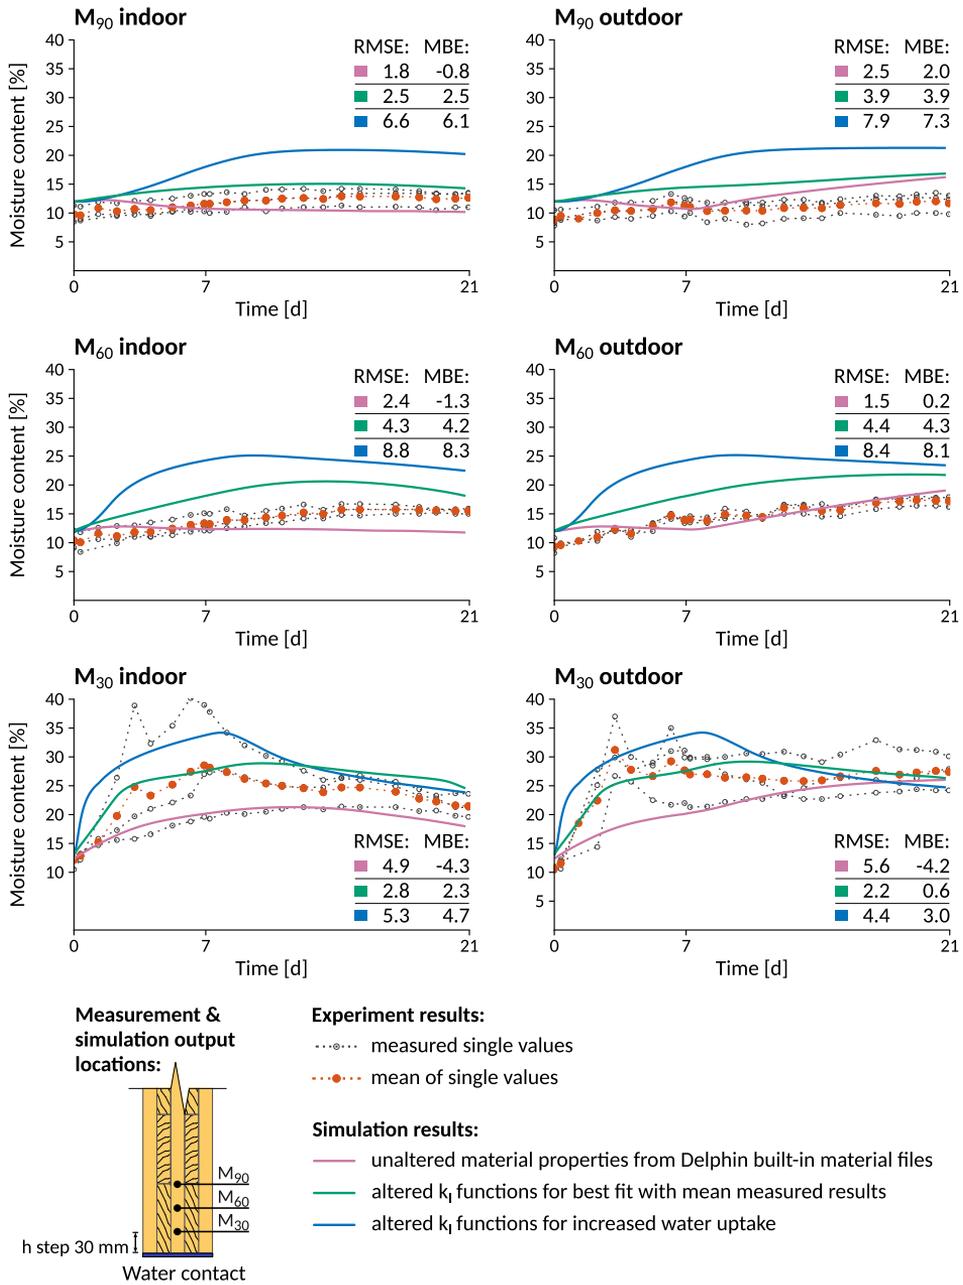
Figure 38. Comparison of simulated MC values (continuous lines) with measured single values (open circles) and the mean of measured values (closed circles). Measurement data from Experiment 1. Values for the inner longitudinal CLT ply.

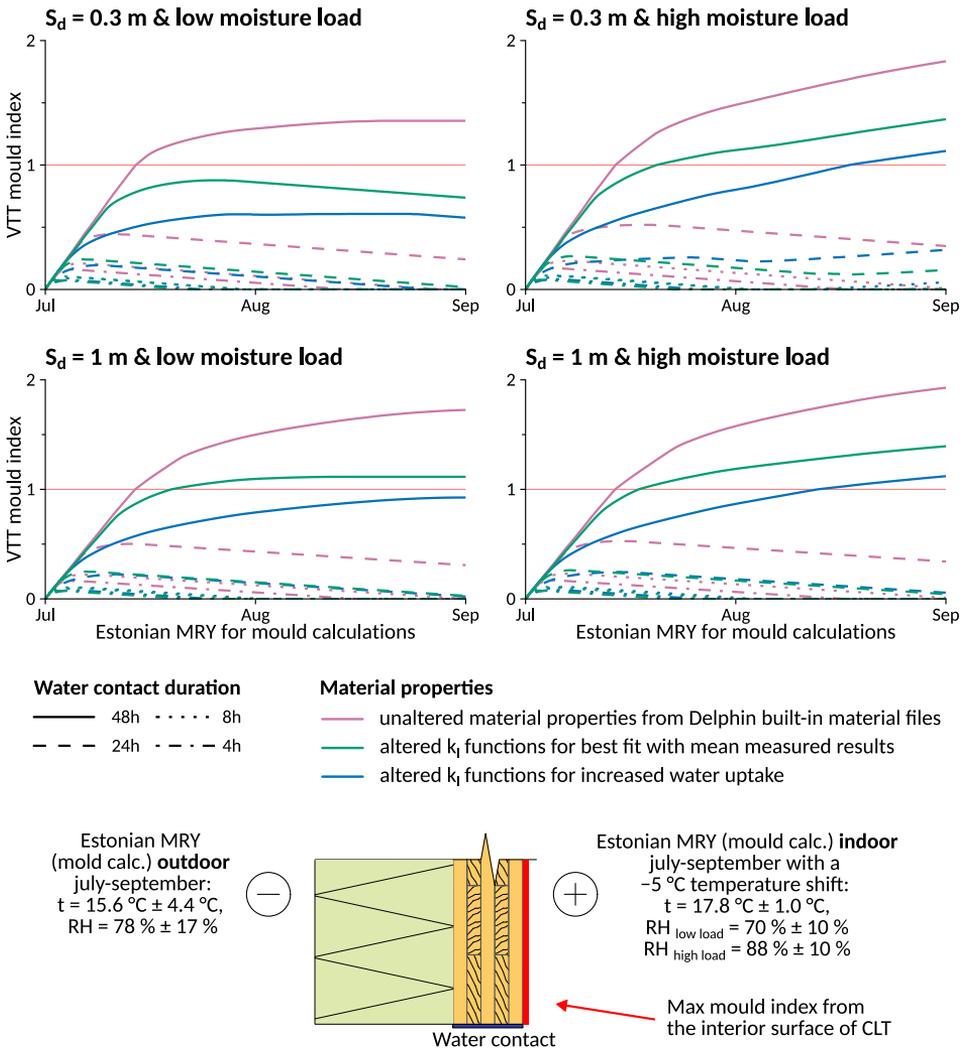
Figure 40. Results of mould index calculations for performance criterion development depending on initial MC distribution in CLT, additional water vapour resistance ( $S_d$ ) of the interior surface and on indoor moisture load.

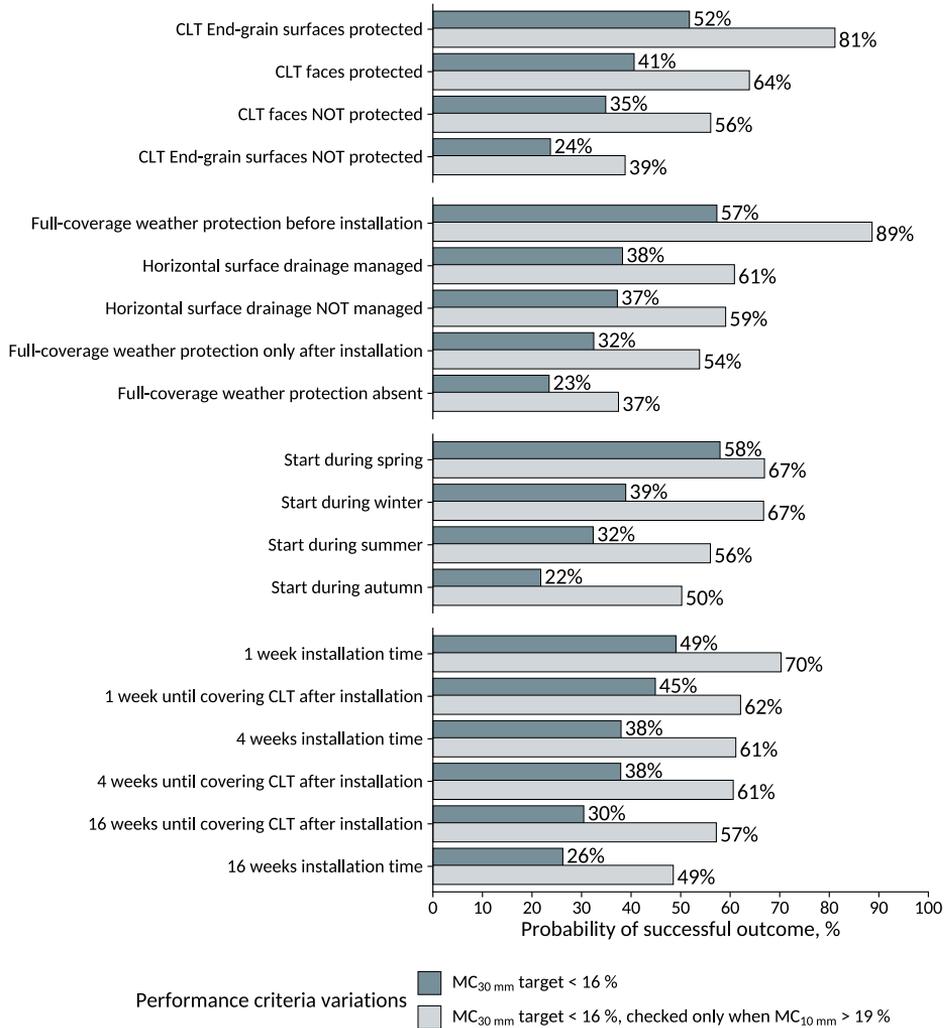
Figure 42. Probability of a successful outcome – defined as maximum mould index < 1 and MC<sub>10mm</sub> and MC<sub>30mm</sub> within specified limits (see Equations 3 and 4) – for all the studied variables.

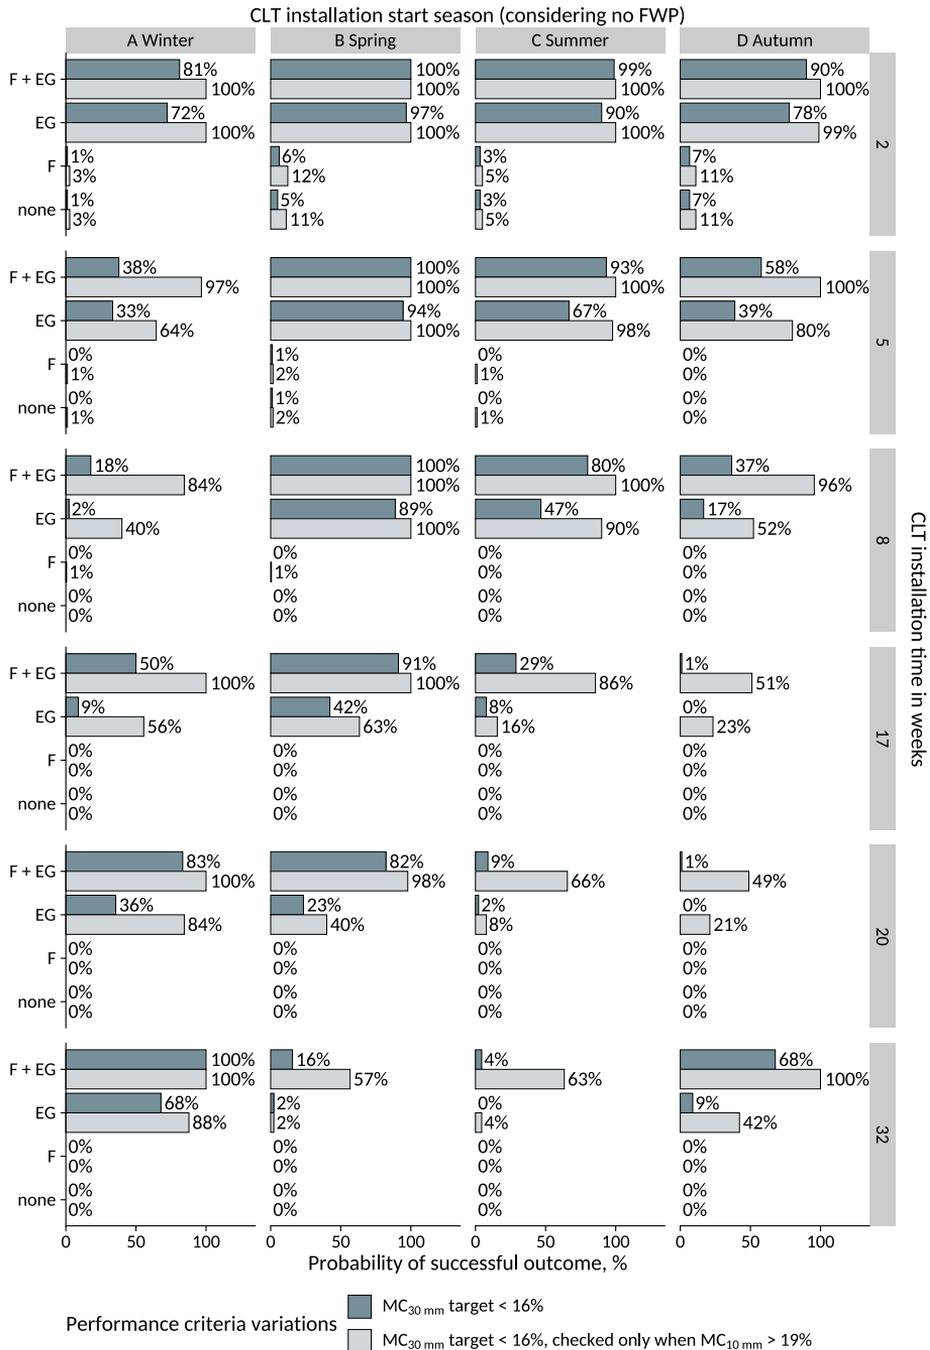
Figure 44. Probability of a successful end-result (maximum  $M < 1$  and  $MC_{10mm} \leq 25\%$ ,  $MC_{30mm} \leq$  varies as per legend in the figure) for the subset of combinations with no FWP. F = CLT vertical face protection, EG = CLT end-grain surface protection and F + EG = both CLT face and end-grain surface protection.

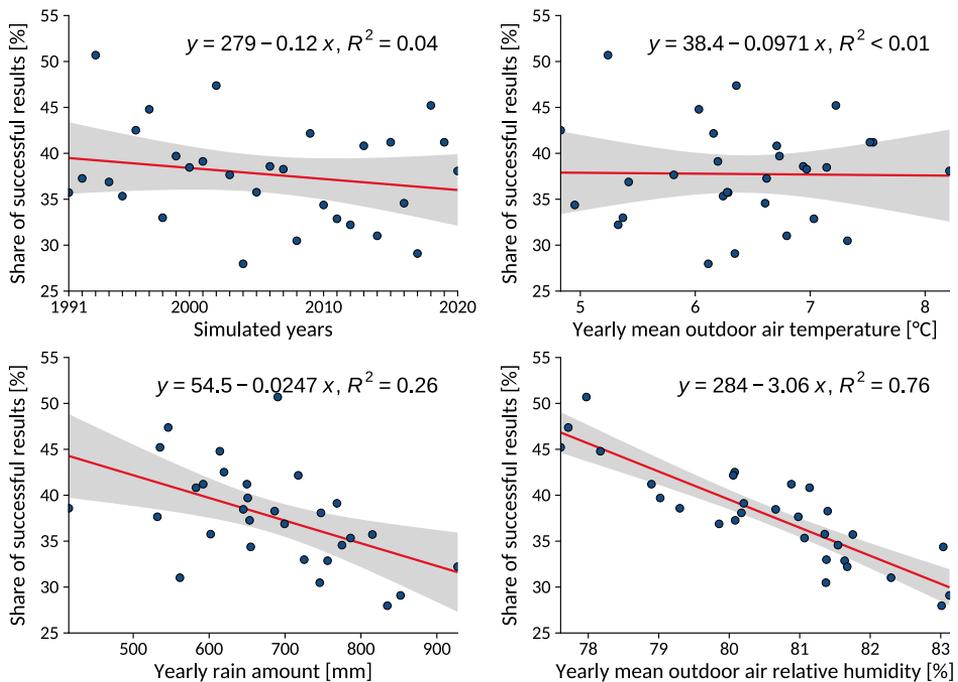
Figure 45. Interannual variability of the share of successful results. Correlation of the share of successful results (y-axis) with simulated years (top left), with yearly mean outdoor air temperature (top right), with yearly rain amount (bottom left), and with yearly mean outdoor air relative humidity (bottom right).

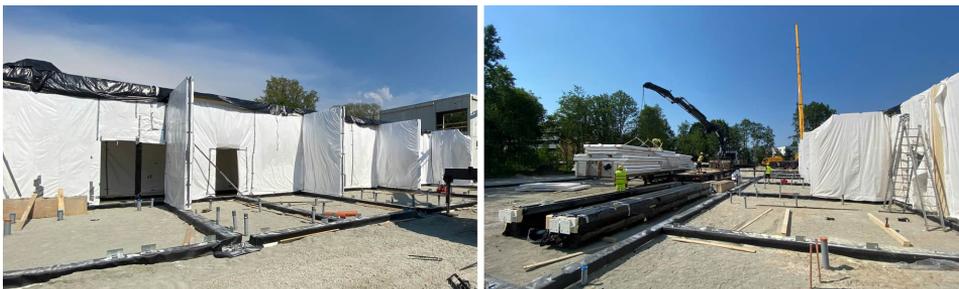
Figure 46. Installation of the first CLT panels (delivered wrapped in white plastic film) at Building G.

The project documentation of the building G advised to install CLT under an FWP structure, or treat the bottom end-grain surfaces with a moisture-proof sealer, wrap panels in thermal film (Figure 46), and apply water resistant self-adhesive protective membranes to floor panels. Drawings for additional weather protection solutions were not provided, as the use of an FWP structure was specified. Moisture safety was partly covered in the architectural section of the project documentation, but the topic remained brief and general in the structural design section, which concentrated only on the load-bearing capacity of the building and overlooked moisture loads during construction.

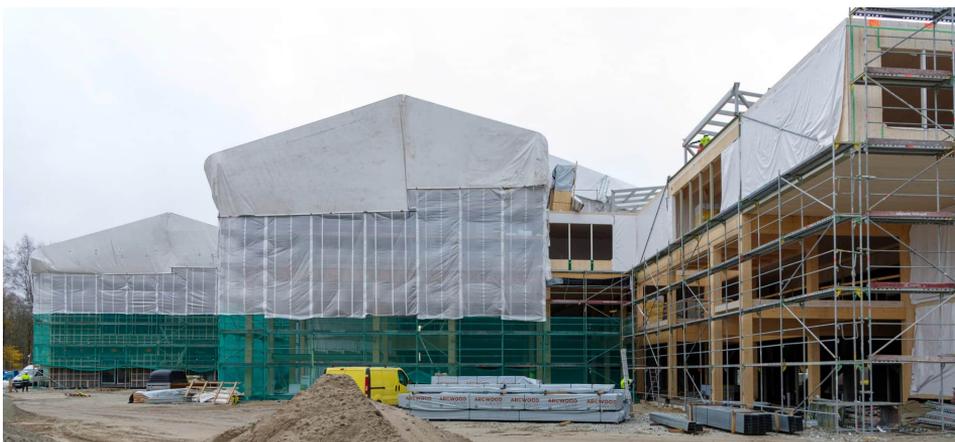
Figure 47. A temporary FWP structure at different stages on the building G.

Moisture was managed in both buildings with varying degrees in thoroughness and moisture protection methods. For the builder of the building G, it was the third large CLT construction they erected, but for the builder and customer of the building H, it was only the first. In the building G, the CLT installation took approximately five weeks per section (the building was divided into three sections, each of which was sequentially covered with an FWP structure). Ideally, the assembly of the FWP structure should be done in parallel with the installation of the CLT panels so that when the installation of a section is finished, so that it would become protected from precipitation immediately. But in this case, there was an approximately two-to-three-week period after the installation when the CLT panels were still exposed to precipitation and were then covered with the weather protection structure (Figure 47).

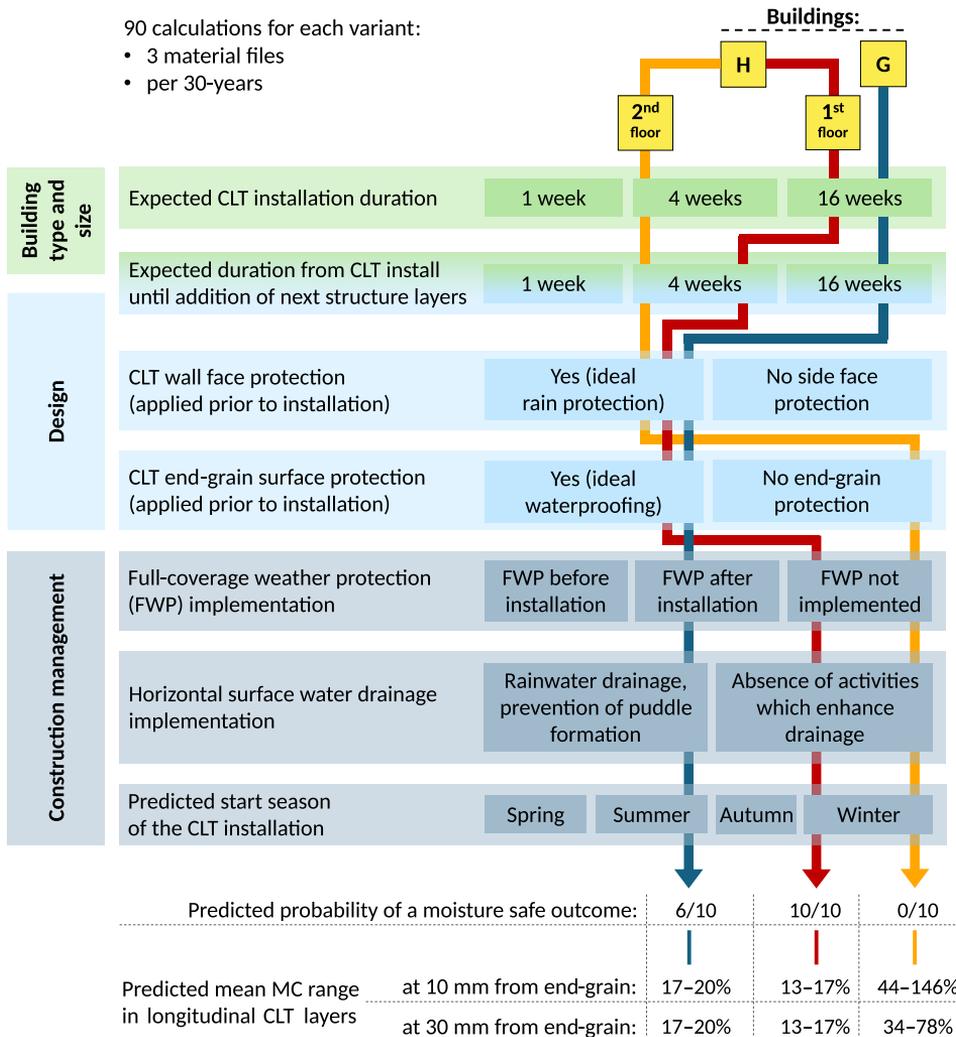
Figure 48. CLT moisture safety process variables with superimposed lines representing the moisture safety strategies of the studied buildings. The building H is divided into floor 1 and floor 2 due to differing end-grain surface protection of the CLT panels on each floor. The durations which the strategy paths pass are close to the actual construction timelines (though not identical).
