# Moisture Safety of Cross-Laminated Timber Construction

TALLINN UNIVERSITY OF TECHNOLOGY  
DOCTORAL THESIS  
44/2025

To answer the research questions, three general methods were used: 1) field studies in eight buildings, including analysis of project and procurement documentation, on-site observations, moisture measurements, and weather data analysis; 2) laboratory experiments on the wetting and drying of CLT; and 3) computer simulations using a novel two-dimensional (2D) anisotropic heat and moisture transfer (HAM) simulation method.

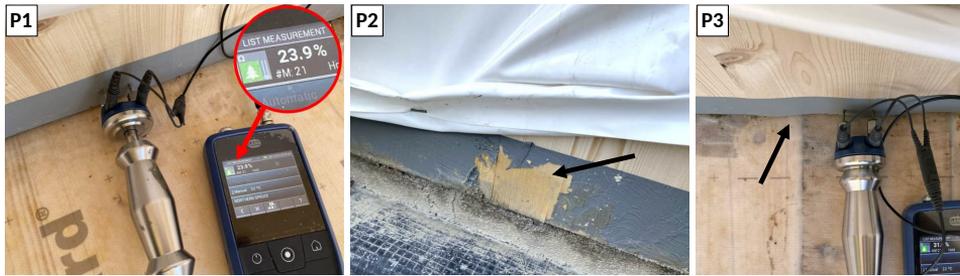
Figure 49. Moisture measurements (P1), waterproofing membrane damage (P2), and timber swelling (P3) in the building G.

While the specific cause of higher-than-expected MC could not be identified, visual inspection revealed potential damage to the Riwega ELLE-Plan ( $S_d < 5$  m) liquid-applied end-grain waterproofing membrane (Figure 49, P2). While many wet areas appeared visually undamaged, potential damage to the membrane on the surface under the panels could not be confirmed due to inaccessible panel undersides. Swelling and warping of timber in the CLT panels correlated with wet areas (Figure 49, P3). Nevertheless, the waterproofing membrane provided adequate moisture protection in most areas.

The chosen strategy for the building G should have provided protection against wetting for both the CLT side faces and the bottom end-grain surfaces. A less-than-ideal outcome for moisture safety was predicted only due to the long period after the installation of the CLT when the panels were still exposed to outside air during autumn, but on average the expected MC in the wall panel bottom area should have ranged between 17 % and 20 %. On-site measurements about a month after the installation started indicated MC values exceeding 21 % and even over 30 % (Figure 49, P1).

The points where the liquid-applied waterproofing membrane was damaged functioned similarly to end-grain zones without protection. Weather data from a nearby weather station indicated that during the period up to the assembly of the FWP structure, the building G received approximately 70 mm of rain (presented previously in Figure 14, in Section 4.1.1). This was mostly diverted, but as the measurements indicated – some areas still got wet. Figure 50 shows the measured MC (point) values and simulated MC values (continuous lines) based on the actual climate data from both building's construction period and based on the main moisture protection strategy. In the case of the building G, the calculations were also made for the hypothetical variant which excluded the end-grain surface protections, although the main strategy assumed ideal end-grain protection. The measured values are also divided into two based on whether their first MC value was over 19 % or not. The measured MC values which exceeded 19 % were deemed to be taken from the areas where a probable end-grain protection damage was present. Most measured values remained below the values simulated with an ideal end-grain protection. Both the simulated and measured results for the variant with a functioning end-grain protection reflected the tendency for MC increase over time which affirmed the risk indicated by the moisture safety analysis framework (Figure 48).

Regarding the effectiveness of moisture safety measures, local protection has demonstrated its benefits. An approach proposed in the early stages of this PhD research (presented in Figure 26 and Figure 27 in Section 4.2) was found to be effective. For instance, the panels on the first floor of the building H remained free from moisture ingress despite the absence of an FWP structure, relying solely on local protection. It has been suggested that if expected rainfall exceeds 40 mm or construction lasts longer than a few weeks, a roof cover becomes essential (Öberg & Wiege, 2018) or that CLT construction should preferably have complete weather protection. However, the results show that with local protection measures and scheduling the installation of CLT for a favourable season a moisture-safe outcome can be achieved, even when installation times exceed a few weeks and the measured cumulative precipitation amounts exceed 40 mm. Nevertheless, despite their potential effectiveness, local protection measures are not infallible. In the case shown in Figure 25 (in Section 4.1.2), the failure appears to be linked to the sequence of membrane installation over the floor panel joints. In contrast, Figure 49 (middle) illustrates damage to a liquid-applied membrane coating, likely caused by mechanical impact.

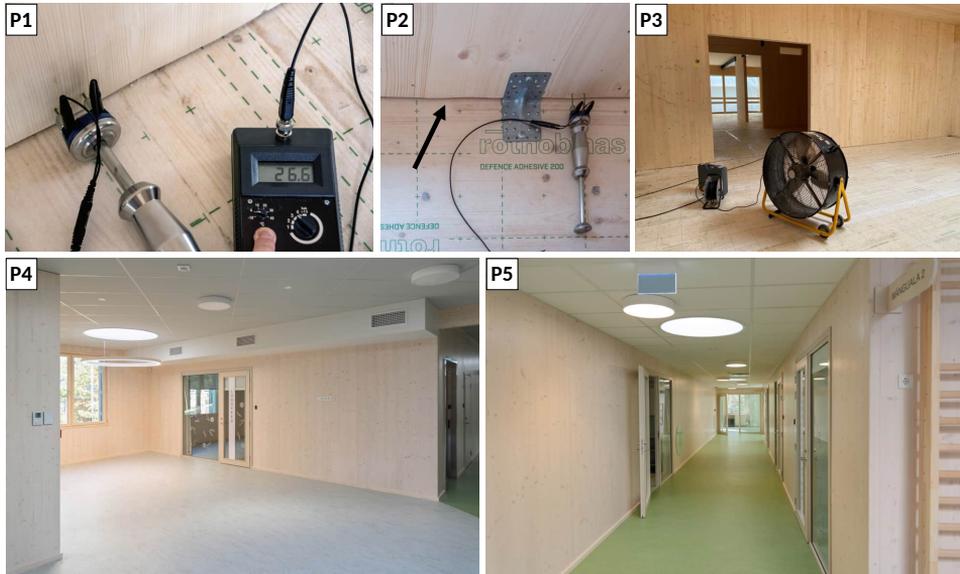
Figure 51 Moisture measurements (top left), timber swelling (top middle) and accelerated air drying (top right) in the building G. The bottom photos show the second-floor interior before completion and handover to the client.

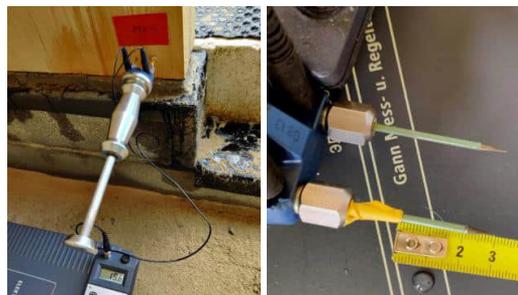
**Fig. 2.** Measuring the timber MC from a previously marked spot (left) using Teflon insulated electrode pins (right). Measuring depth was marked on the pins with contrasting tape.

MC in CLT structures was measured according to the EN 13183-2:2002 standard with an electrical resistance-based wood moisture meter, the Gann Hydromette LG 3. The measuring range of the moisture meter was 4 to 30% with a resolution of 0.1% and an accuracy of  $\pm 1\%$ . The uncertainty increases considerably with measurement values over fibre saturation point ( $\approx 30\%$ ). Nevertheless, we opted to report all the measurement readings as is. Values over 30% have a lower accuracy but are helpful to describe the extent of wetting. The moisture meter consisted of a measuring device and a ram-in electrode (Fig. 2, left). We used 60 mm long Teflon insulated pins for the ram-in electrode. The pins had 10 mm long uninsulated peaks that made it possible to measure the MC at different depths in the CLT. We selected a fixed depth of 30 mm (measuring range 20 to 30 mm, Fig. 2, right). The MC was measured at a height of 30 mm from the lower edge of the CLT wall panels, as the preliminary observations suggested that the cut edges of wall panels are the most critical. We chose 20 measurement points

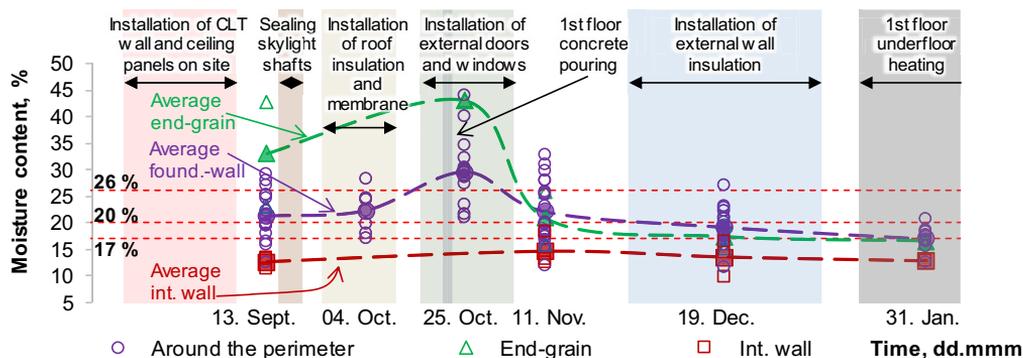
Fig. 4. MC of the CLT panels during distinct phases of construction. The filled markers show the average values of the measurements and the dashed lines represent the trend of average values. There were no measurements for the end grain on 4th October. The red dotted lines represent limiting values for mould growth and decay initiation.

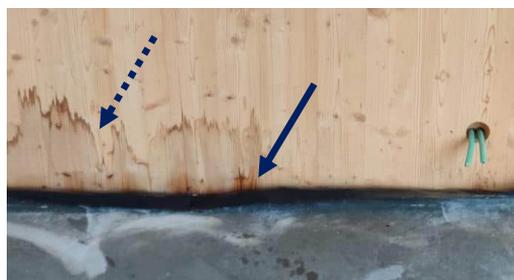
Fig. 5. CLT exterior wall and newly poured 1<sup>st</sup> floor concrete screed. Note the discoloration of timber from the previous wetting incident (dashed arrow) and new wetting mark (solid arrow) possibly from the concrete pouring.

The next construction phase was the installation of external doors and windows, between the 16<sup>th</sup> October and 4<sup>th</sup> November, which also included the first-floor concrete pouring on the 21<sup>st</sup> and 22<sup>nd</sup> October. The average precipitation was 0.8 mm/h and the maximum reached 4.6 mm/h. We measured MC again on the 25<sup>th</sup> October and the results showed a significant increase in MC. Average MC around the perimeter had risen to 29.5% and the average MC measured from end-grain reached 43%. MC was above 20% in all points and exceeded 26% in most points. This phenomenon might have occurred because of the concrete pouring on the 1<sup>st</sup> floor just before the measurements. Concrete pouring is a very moisture-intensive task and leads to great moisture excess. This prohibited the moisture dry-out from the CLT and might have increased the moisture content on surface layers because of the hygroscopic properties of timber. Moreover, it is possible that some of the wet, uncured concrete could have made contact with the CLT (Fig. 5). This further confirms our suggestion that the most critical joint is the exterior wall to foundation connection.

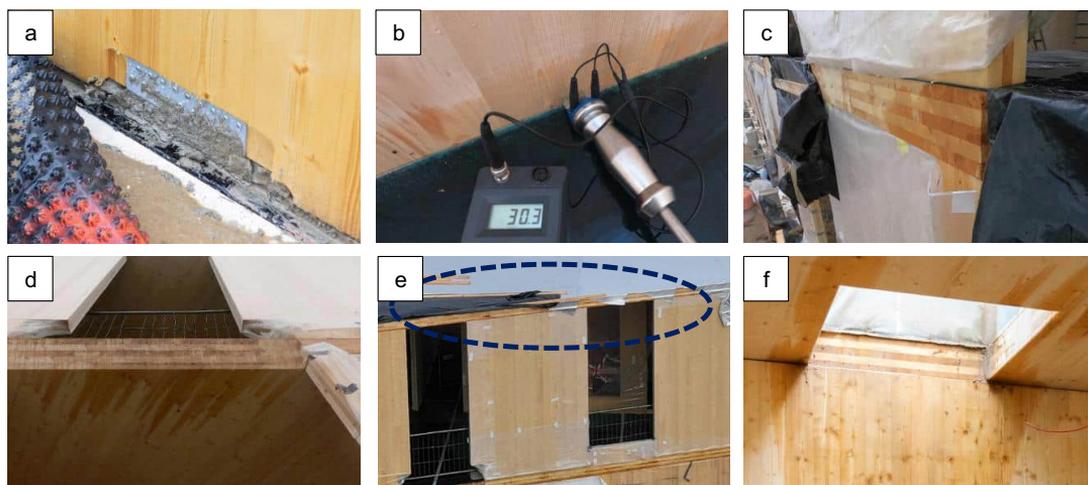
**Fig. 6.** Photographs of CLT junctions where wetting occurred frequently during our observation: a) exterior wall to foundation connection; b) intermediate ceiling to intermediate wall connection; c) intermediate ceiling to external wall connection; d) intermediate ceiling to window connection; e) roof to exterior wall connection and f) roof to skylight shaft connection.

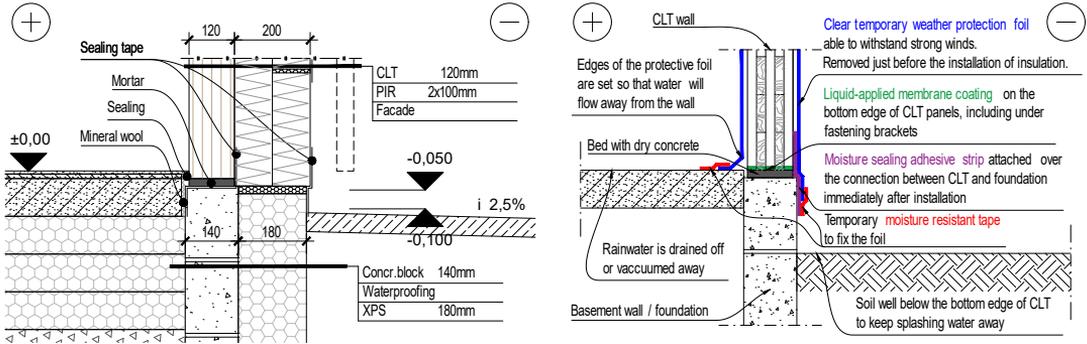
Fig. 7. Design drawing (left) of the exterior wall to foundation connection and our proposal (right) of wetting mitigation practices.

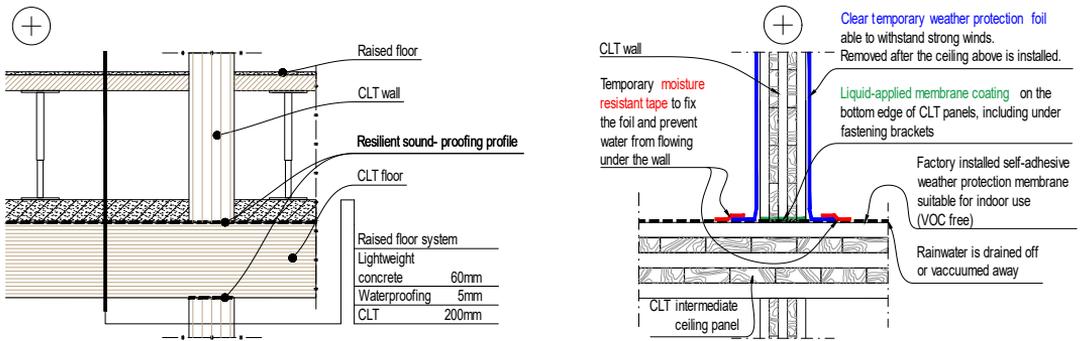
Fig. 8. Design drawing (left) of the intermediate ceiling to intermediate wall connection and our proposal (right) of wetting mitigation practices.

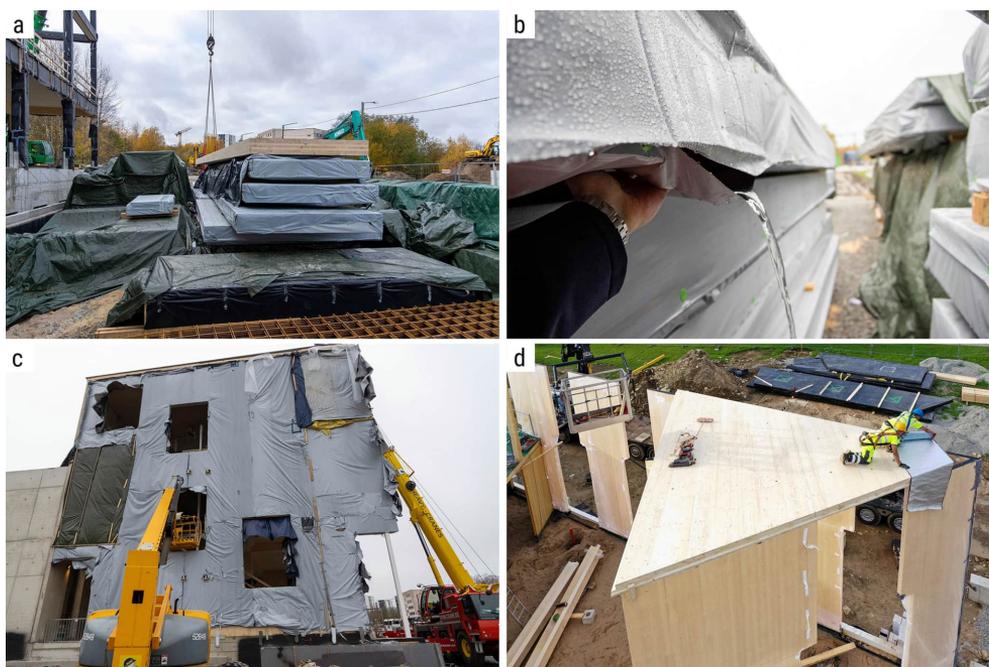
Fig. 5. Interim storage of CLT on-site (a) which proved to be inadequate and allowed water to enter the package (b). Problem detection was inhibited with opaque foils (a, b, c) but not with translucent foils (wall panels in photo d, however the roof panels were delivered without any protection and the on-site work to install the self-adhesive foil was time consuming and dangerous).

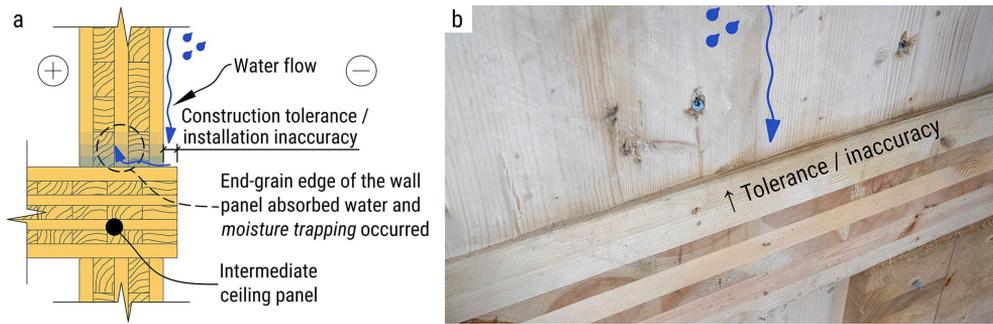
Fig. 7. CLT floor and wall panel connection joint (a) where the protruding floor panel (b) facilitated water ingress to the wall panel. Photo b is from building A.

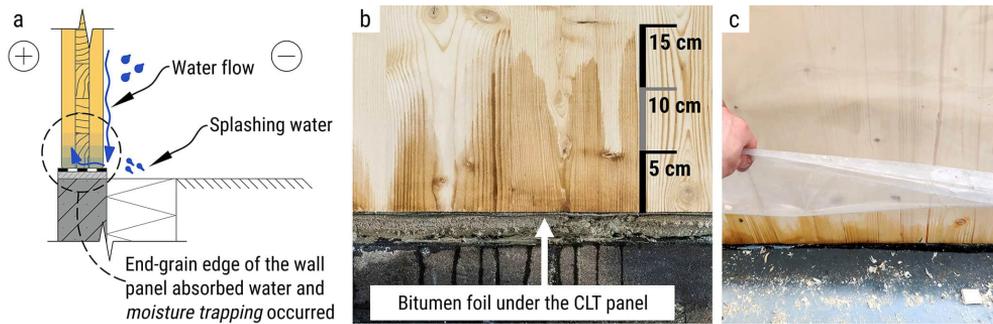
Fig. 8. CLT wall panel and foundation connection joint (a). The bottom edges of wall panels absorbed moisture despite bitumen strips under the CLT panels (b & c). Photo b = building B, photo c = building C.

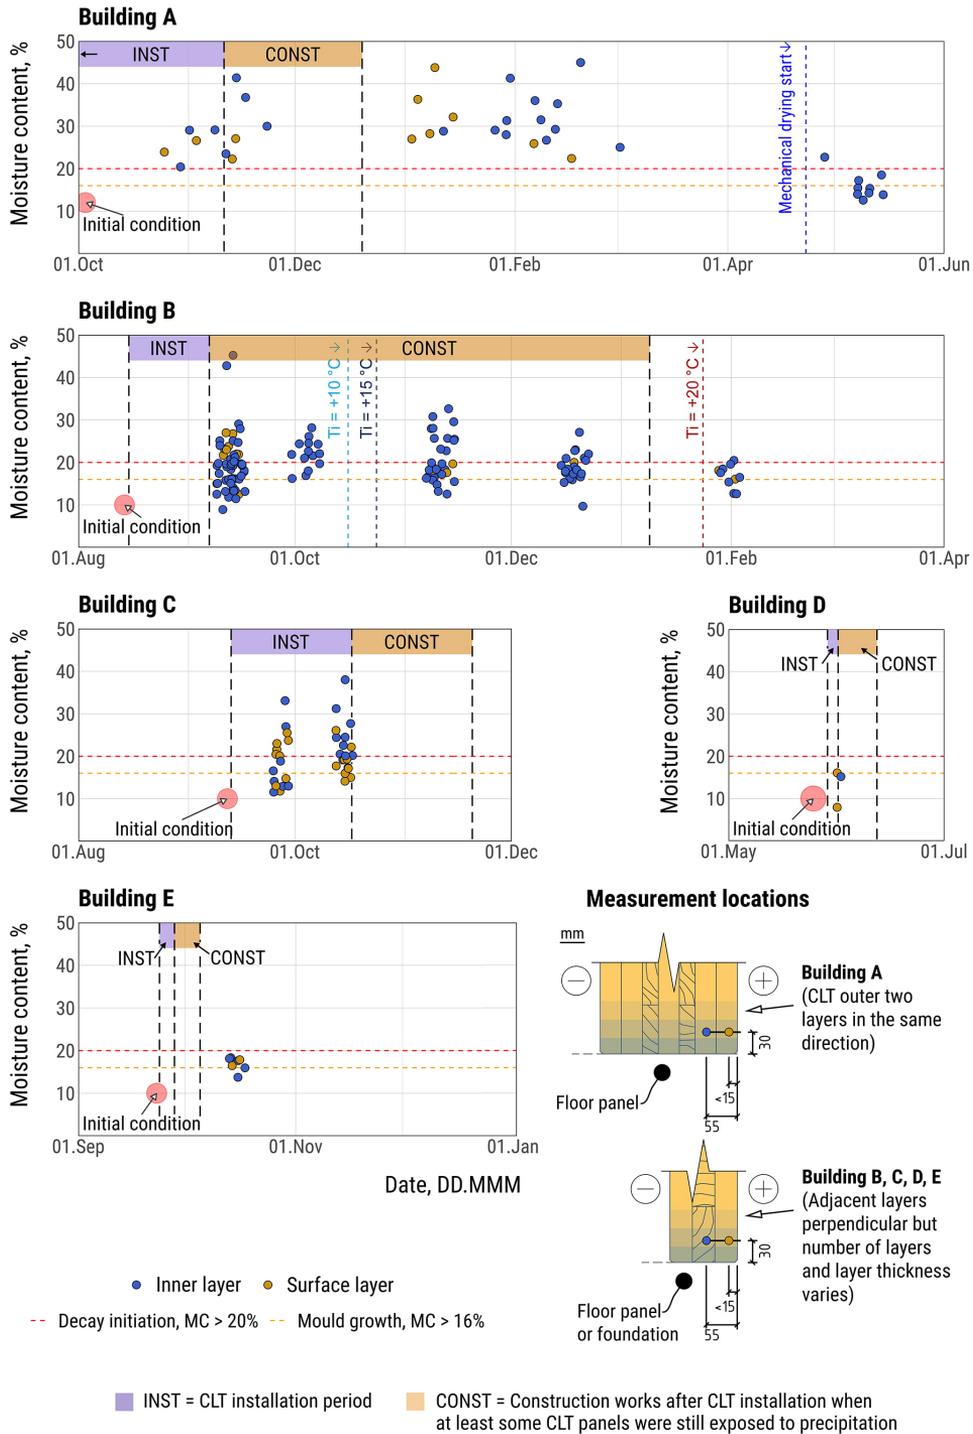
Fig. 9. Measured moisture content (MC) on the CLT wall panel bottom connection in five of the studied buildings. The initial condition circles mark the average range of CLT MC after leaving the factory (reported by the contractors).

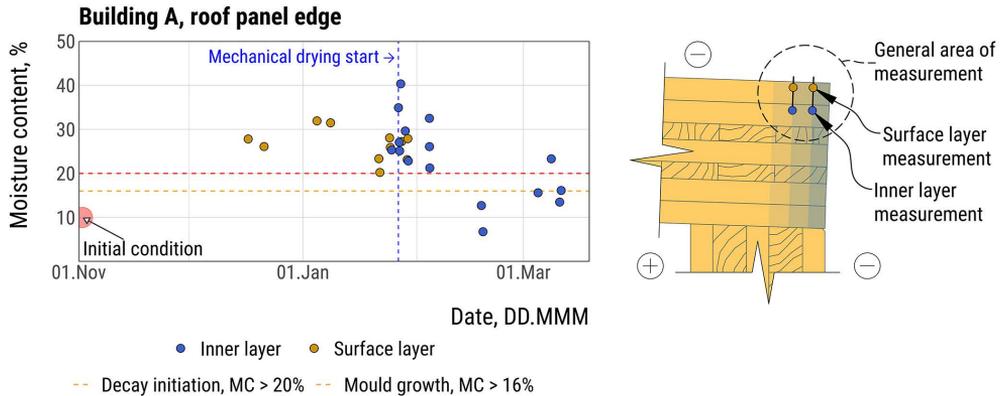
Fig. 13. Measured moisture content (MC) in the CLT roof panel edge in building A.

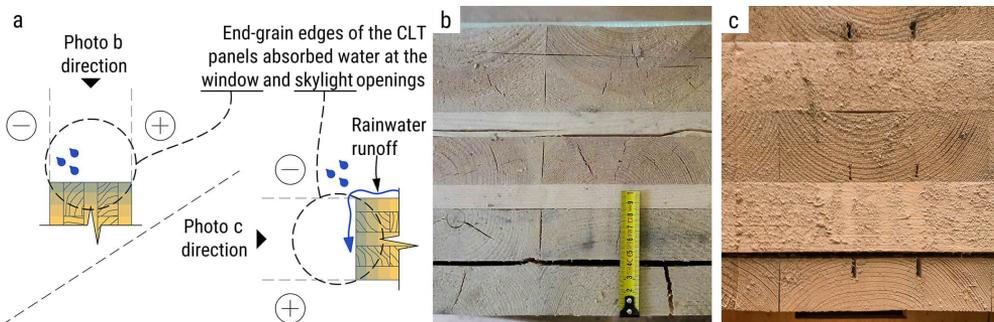
Fig. 14. Wall to window (b) and roof to skylight (c) connections (a), which experienced repeated wetting and where cracks and delamination occurred (b, c) after moisture dry-out (b = building A, c = building B).

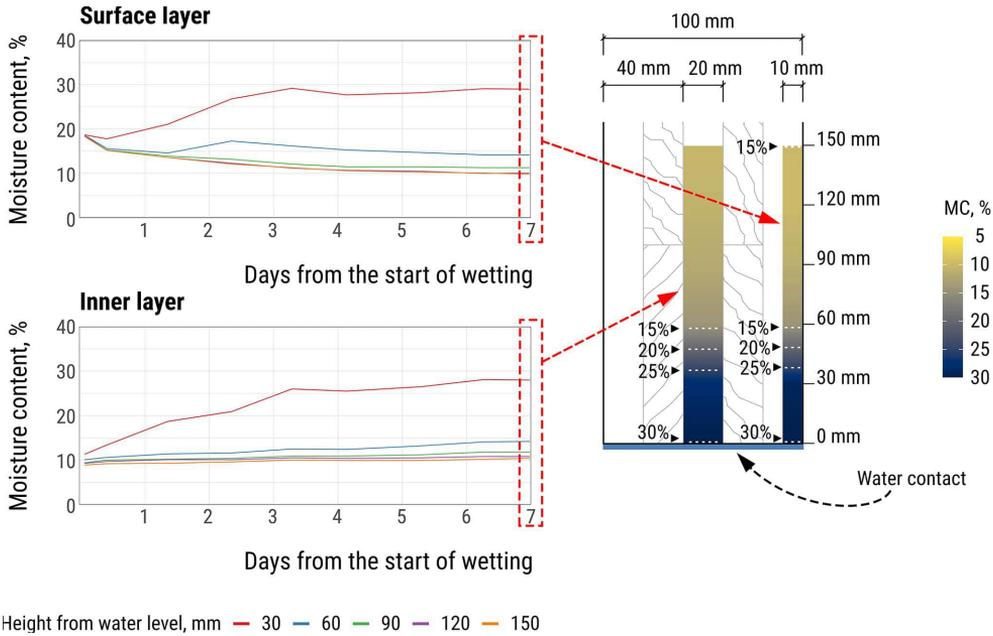
Fig. 15. Average measured moisture content in the CLT test specimen surface and inner layers (left) during the 7-day water contact period and a moisture distribution diagram interpolated from the datapoints of the last measurement.

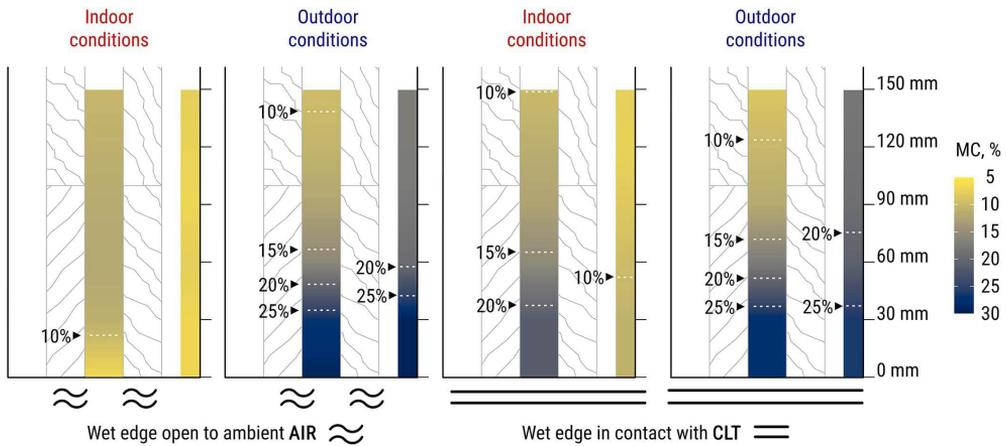
Fig. 16. Moisture distribution diagrams interpolated from the measured data after two weeks of drying.

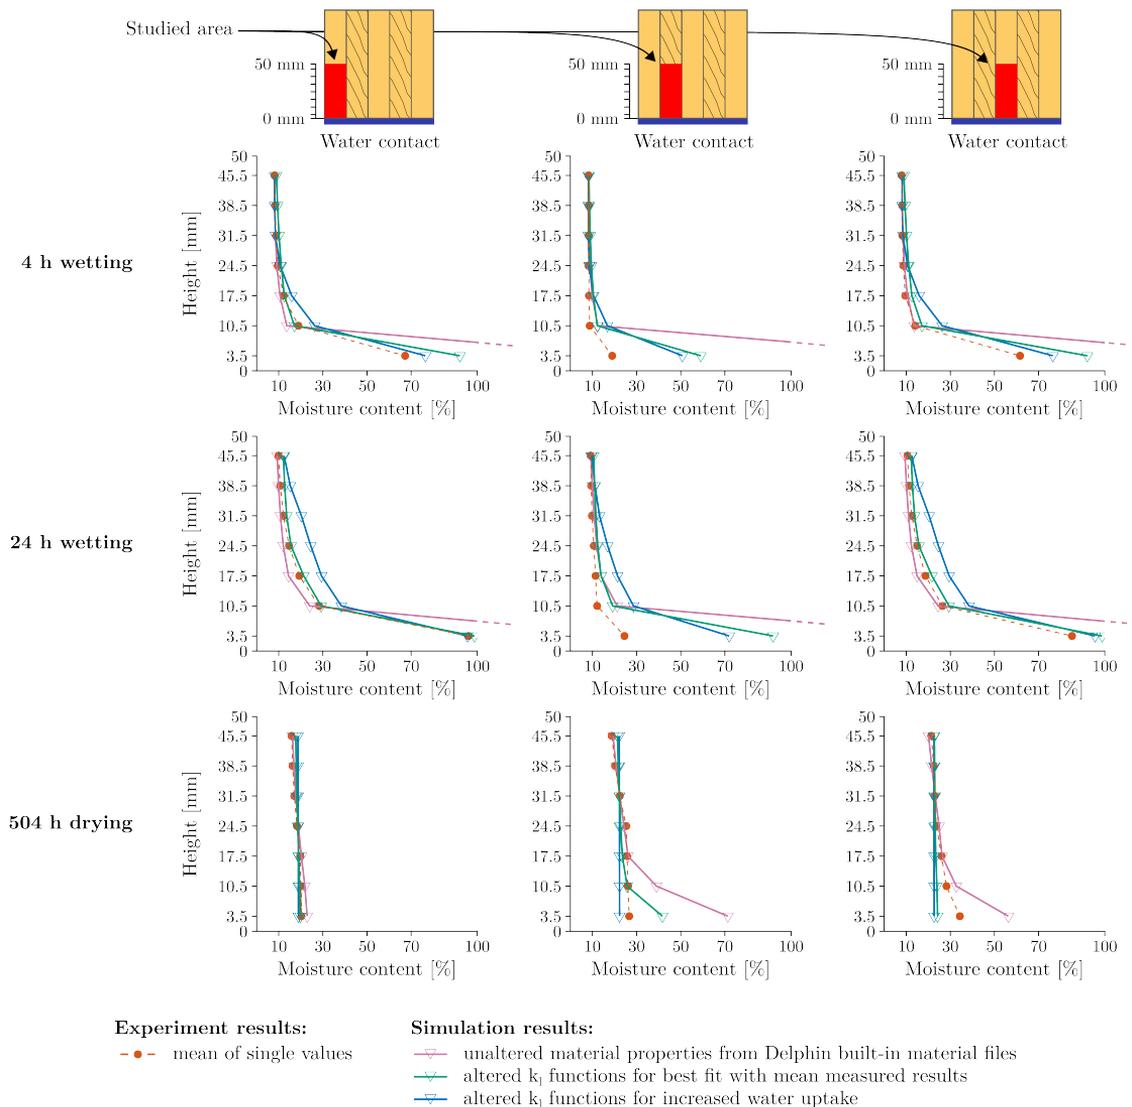
Fig. 9. Comparison of simulated results (open triangles and continuous lines) with the mean of measured values (closed circles and dashed lines). Measurement data originates from experiment 3, section 2.1.3.

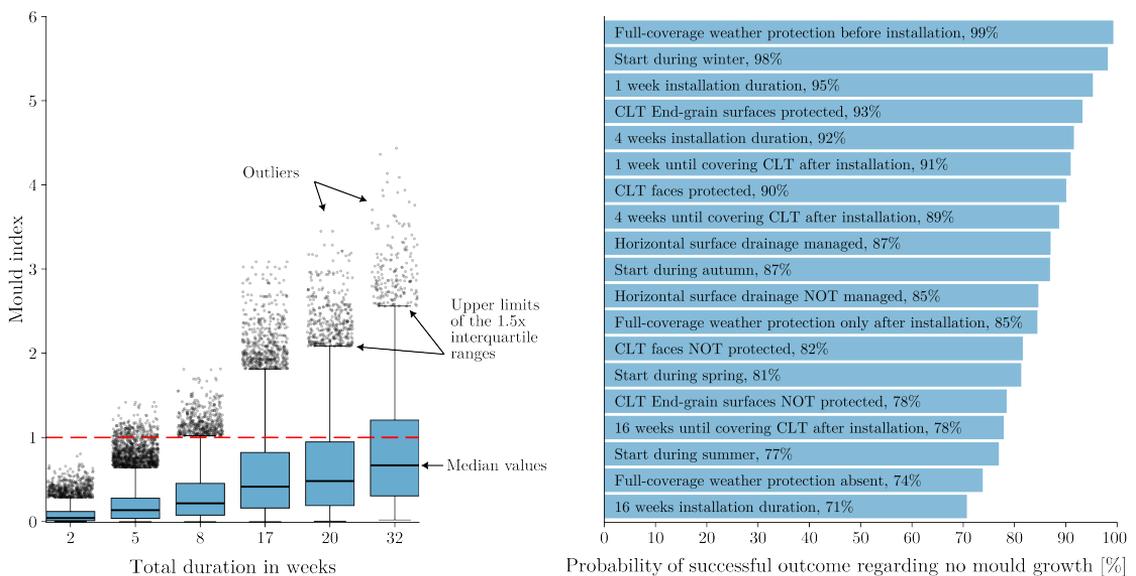
Fig. 12. Maximum mould index for all simulated combinations (left) and the probability of maximum M remaining below 1 during the CLT installation period and the post-installation period until covering the CLT with additional material layers (right).

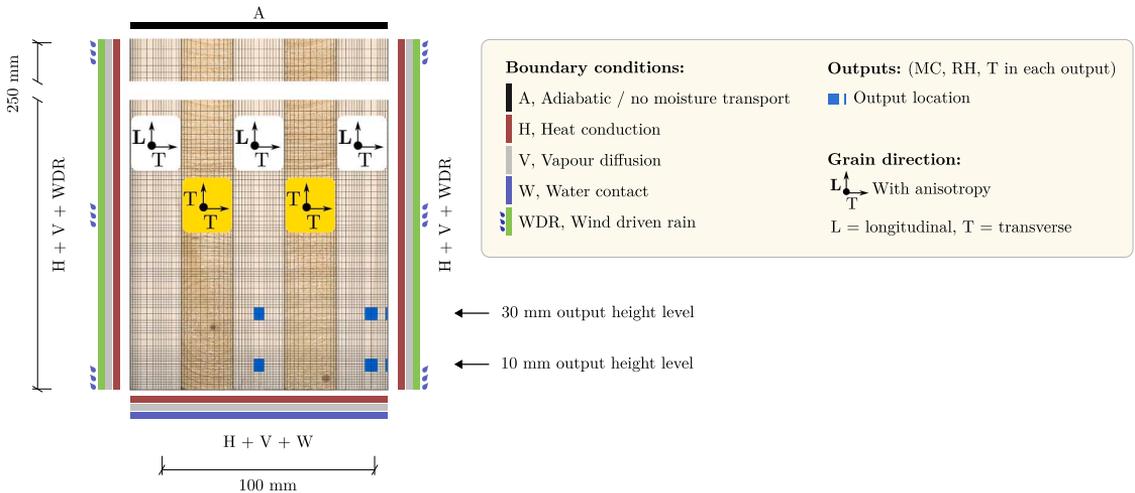
**Fig. 4.** Modelled geometry for the analysis of the CLT end-grain moisture safety. The illustration displays grain direction, boundary conditions, discretisation grid and output locations. CLT layer thicknesses in the model were adjusted to reflect the actual built structure of the case study buildings for MC comparisons with measured values.

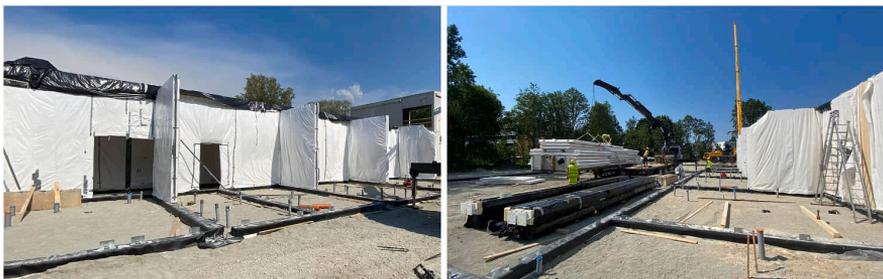
Fig. 5. Installation of the first CLT panels in building G. The CLT panels arrived wrapped in white plastic film.

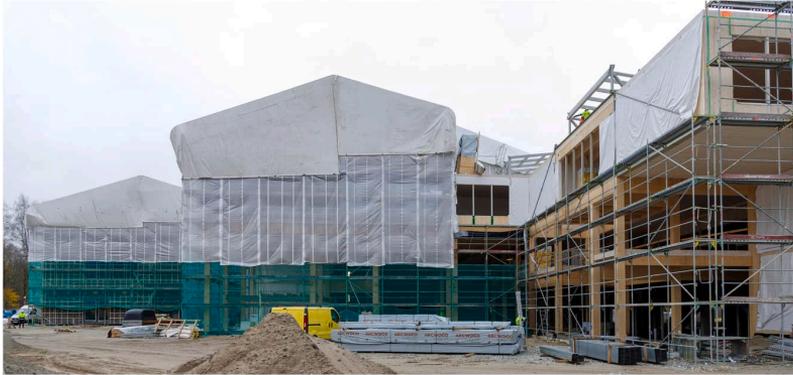
Fig. 6. Temporary full-coverage weather protection structure at different stages on the building G.

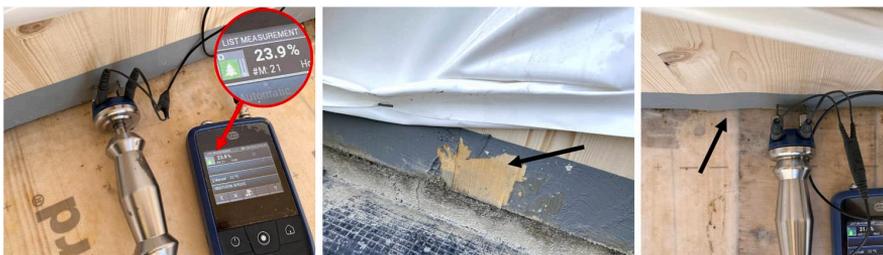
Fig. 9. Moisture measurements (left), waterproofing membrane damage (middle), and timber swelling (right) in the building G.

The points where the liquid applied waterproofing membrane was damaged functioned similarly to end-grain zones without protection. Weather data from a nearby weather station indicated that during the period up to the assembly of the full-coverage weather protection structure, the building G received approximately 70 mm of rain (Fig. 10, left), which was mostly diverted, but as the measurements indicated – some areas still got wet. Fig. 11 shows the measured moisture content (point) values and simulated moisture content values (continuous lines) based on the actual climate data from each building's construction period and based on the main moisture protection strategy. In case of the building G, the calculations were also made for the hypothetical variant which excluded the end-grain surface protections, although, the main strategy assumed ideal end-grain protection. The measured values are also divided into two based on whether their first moisture content value was over 19 % or not. The measured moisture content values which exceeded 19 % were deemed to have been taken from the areas where a probable end-grain protection damage was present. Most measured values remained below the values simulated with an ideal end-grain protection. Both the simulated and measured results for the variant with a functioning end-grain protection reflected the tendency for moisture content increase over time which affirms the risk indicated by the moisture safety analysis framework (Fig. 7). Fortunately, the long period under the full-coverage weather protection structure without additional wall assembly layers also provided time for moisture dry-out. The measured values from the areas with presumed end-grain protection damage correlated well with the simulation where no end-grain protection was assumed. Both of these indicated a moisture dry-out over time. A long period after the CLT installation when the panels were exposed to outside air had a dual effect: it caused an increase of moisture content in the panels, yet also allowed excess moisture dry-out from previous wetting incidents.

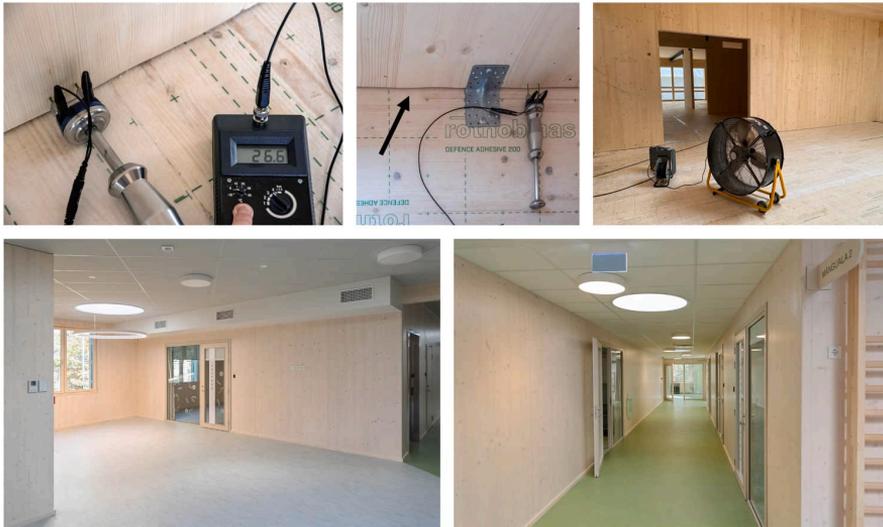
Fig. 12. Moisture measurements (top left), timber swelling (top middle) and accelerated air drying (top right) in the building G. The bottom photos show the second floor interior before final completion and handover to the client.

Visual findings also confirmed that the wet areas exhibited swelling (Fig. 12, top middle). After the discovery of the wet CLT on the second floor, large air fans were brought on the site to accelerate the moisture dry-out (Fig. 12, top right). Fortunately, the installation start was during winter and the main period when moisture was dried out was during spring, which is the period with the highest moisture dry-out potential in Estonia. The simulated moisture content showed a sufficient correlation with the measured values throughout the dry-out period (Fig. 11, right chart) though it was slightly higher – likely because of increased air change from the fans. Safe moisture content was achieved at approximately 8 weeks after the building was enclosed. Furthermore, most walls were left

exposed in the final interior, allowing for extended moisture dry-out periods without disrupting the construction schedule (Fig. 12, bottom).
